Preliminary Karst Field Reconnaissance

AES – Riverside Solar Project

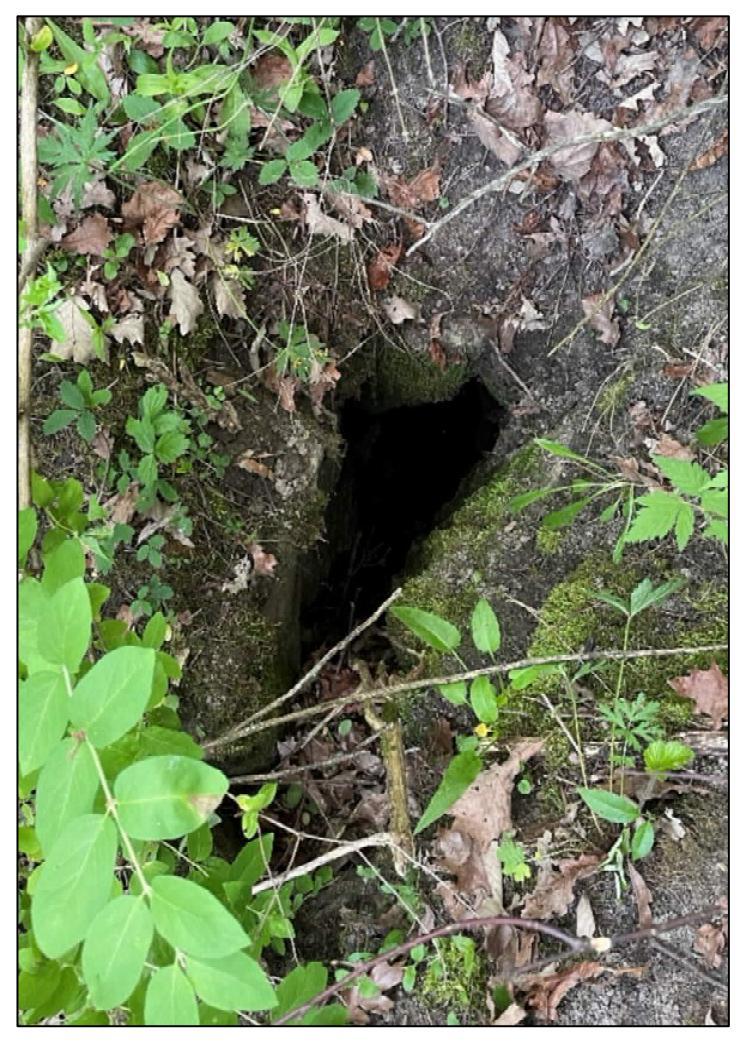
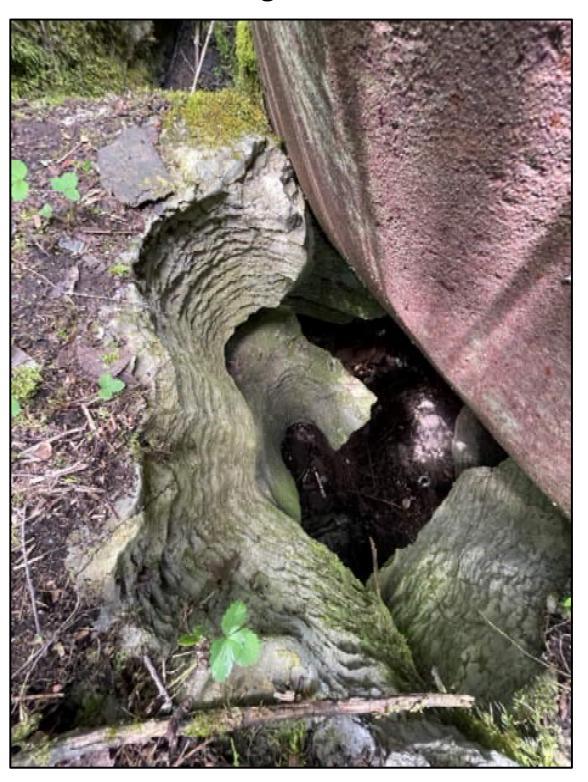
Visual inspection by our onsite geotechnical representative showed there were several features consistent with karst topography. On the northern end of this AOC was an opening in the rock roughly one square foot in size. This opening was fairly deep, approximately 25 feet based on visual estimates. Our geotechnical representative classified this as a small ponor. There was also an additional light source in the hole which points to a second opening to the cavern. However, our geotechnical representative was unable to locate this opening. This feature can be seen in **Figure 4**. Approximately 20 feet to the south was a narrow chasm, with walls lined with bedrock. It was approximately 50 feet in length. It varied in width from less than a foot to upwards of 5 feet. It was difficult to discern the depth of the feature because it had been used as a dumping ground for trash. This feature can be seen in **Figure 5** and **Figure 6**. AOC-01 was heavily vegetated and therefore the video recorded by our aerial drone does not show these features.

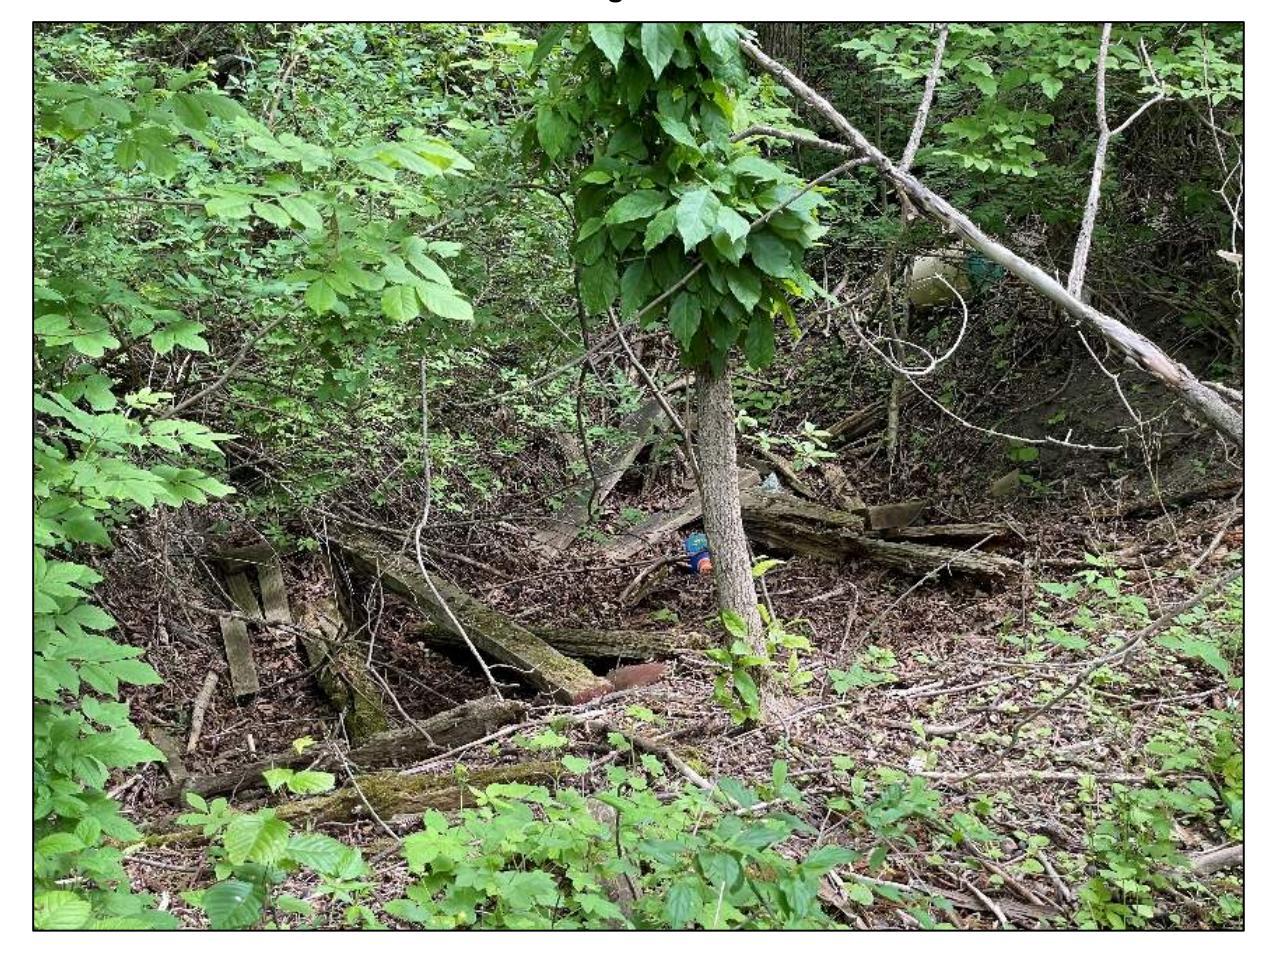
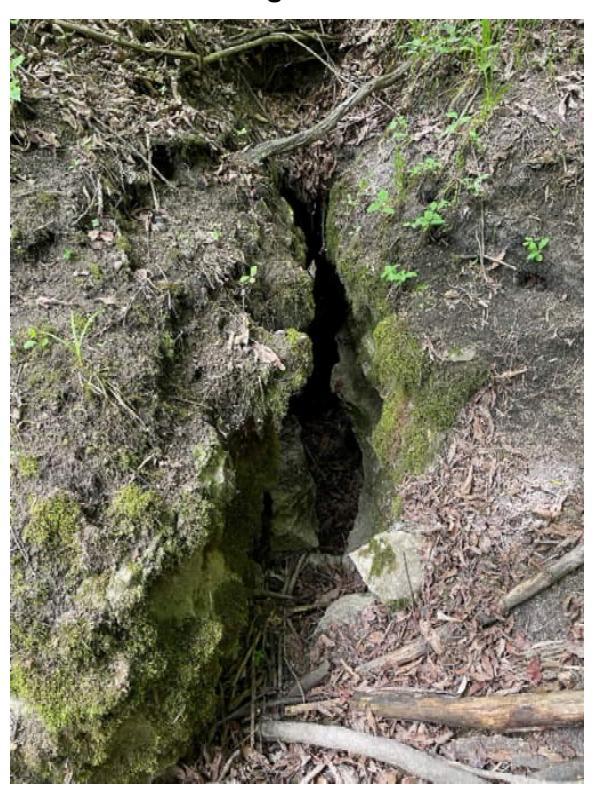
Visual inspection revealed the presence of karst features. To the south of the AOC, there were multiple depression areas which varied in size from 5 feet wide to 20 feet wide. These features can be found in **Figure 7**. This AOC was also mapped as having a disappearing stream. Our geotechnical representative was able to find evidence of a streambed; however, it should be noted it had rained the night prior to inspection and the streambed was dry. There was also a considerable amount of leaf litter in the streambed indicated that water had not flown in some time. Regardless, the streambed led to a narrow chasm characteristic of karst. The streambed can be seen in **Figure 8** and the chasm can be seen in **Figure 9**. A rock sample was taken from the wall of the chasm. AOC-02 was heavily vegetated and therefore the video recorded by our aerial drone does not show these features.

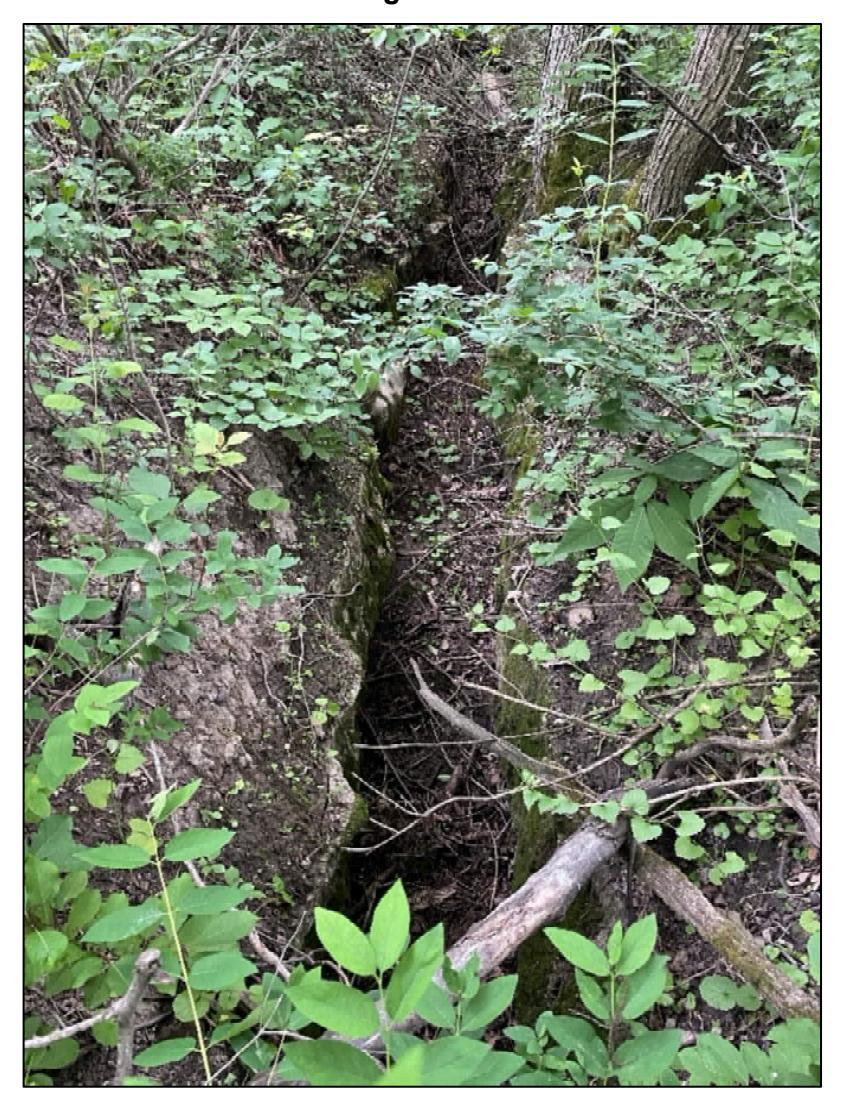
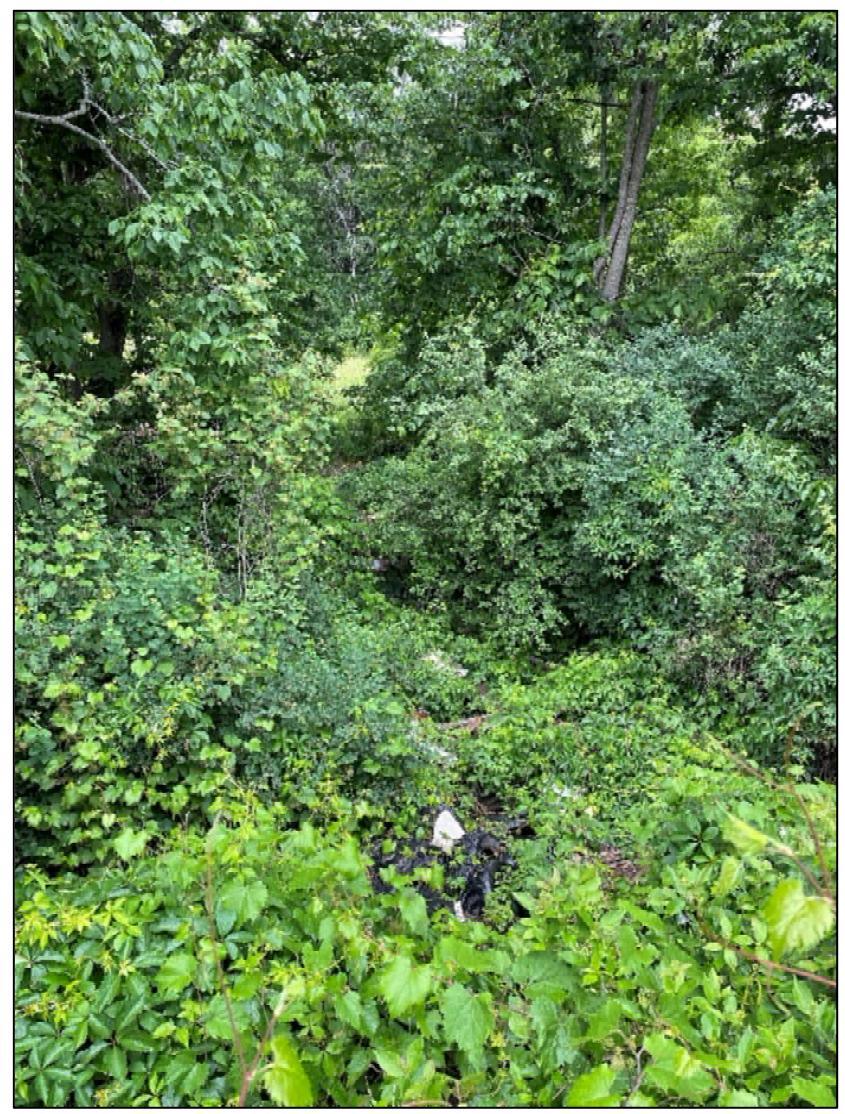
Visual inspection by our geotechnical representative revealed the presence of karst topography in this area. At the southern end of the area were several depressed areas around 5 feet in diameter. There was also a shallow, narrow vertical chasm ranging from 1 to 2 feet in width and approximately 20 feet in length. This chasm is pictured in **Figure 10**. The northern end of the AOC was covered with very thick brush making navigating through the area and visually inspecting it quite difficult. However, our geotechnical representative was still able to find a large sinkhole, approximately 50 feet in diameter. This sinkhole is pictured in **Figure 11**. AOC-03 was heavily vegetated and therefore the video recorded by our aerial drone does not show these features.

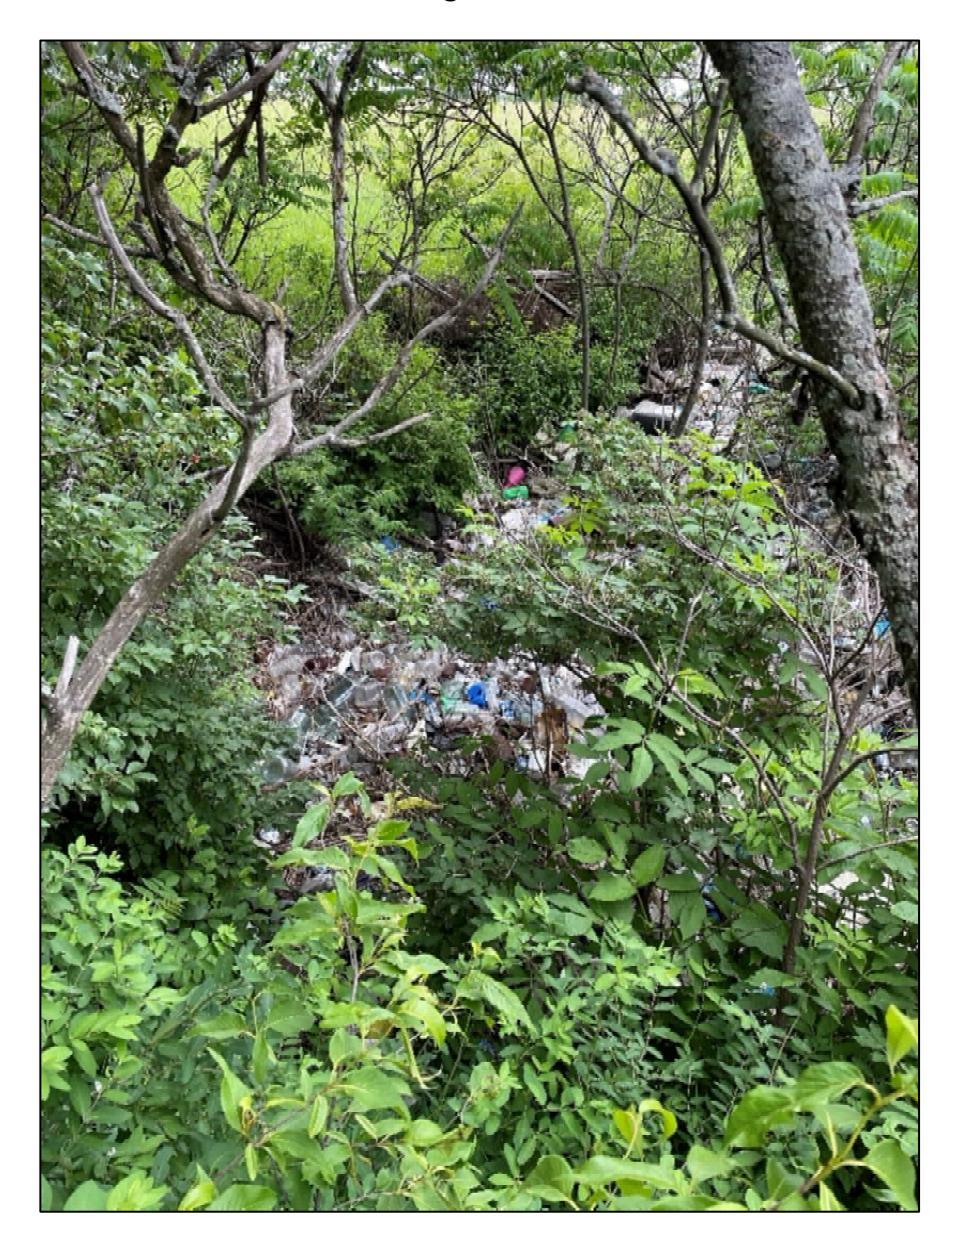
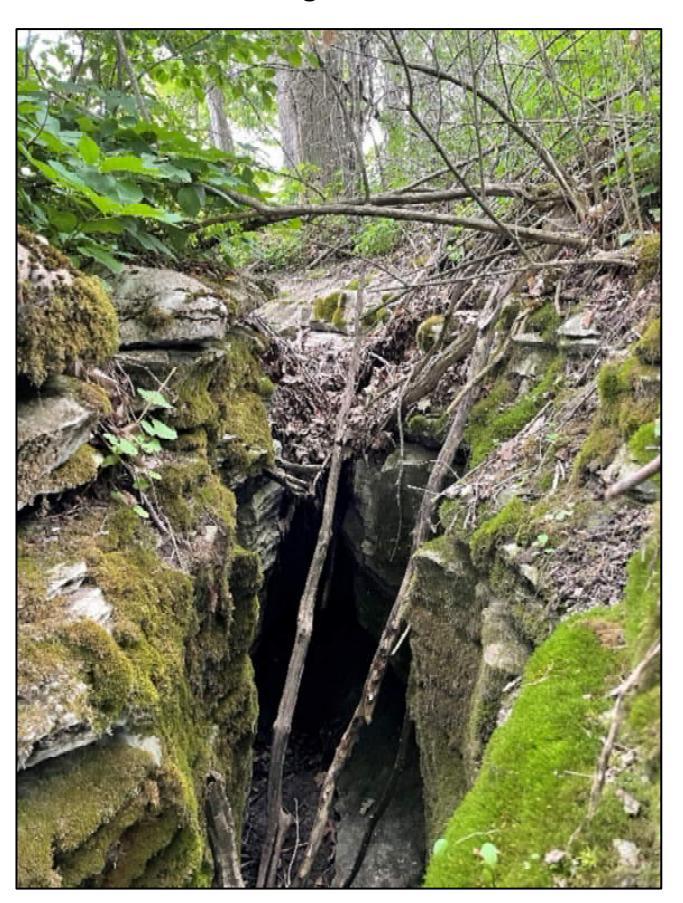
Visual inspection by our geotechnical representative revealed the presence of karst topography. At the southern end of the AOC was a large sinkhole, approximately 45ft in diameter. Depth was difficult to discern as the sinkhole had been filled with trash. The sinkhole is pictured in **Figure 12**. At the northern end of the AOC was another large sinkhole. This sinkhole was similar in size to the other one at this AOC. It is worth nothing that there were no large trees in this sinkhole and there was one fallen tree. This may indicate some more recent activity. Immediately adjacent to this sinkhole was a narrow chasm approximately 3 feet in width a depth of approximately 6 feet. The sinkhole can be seen in **Figure 13** and the chasm can be seen in **Figure 14**. Aerial footage taken by the drone here shows the large surface depressions.

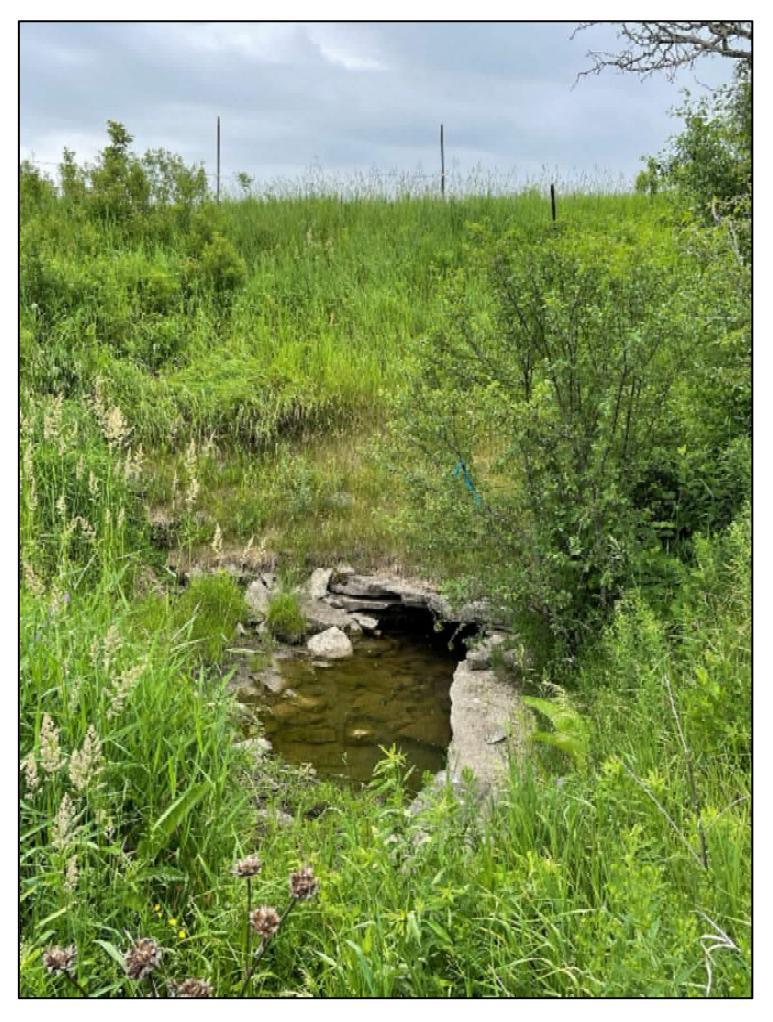
Figure 15

AOC-05, located south of AOC-04 and west of AOC-06, contained a spring located within a deep surface depression. There is also a deep depression approximately 10 feet in diameter just north of the spring. This spring is pictured in **Figure 15**.

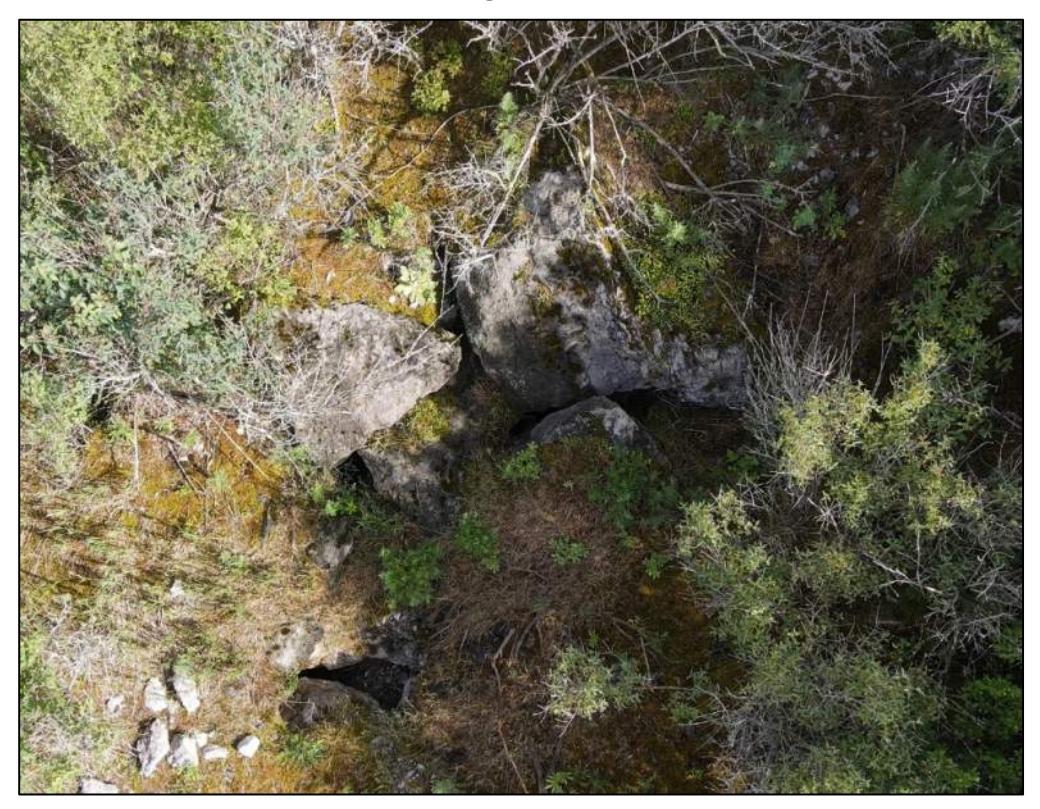
Figure 16

AOC-07 was located off the site boundaries however it is immediately adjacent to the site and in close proximity to AOC-01 and AOC-02. Our geotechnical representative did not go onto the property but did inspect the area with an aerial drone. It appears that there may be karst terrain at the location of AOC-07, pictured in **Figure 16**.
