SOMERSET SOLAR FACILITY

VISUAL SIMULATION

AUGUST 2023

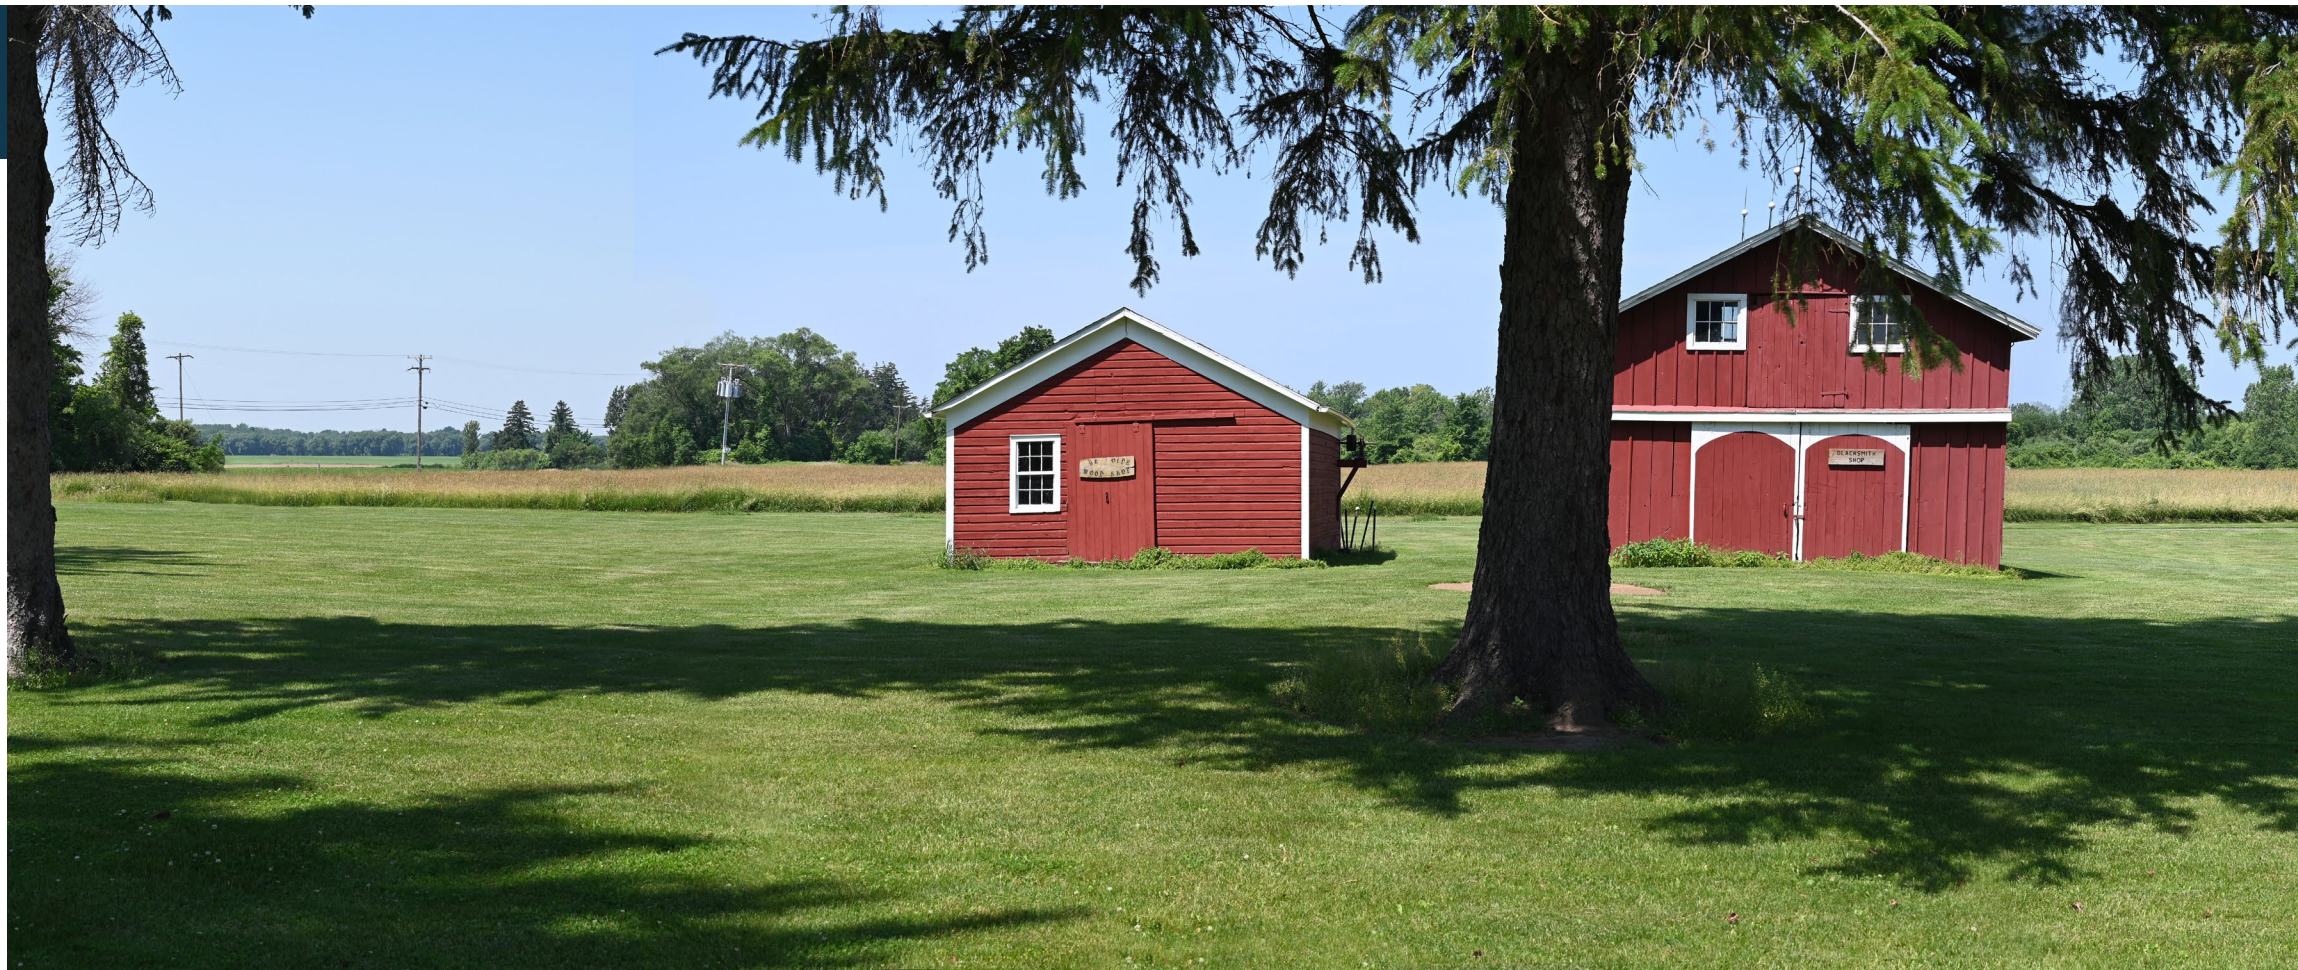
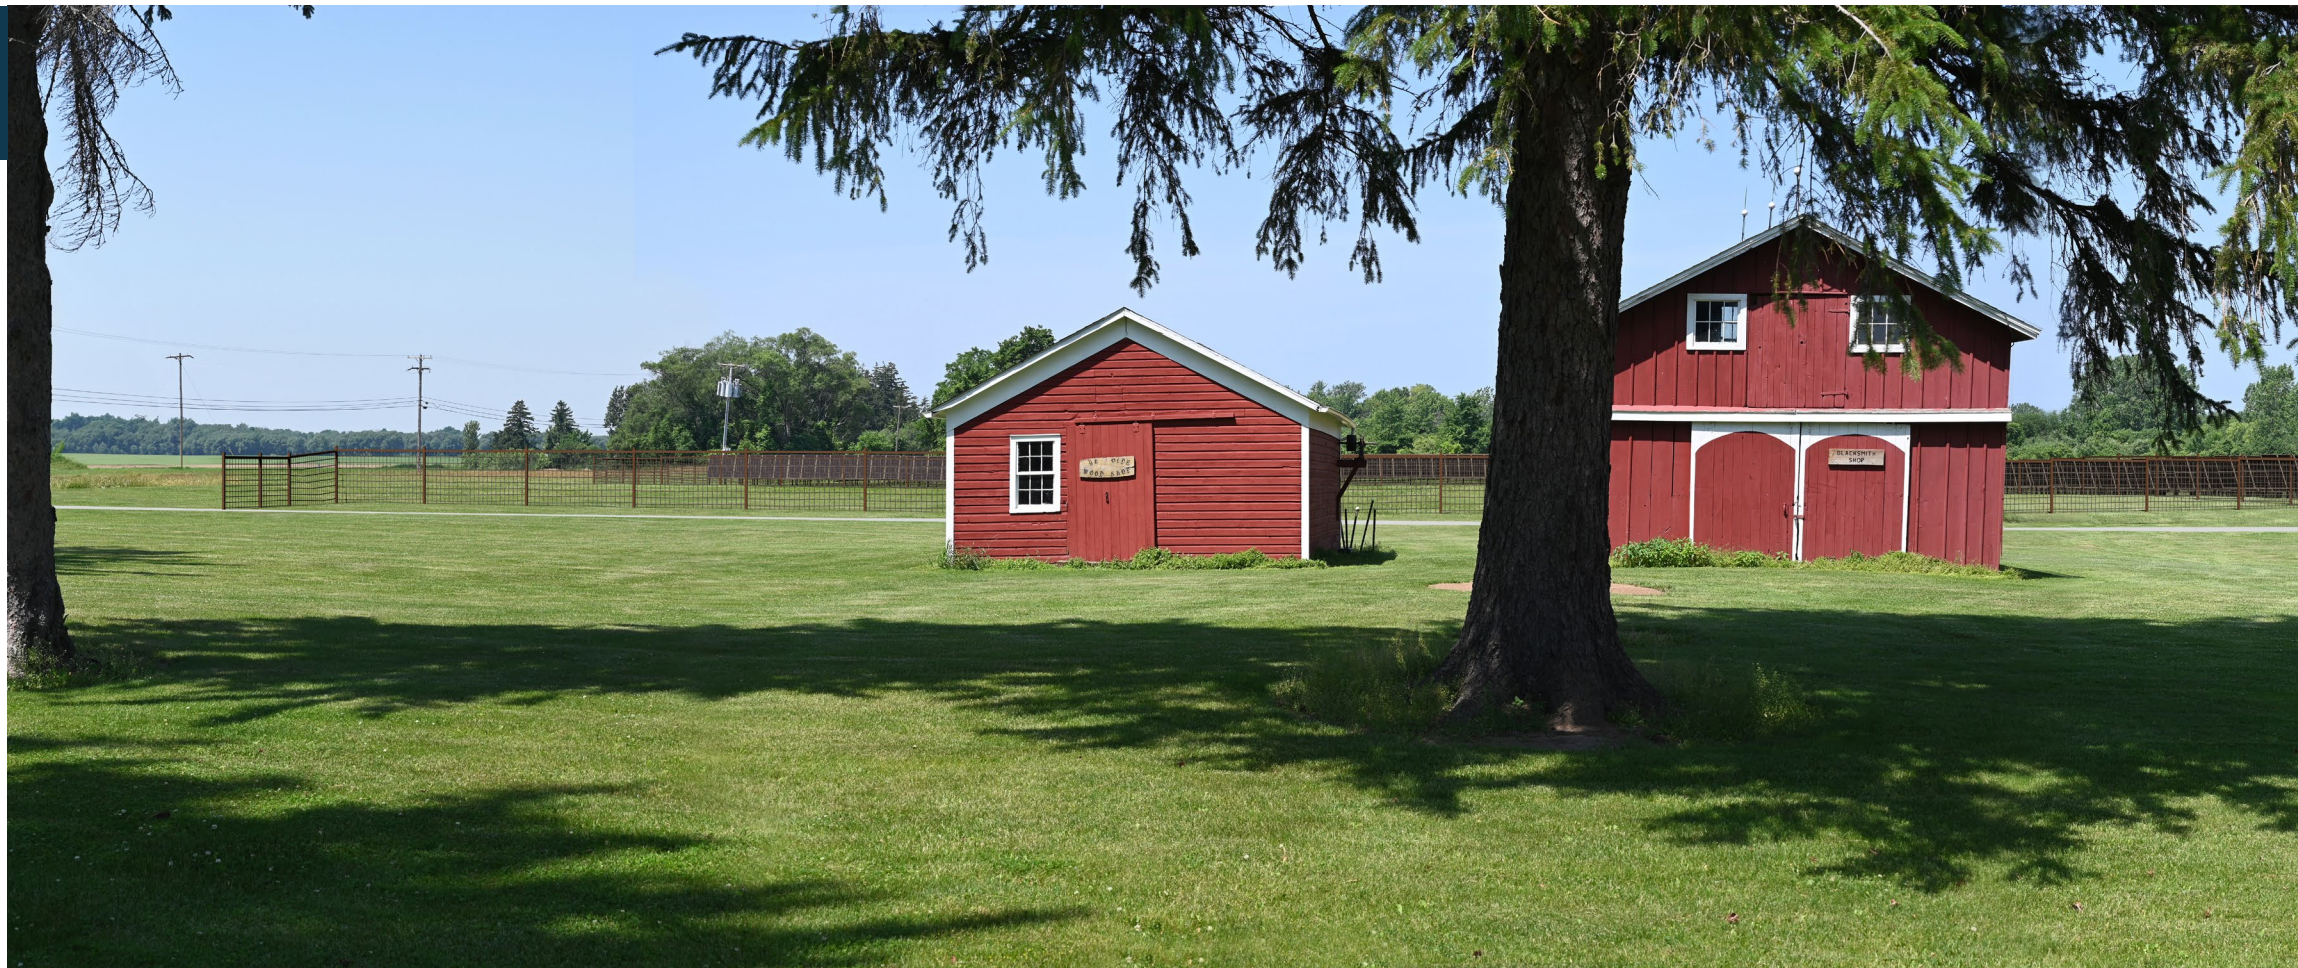
VIEWPOINT 1A

EXISTING CONDITIONS

SIMULATED CONDITIONS

Leaf On

No Proposed Screening

Time of photograph: 9:39 a.m.
Date of photograph: 06/22/2022
Weather condition: Sunny
Viewing direction: West
View orientation: Level
Latitude: 43.349703°
Longitude: -78.615066°
Elevation: 302 ft.
Photo Location: The photo was taken from Babcock House property looking west toward project area.

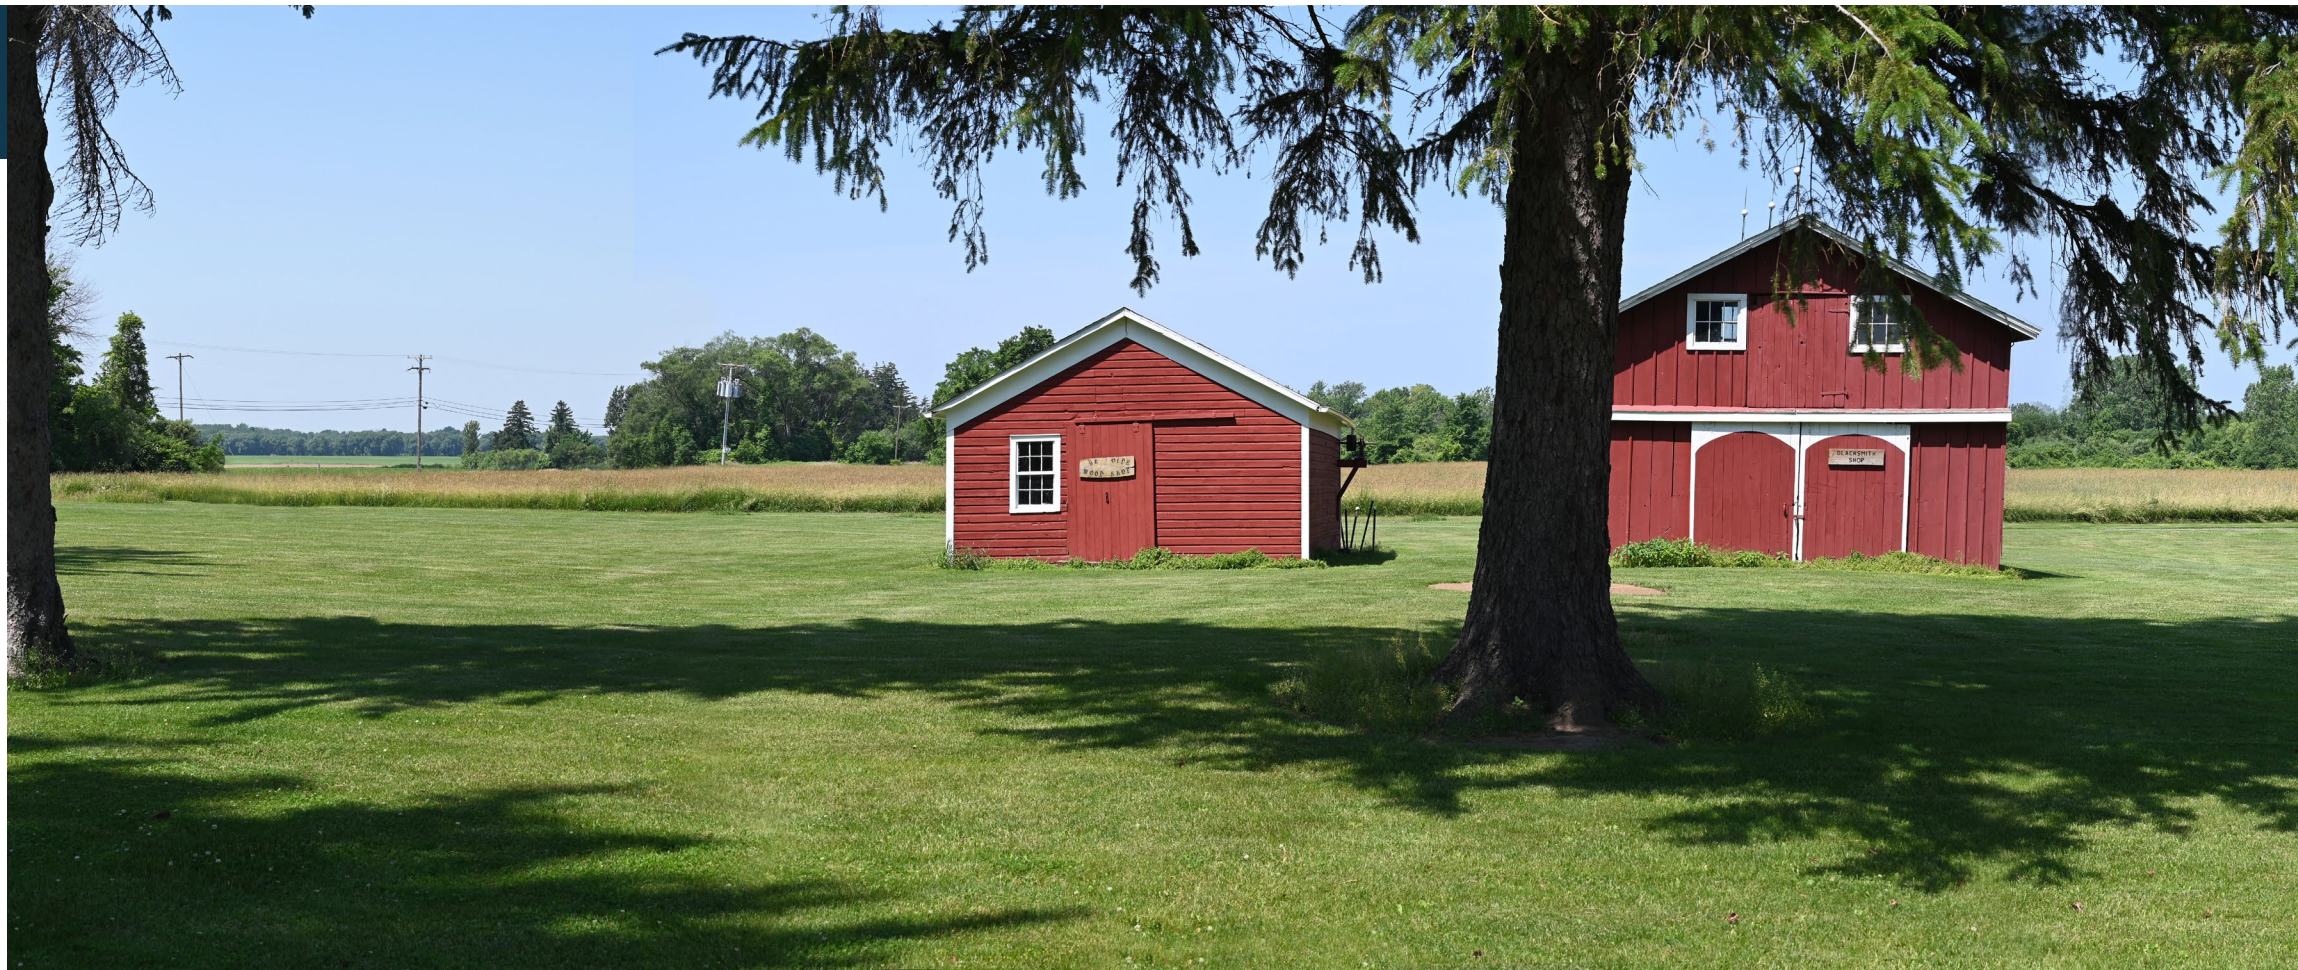
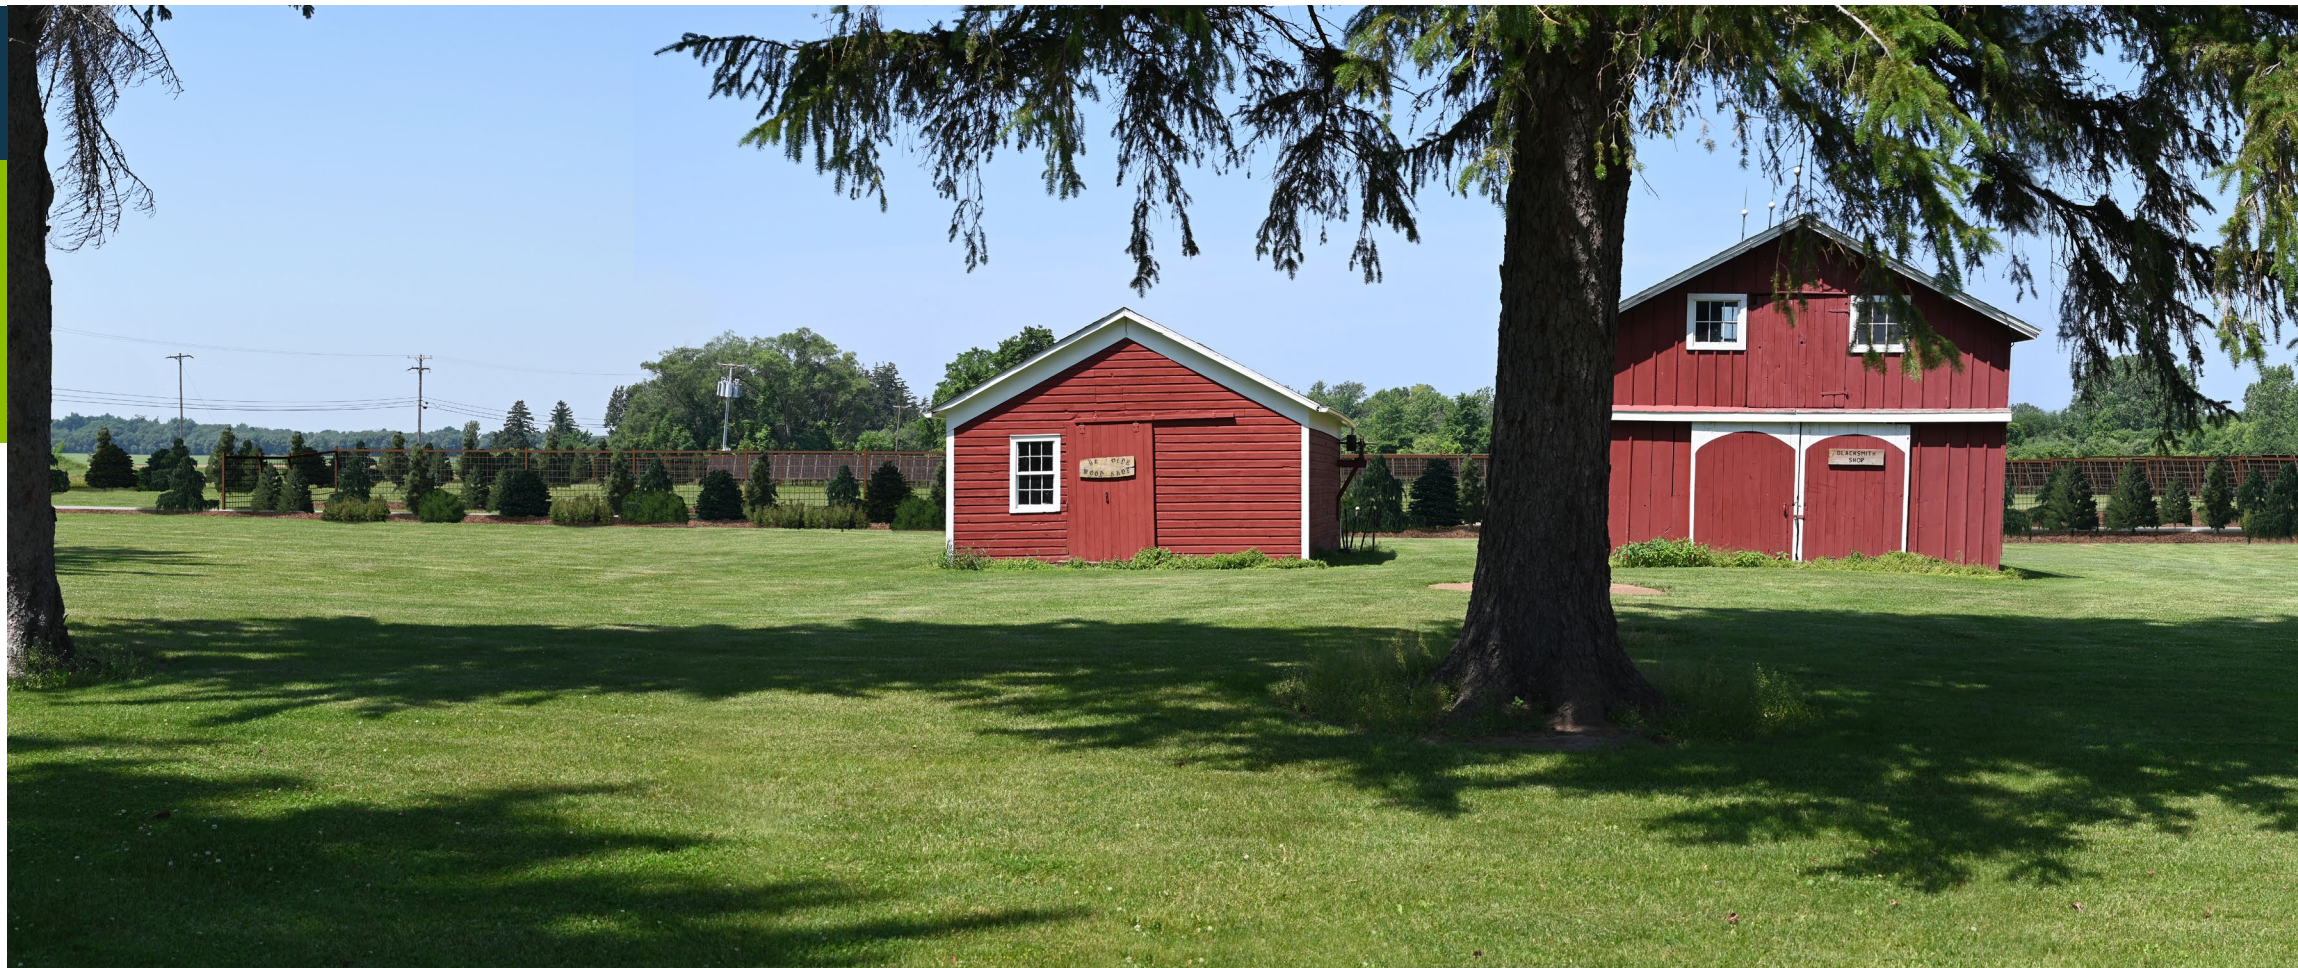
Viewpoint 1A

EXISTING CONDITIONS

SIMULATED CONDITIONS

WITH
PROPOSED
SCREENING
(YEAR 0)

Leaf On

With Proposed Screening
Year 0

Time of photograph: 9:39 a.m.
Date of photograph: 06/22/2022
Weather condition: Sunny
Viewing direction: West
View orientation: Level
Latitude: 43.349703°
Longitude: -78.615066°
Elevation: 302 ft.
Photo Location: The photo was taken from Babcock House property looking west toward project area.

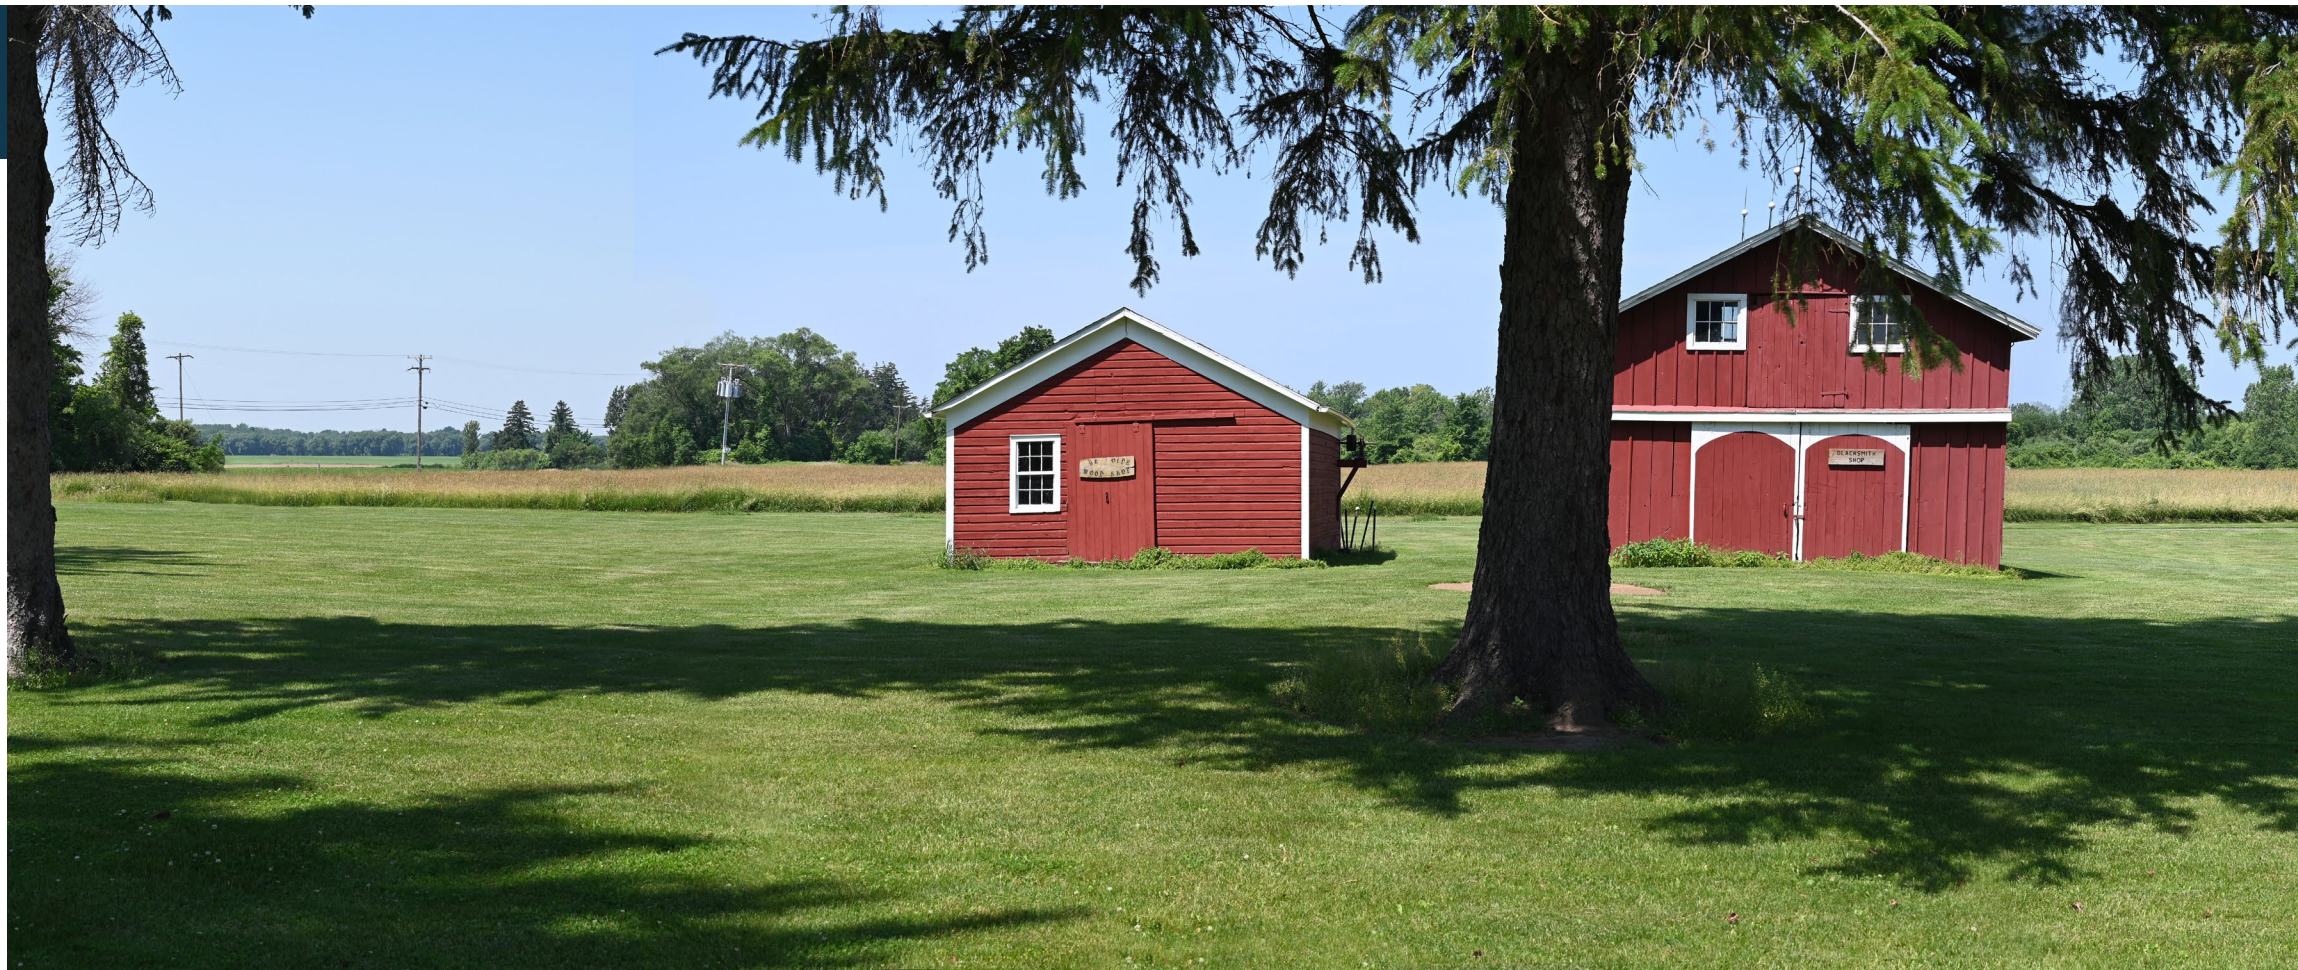
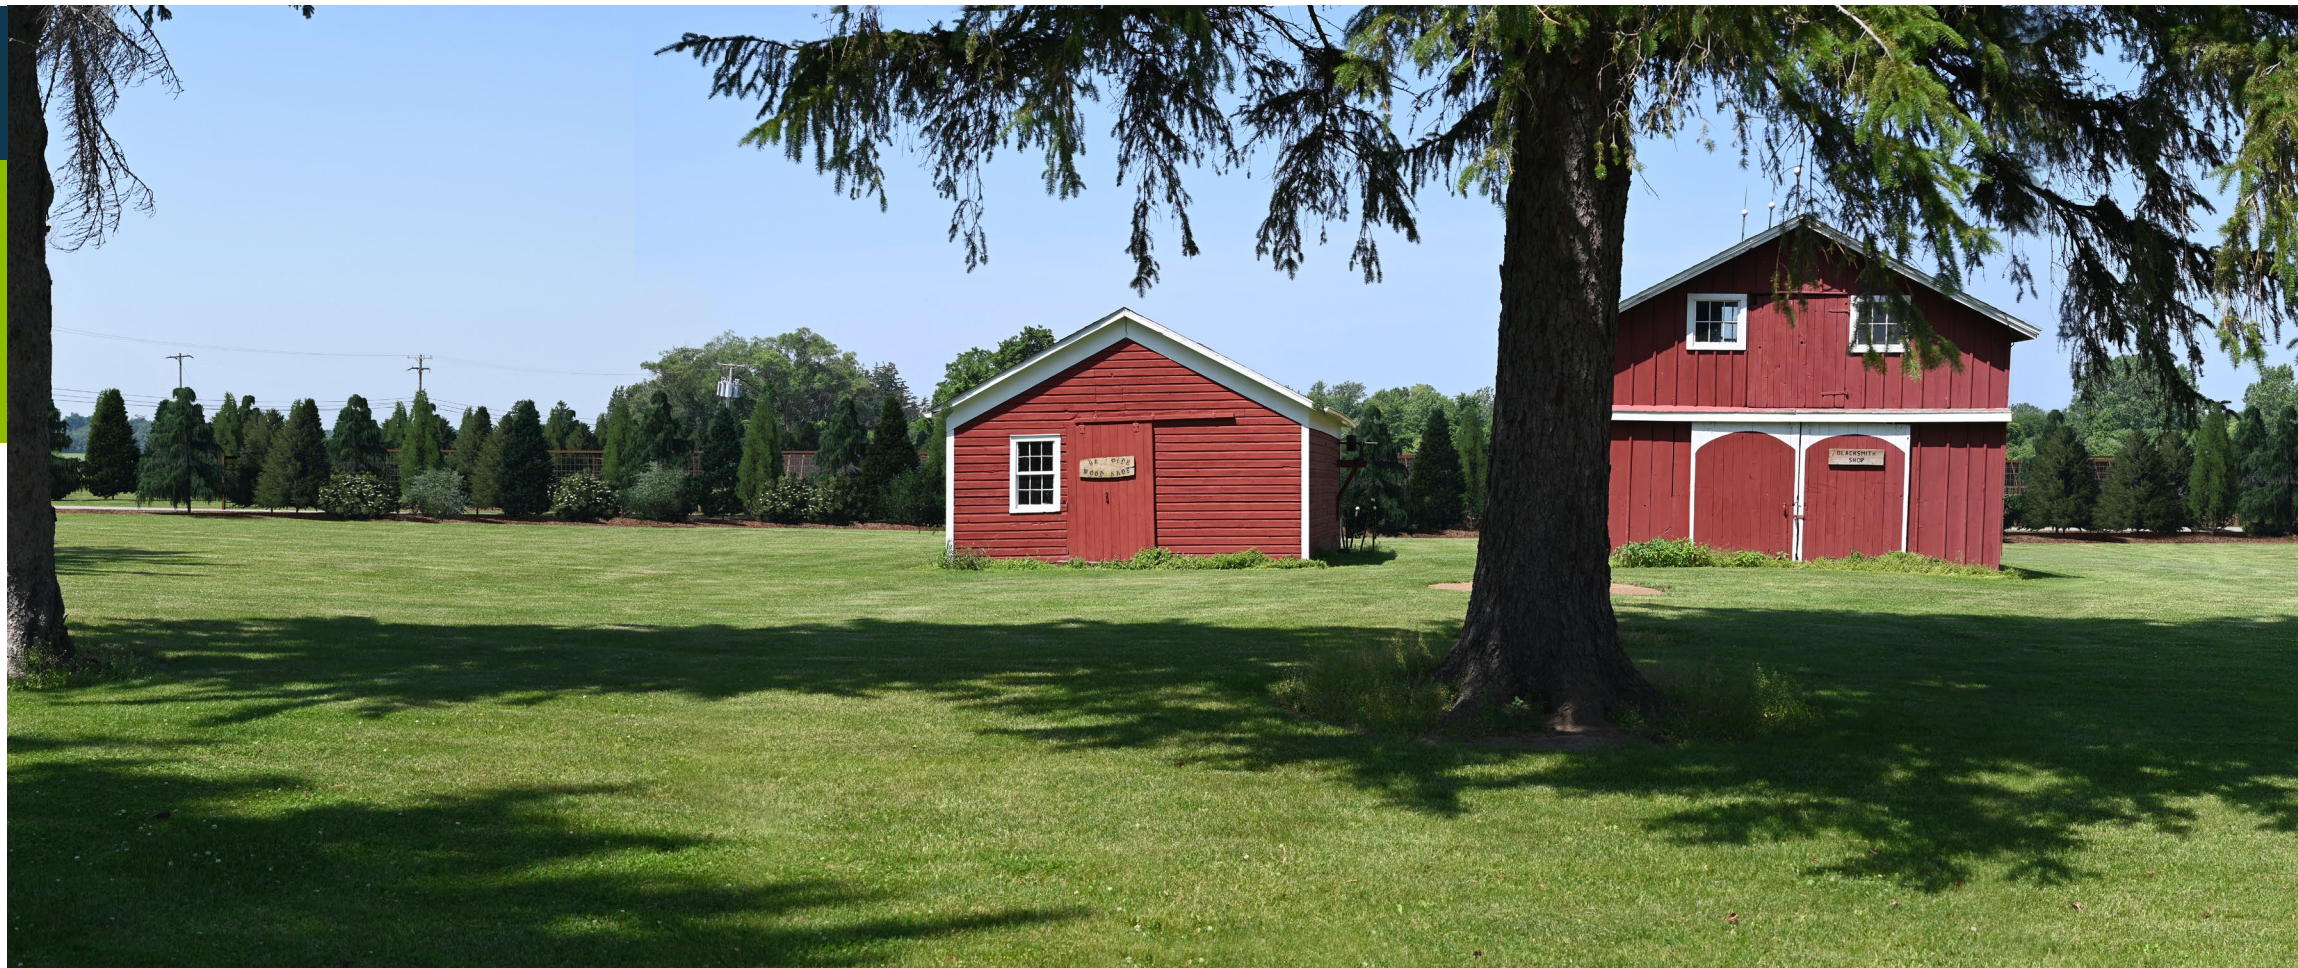
Viewpoint 1A

EXISTING CONDITIONS

SIMULATED CONDITIONS

WITH
PROPOSED
SCREENING
(YEAR 5)

Leaf On

With Proposed Screening
Year 5

Time of photograph: 9:39 a.m.
Date of photograph: 06/22/2022
Weather condition: Sunny
Viewing direction: West
View orientation: Level
Latitude: 43.349703°
Longitude: -78.615066°
Elevation: 302 ft.
Photo Location: The photo was taken from Babcock House property looking west toward project area.

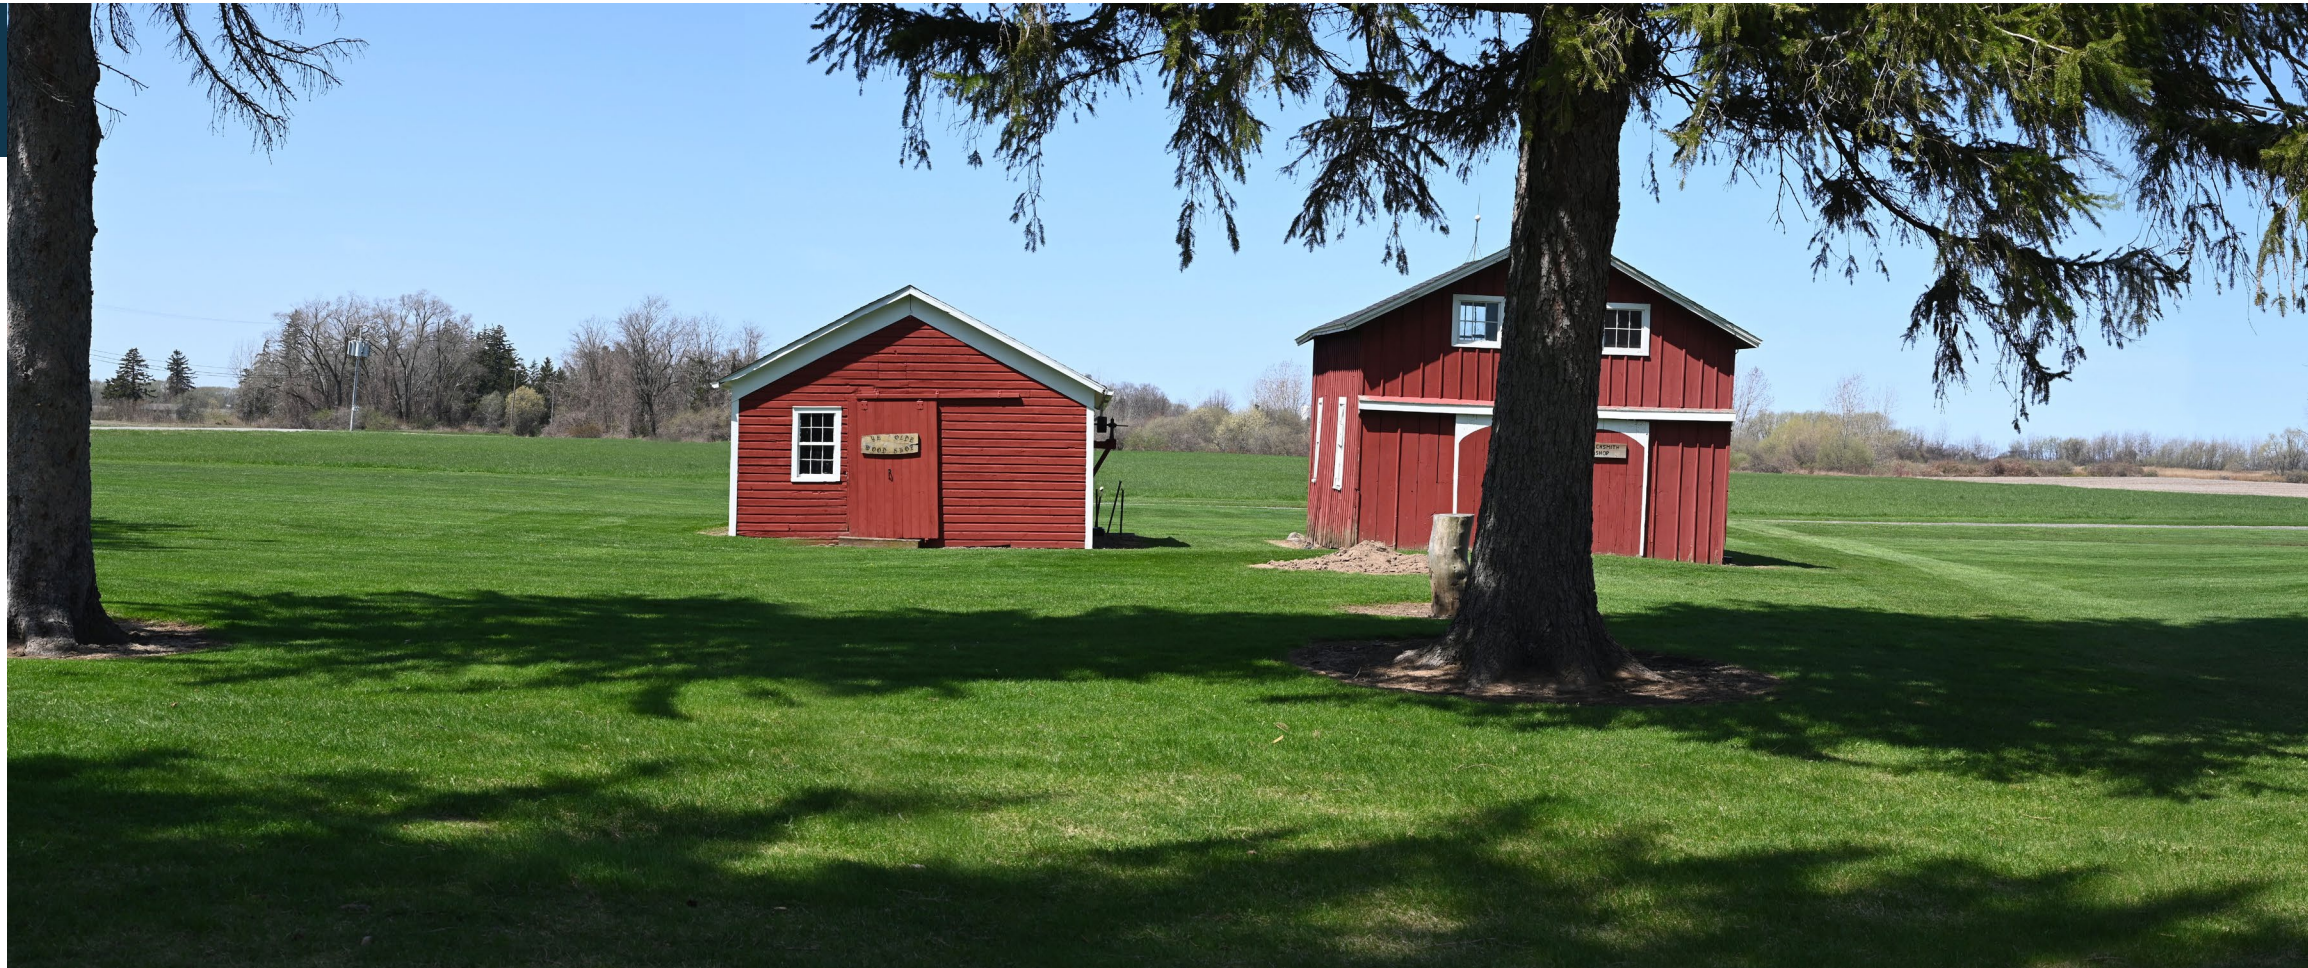
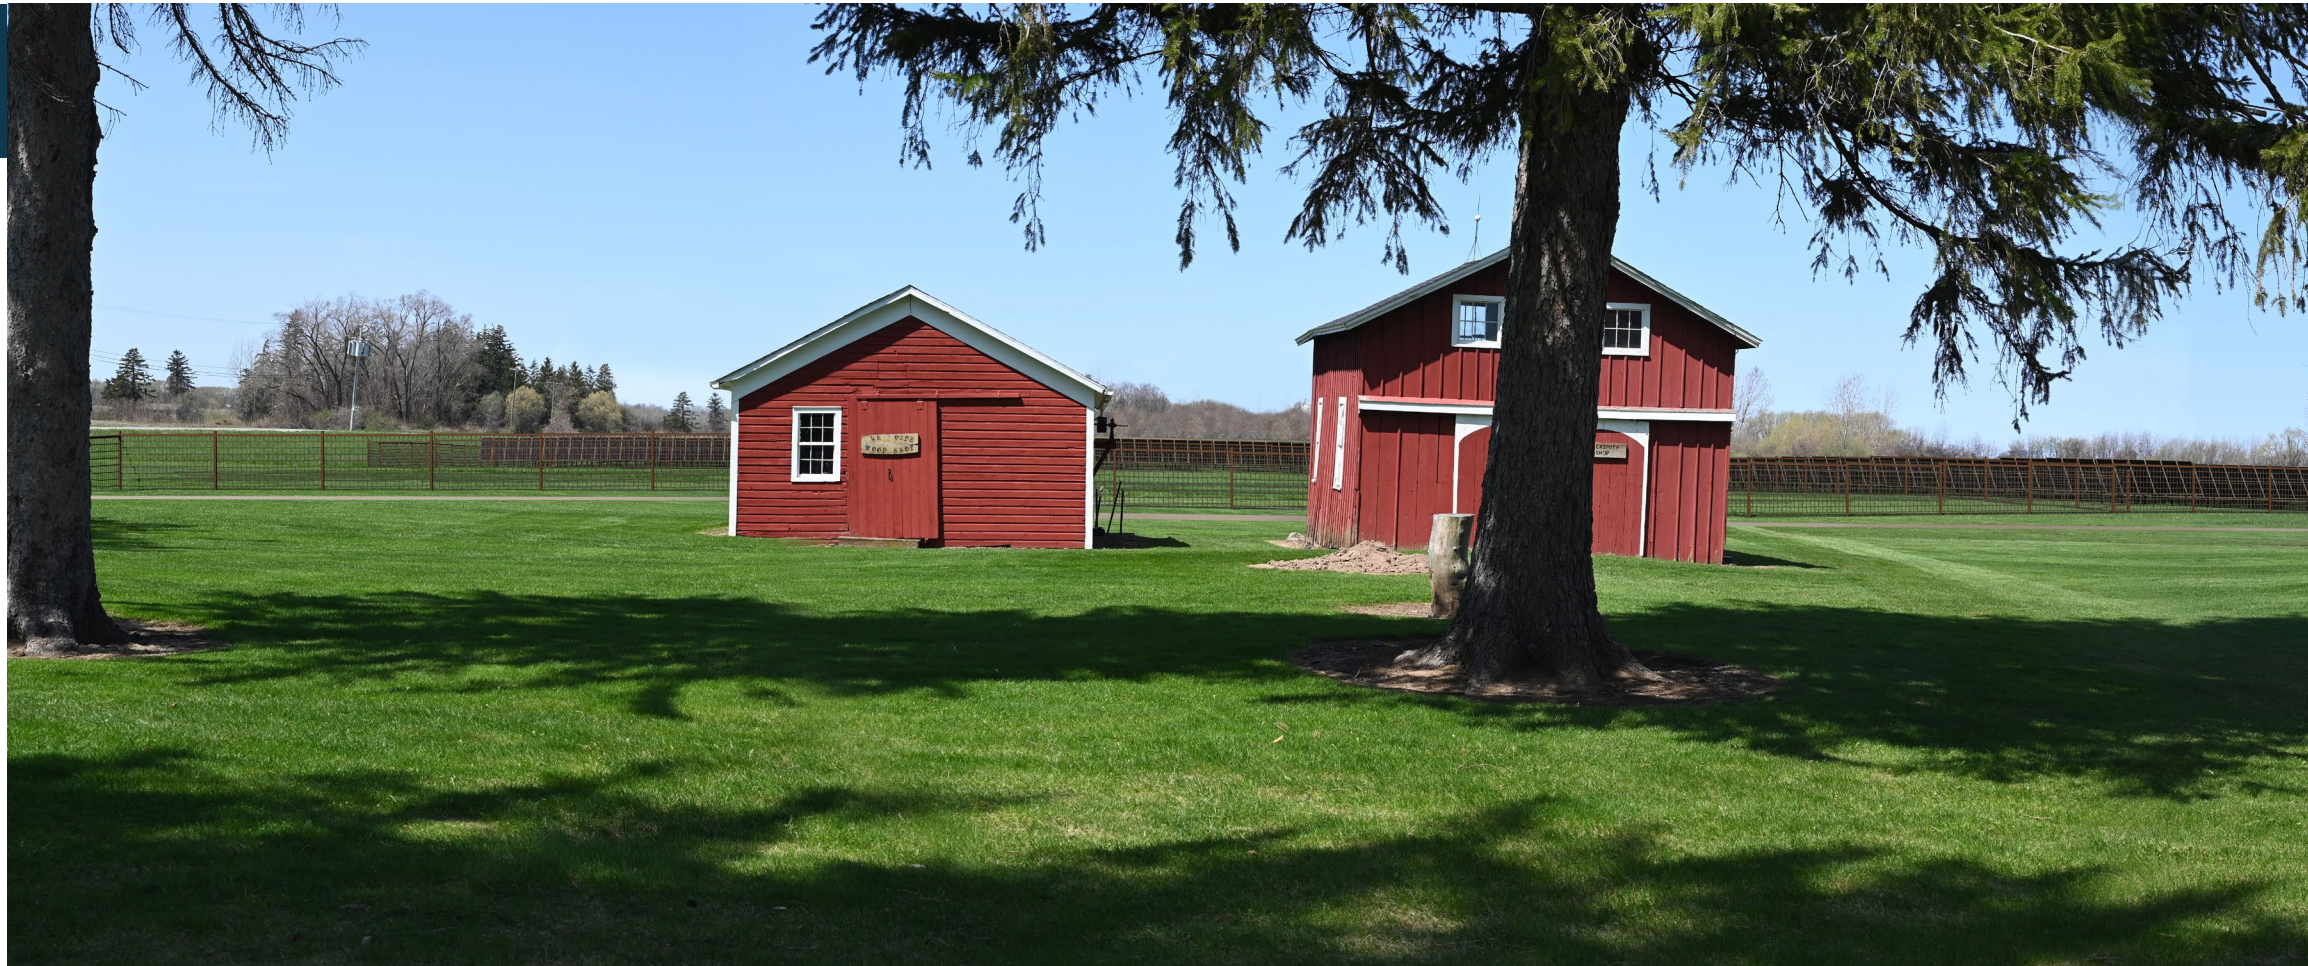
Viewpoint 1A

EXISTING CONDITIONS

SIMULATED CONDITIONS

Leaf Off

No Proposed Screening

Time of photograph: 10:10 a.m.
Date of photograph: 04/29/2022
Weather condition: Sunny
Viewing direction: West
View orientation: Level
Latitude: 43.349703°
Longitude: -78.615066°
Elevation: 302 ft.
Photo Location:
The photo was taken from Babcock House property looking west toward project area.

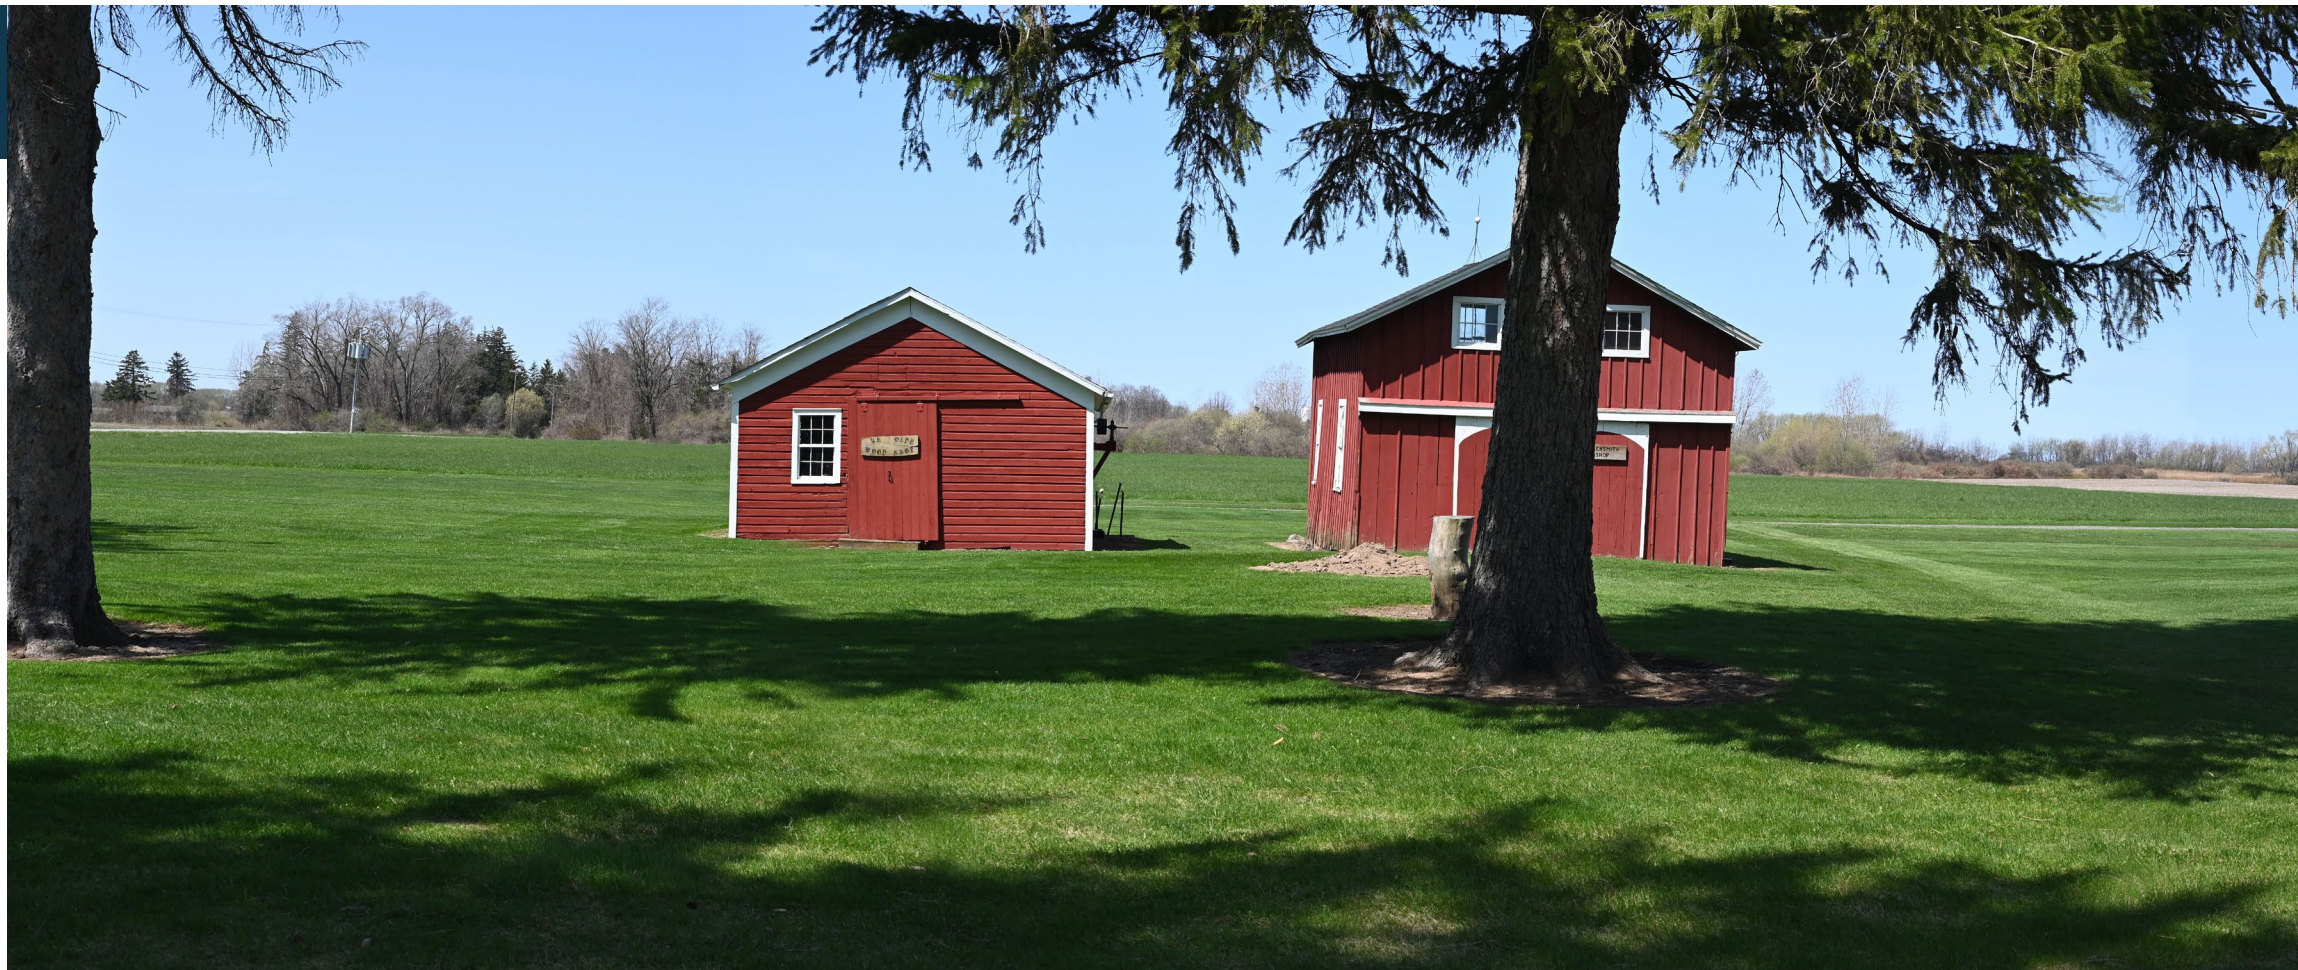
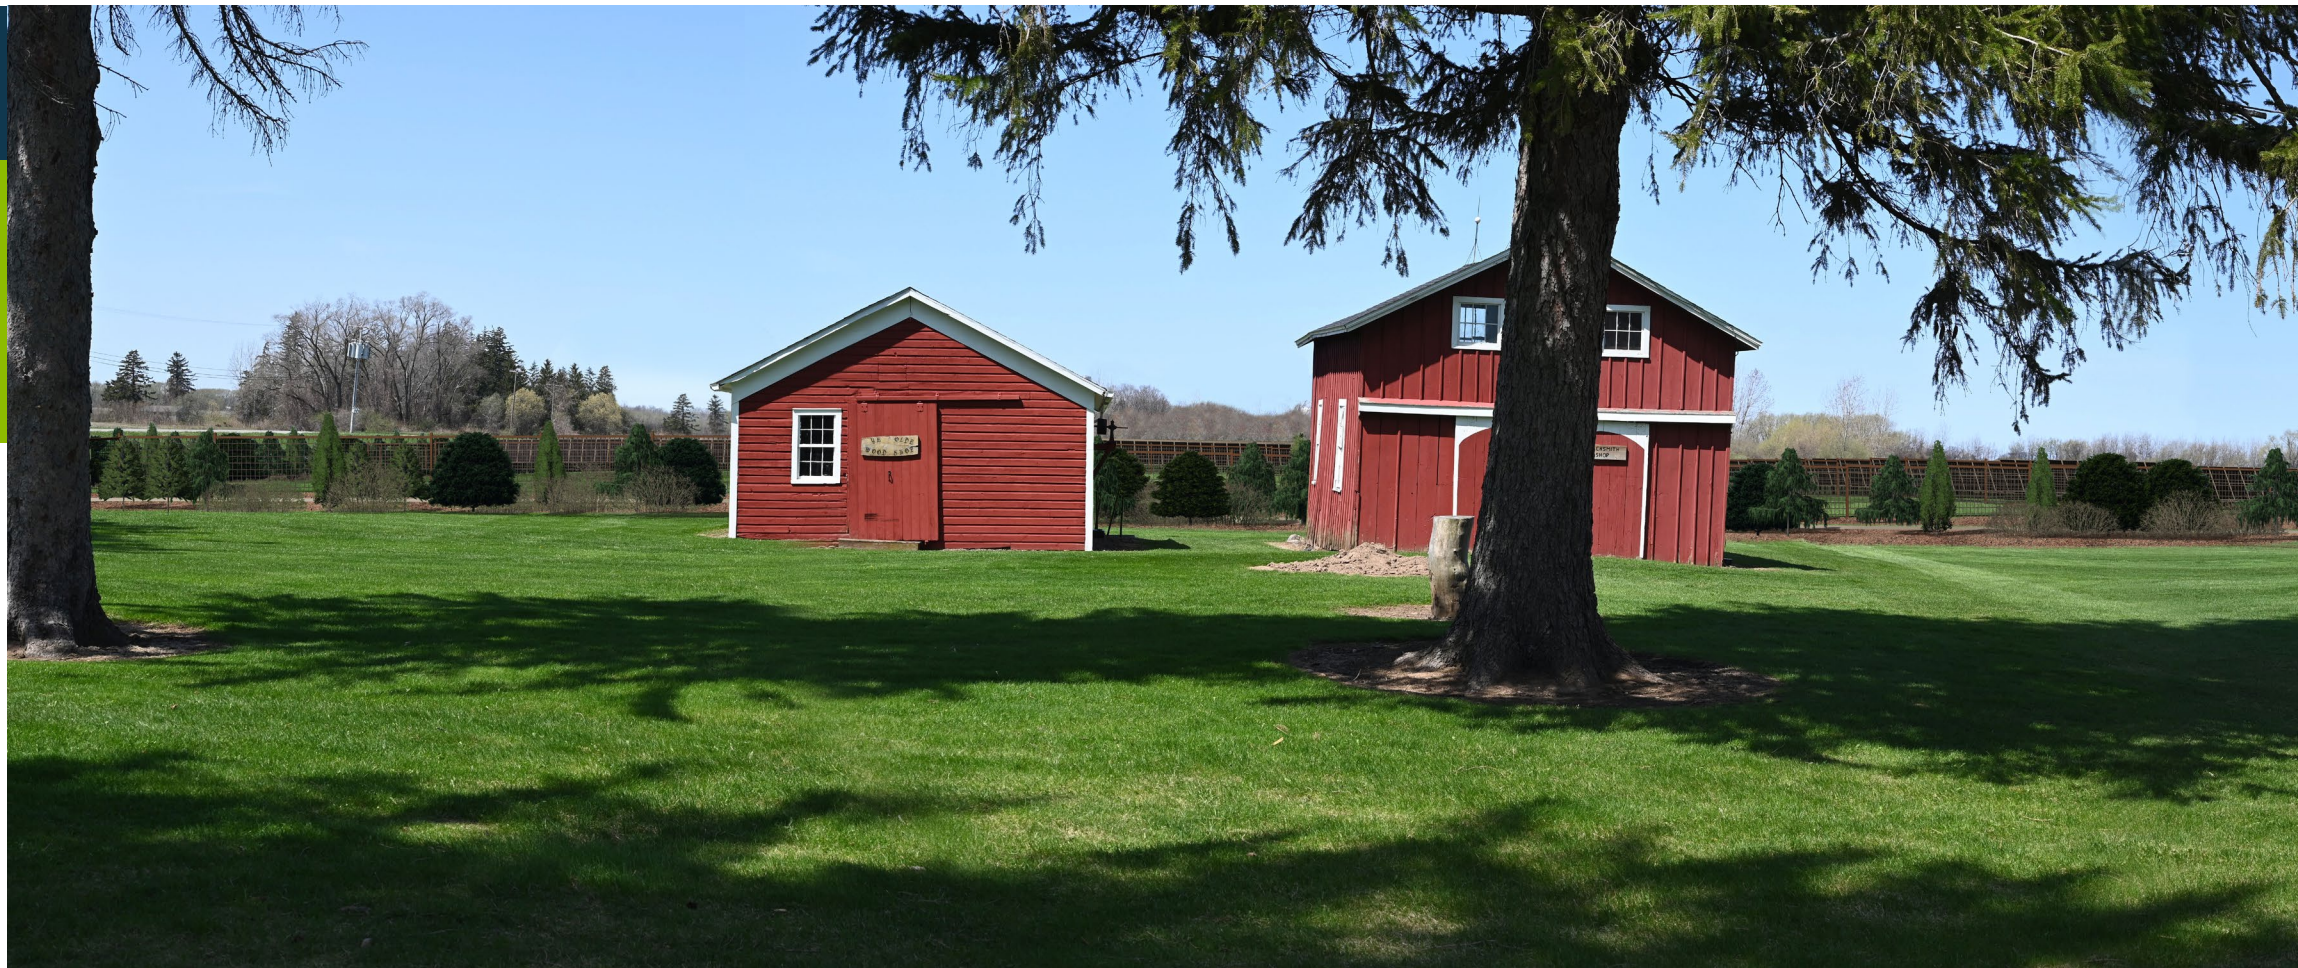
Viewpoint 1A

EXISTING CONDITIONS

SIMULATED CONDITIONS

WITH
PROPOSED
SCREENING
(YEAR 0)

Leaf Off

With Proposed Screening
Year 0

Time of photograph: 10:10 a.m.
Date of photograph: 04/29/2022
Weather condition: Sunny
Viewing direction: West
View orientation: Level
Latitude: 43.349703°
Longitude: -78.615066°
Elevation: 302 ft.
Photo Location:
The photo was taken from Babcock House Museum looking west toward project area.
