SOMERSET SOLAR FACILITY

VISUAL SIMULATION

AUGUST 2023

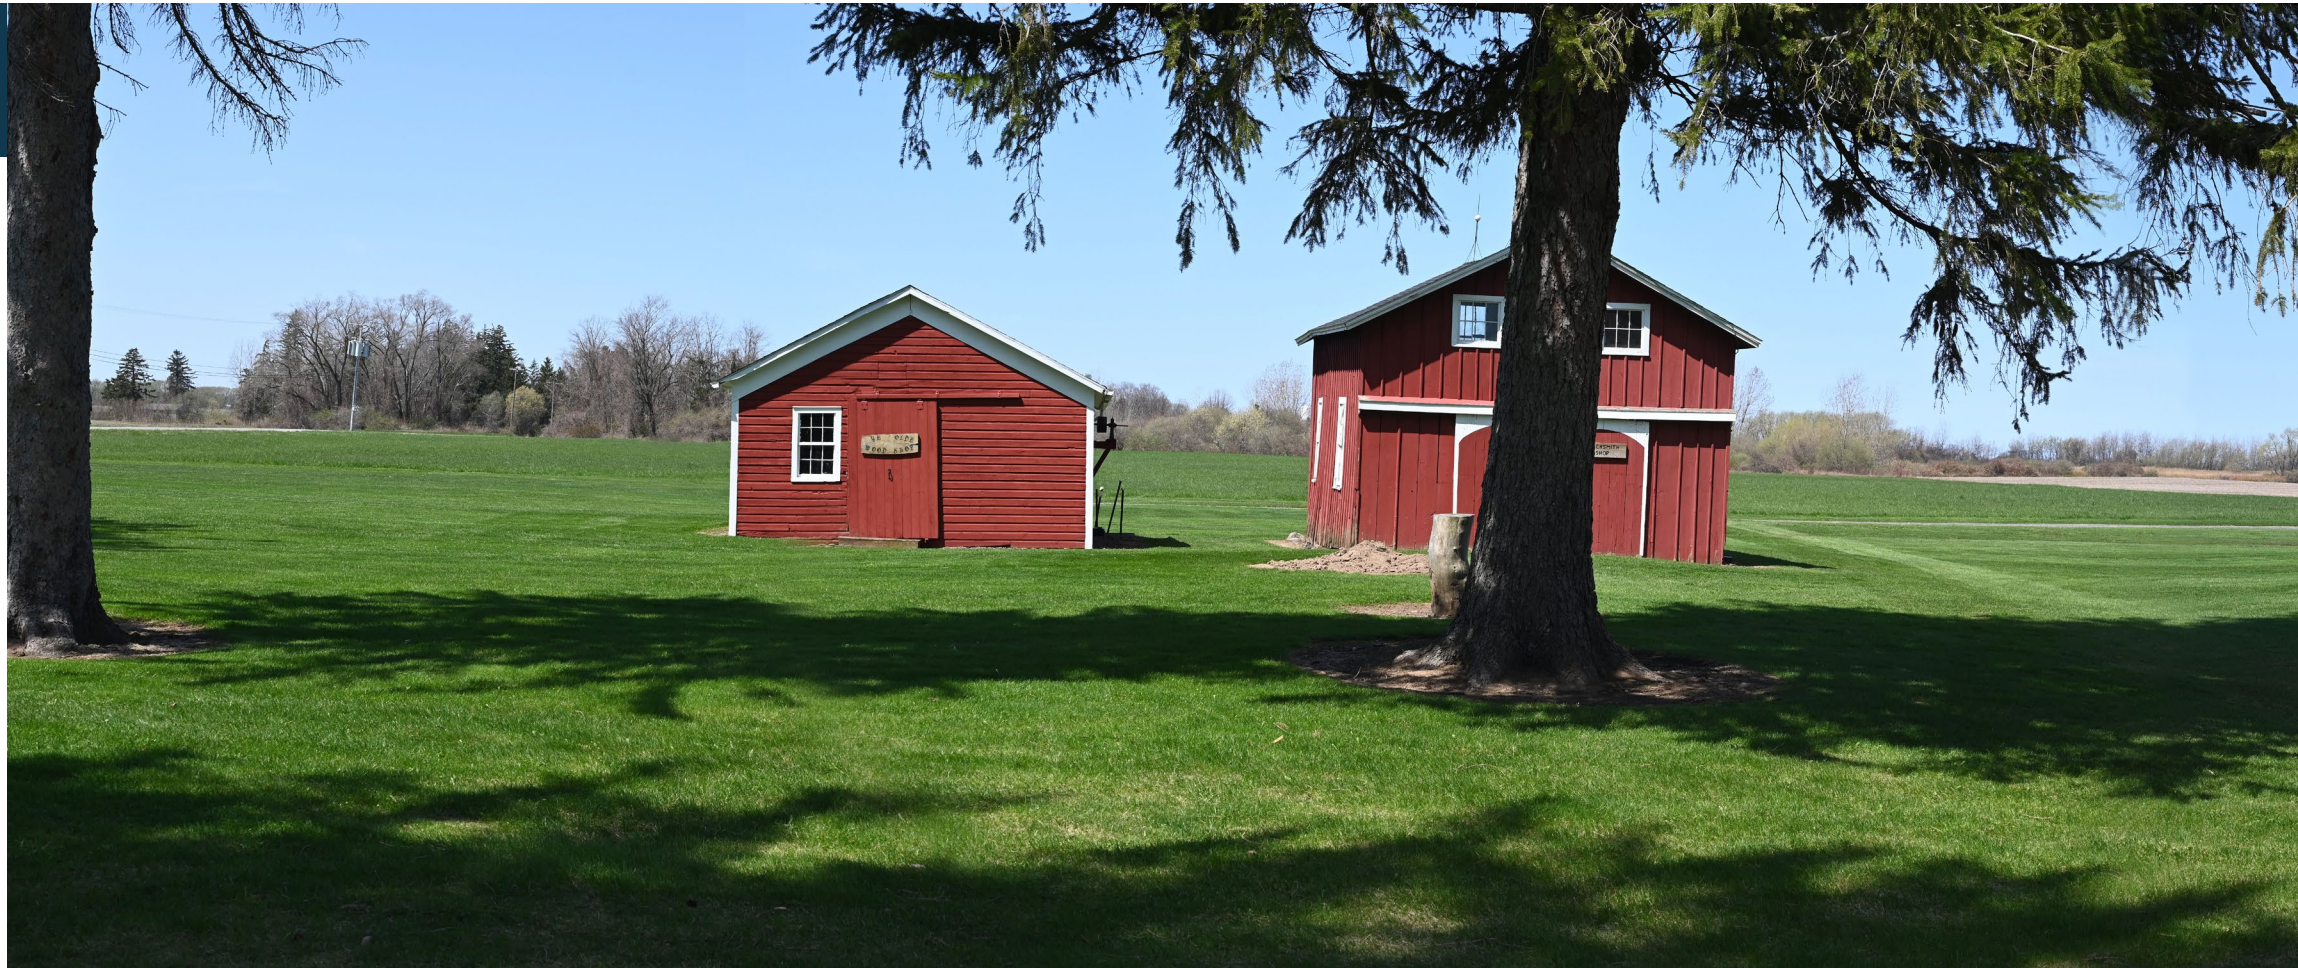
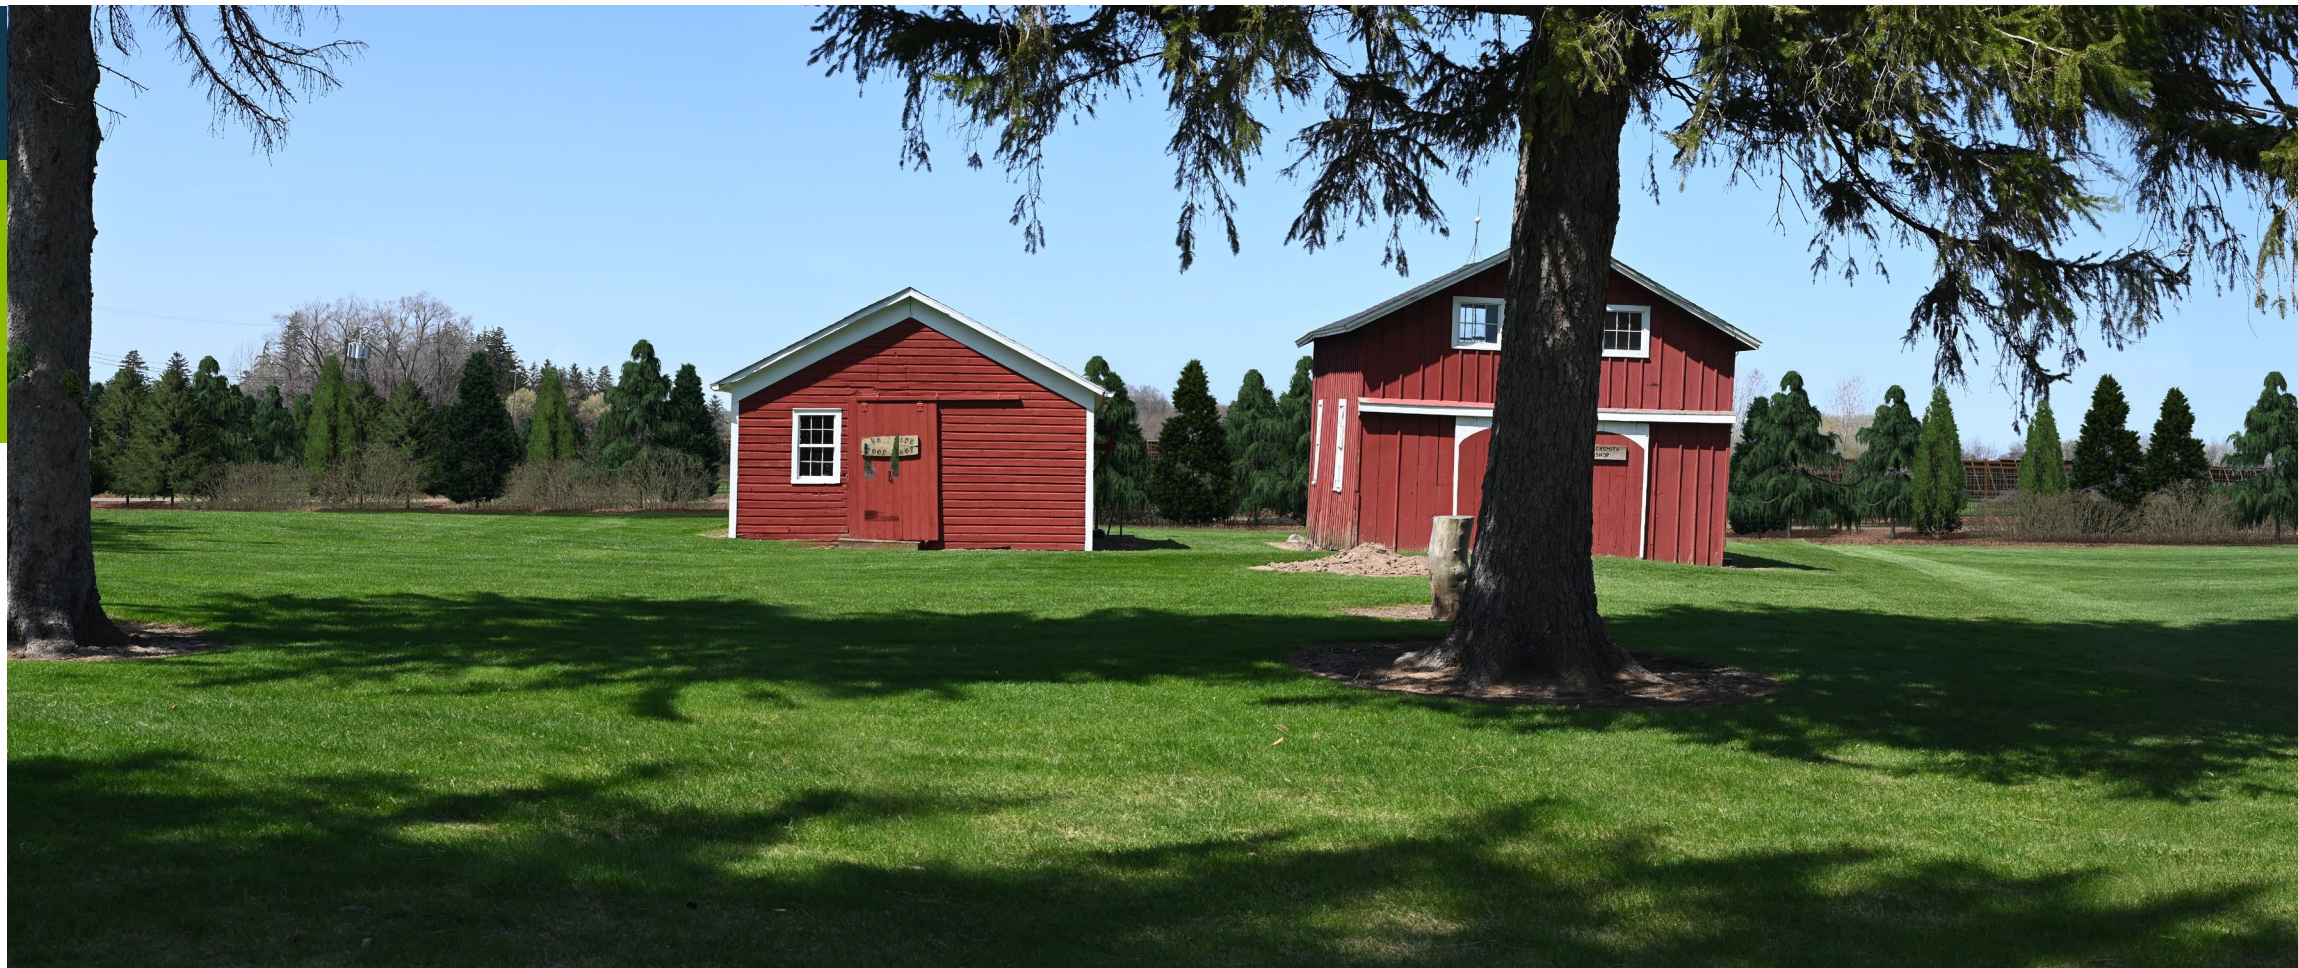
Viewpoint 1A

EXISTING CONDITIONS

SIMULATED CONDITIONS

WITH
PROPOSED
SCREENING
(YEAR 5)

Leaf Off

*With Proposed Screening
Year 5*

Time of photograph: 10:10 a.m.
Date of photograph: 04/29/2022
Weather condition: Sunny
Viewing direction: West
View orientation: Level
Latitude: 43.349703°
Longitude: -78.615066°
Elevation: 302 ft.
Photo Location:
The photo was taken from Babcock House Museum looking west toward project area.

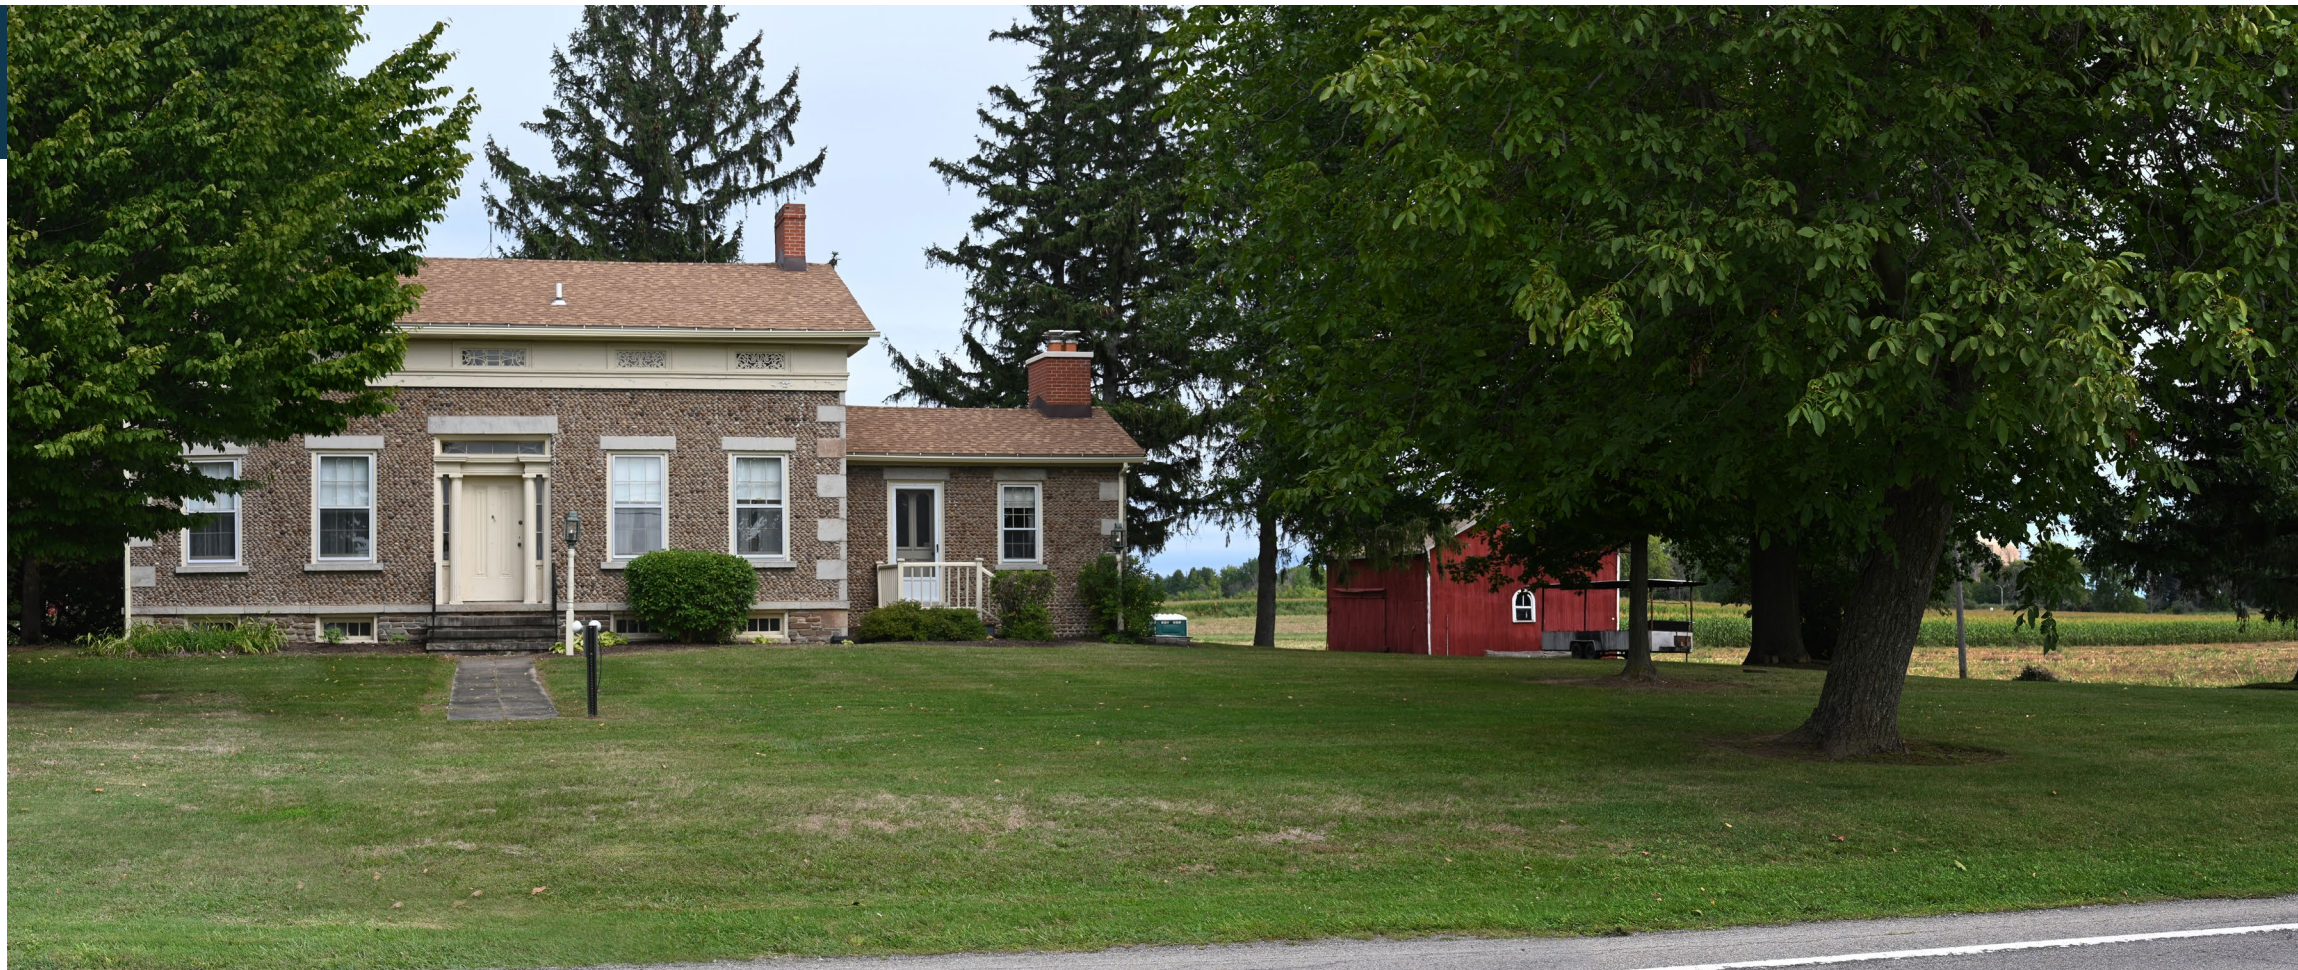
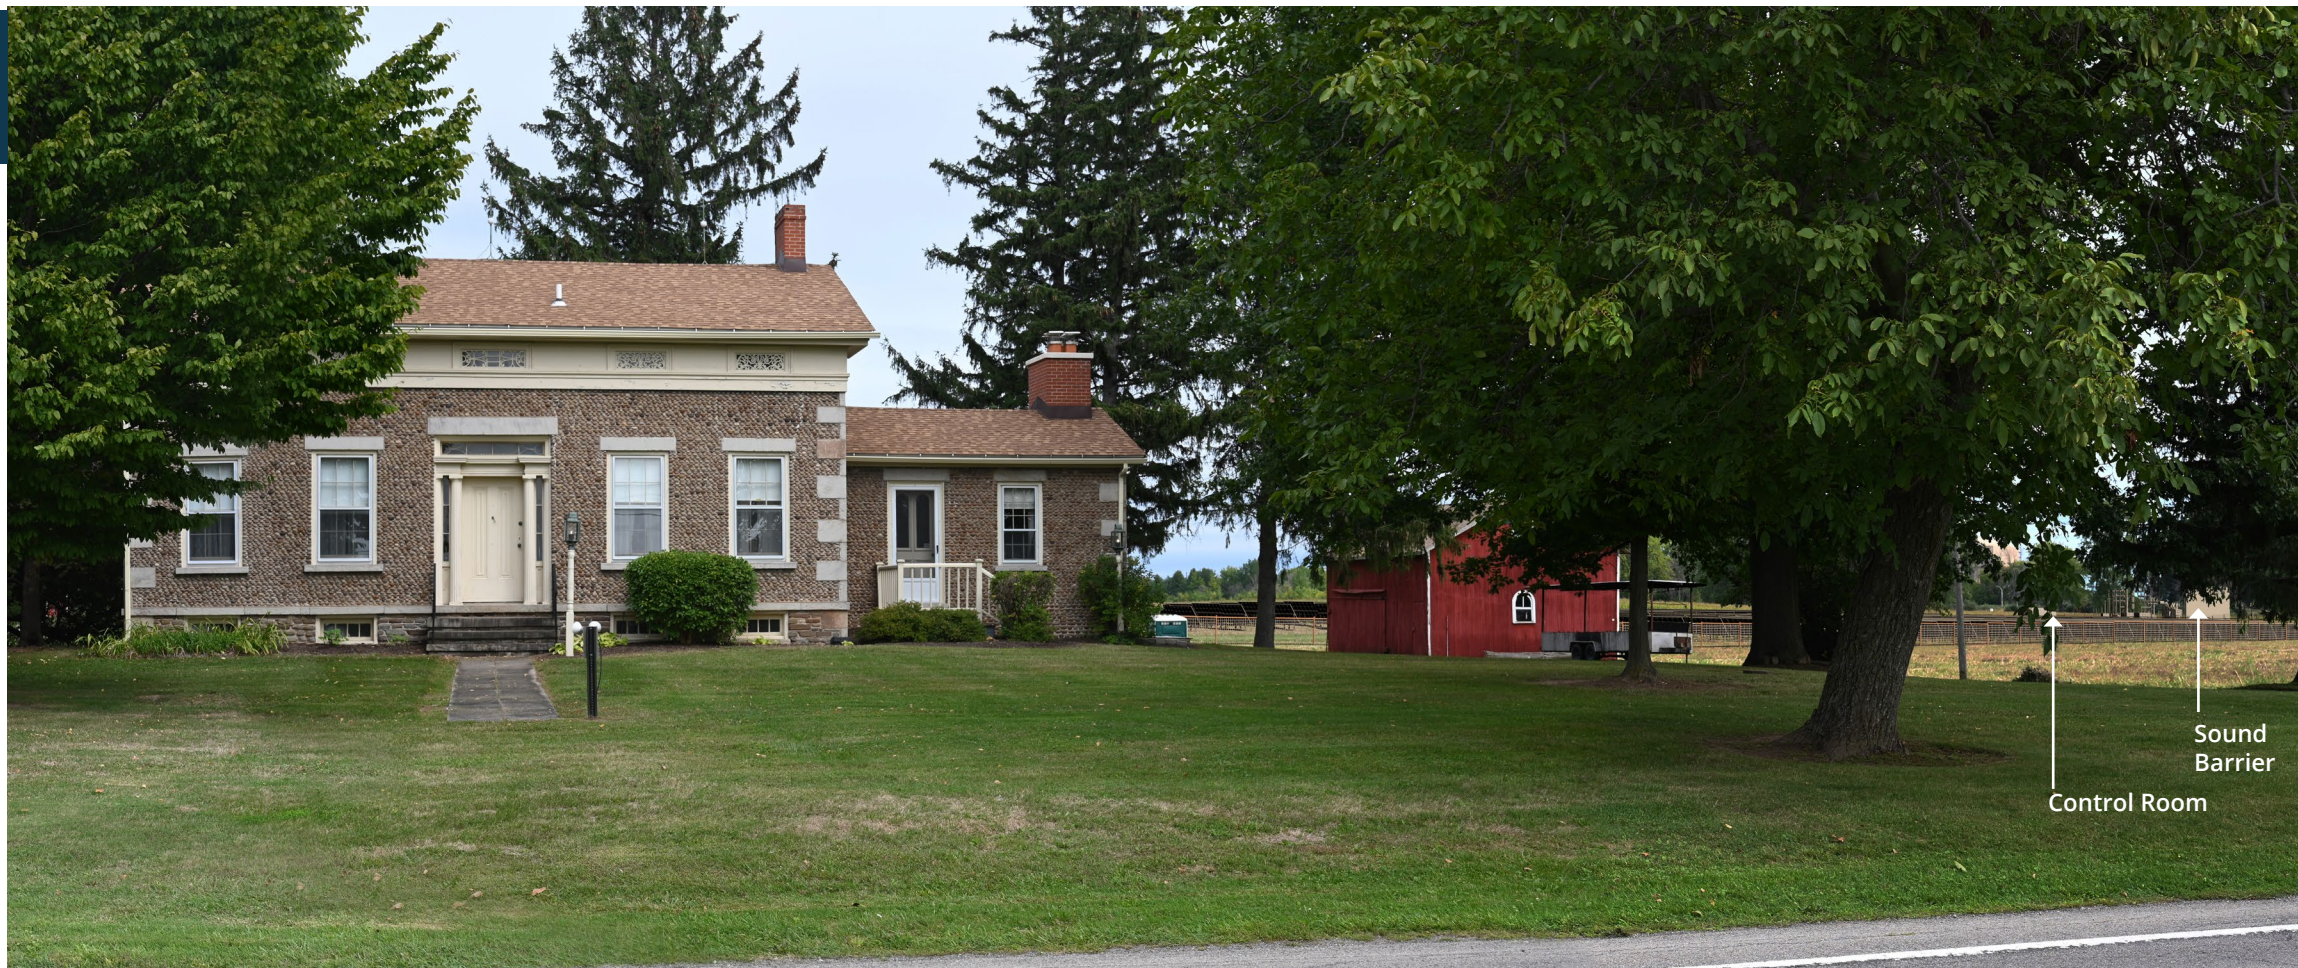
VIEWPOINT 1B

EXISTING CONDITIONS

SIMULATED CONDITIONS

Leaf On

No Proposed Screening

Time of photograph: 9:02 a.m.
Date of photograph: 09/16/2022
Weather condition: Sunny
Viewing direction: Northeast
View orientation: Level
Latitude: 43.348945°
Longitude: -78.615007°
Elevation: 302 ft.
Photo Location:
The photo was taken across Lake Road looking toward Babcock House Museum and project area.

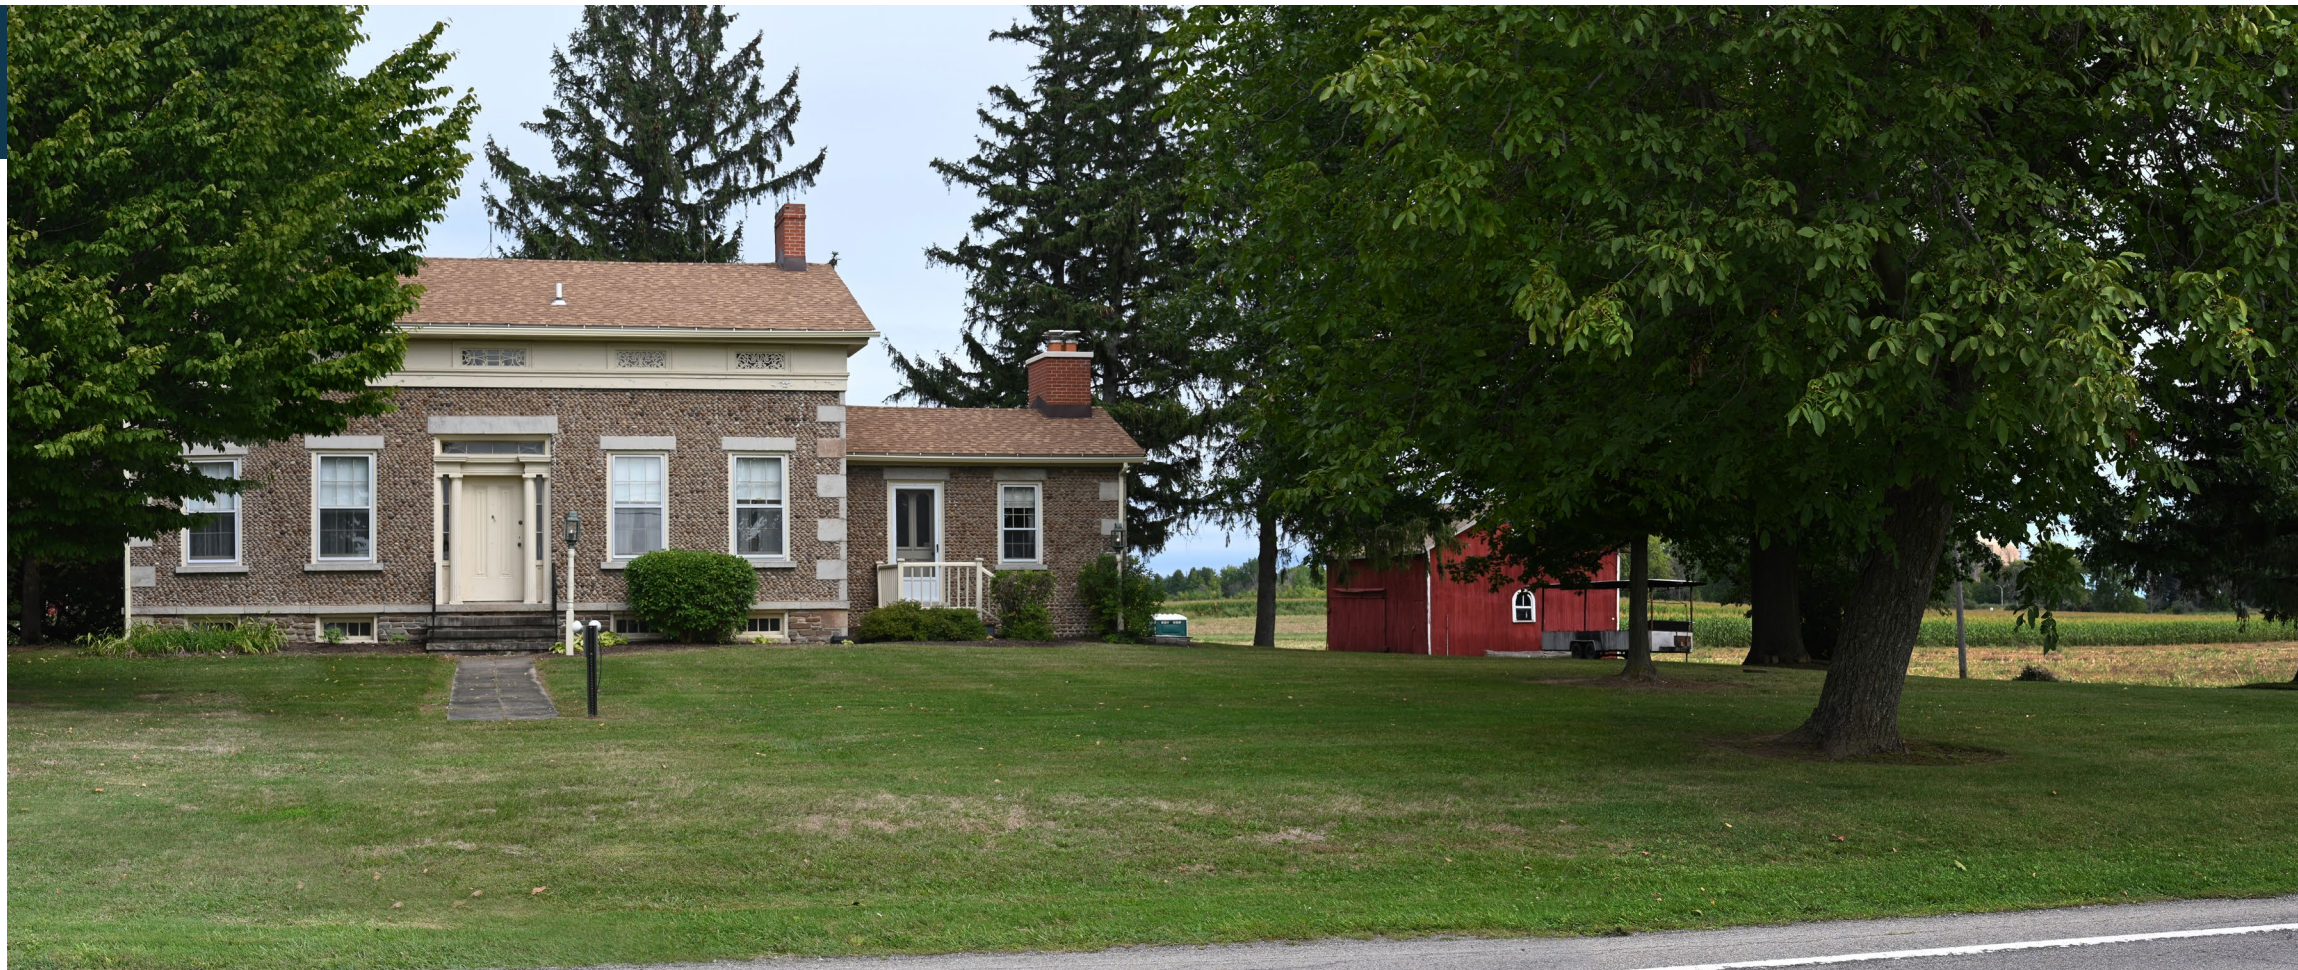
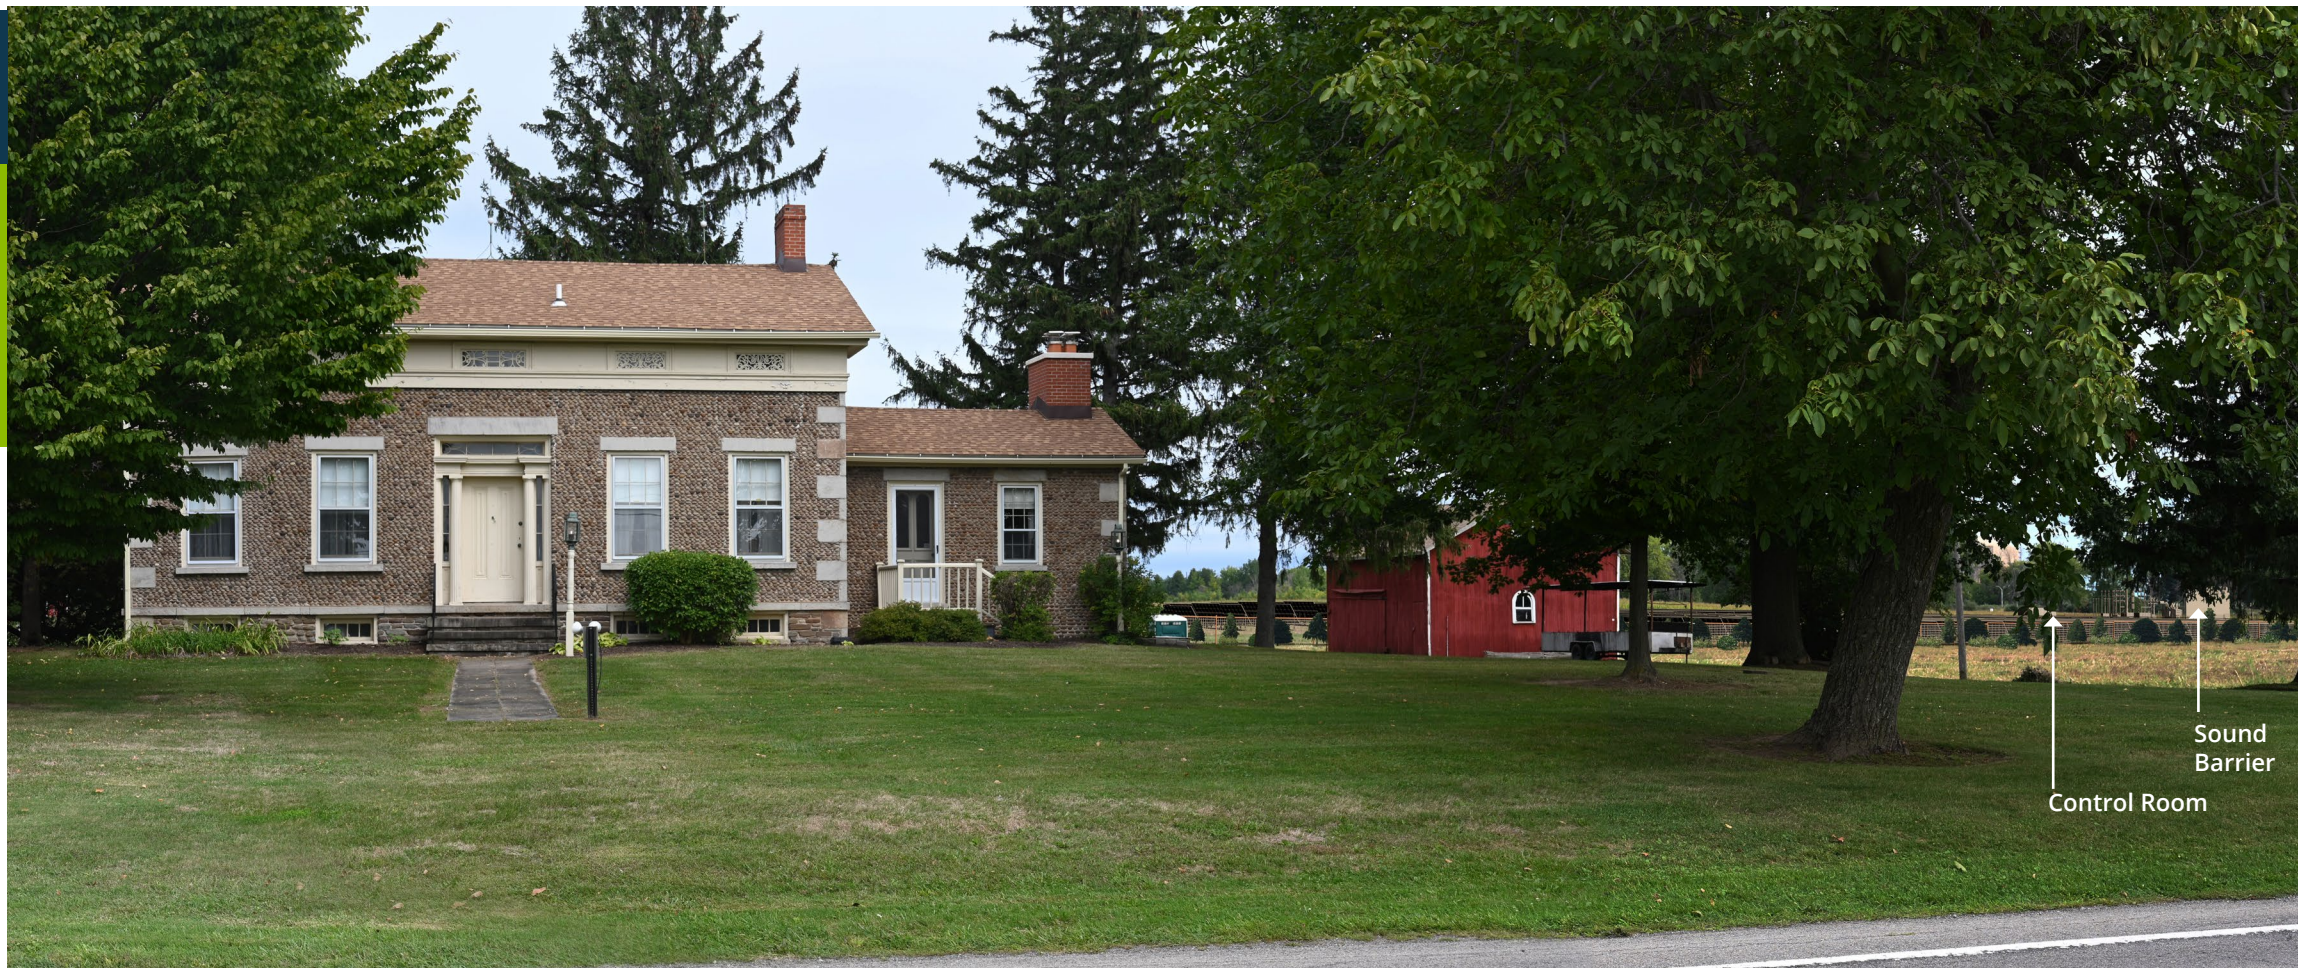
Viewpoint 1B

EXISTING CONDITIONS

SIMULATED CONDITIONS

WITH
PROPOSED
SCREENING
(YEAR 0)

Leaf On

*With Proposed Screening
Year 0*

Time of photograph: 9:02 a.m.
Date of photograph: 04/29/2022
Weather condition: Sunny
Viewing direction: Northeast
View orientation: Level
Latitude: 43.349136°
Longitude: -78.61498°
Elevation: 302 ft.
Photo Location:
The photo was taken from Lake Road looking toward Babcock House Museum and project area.

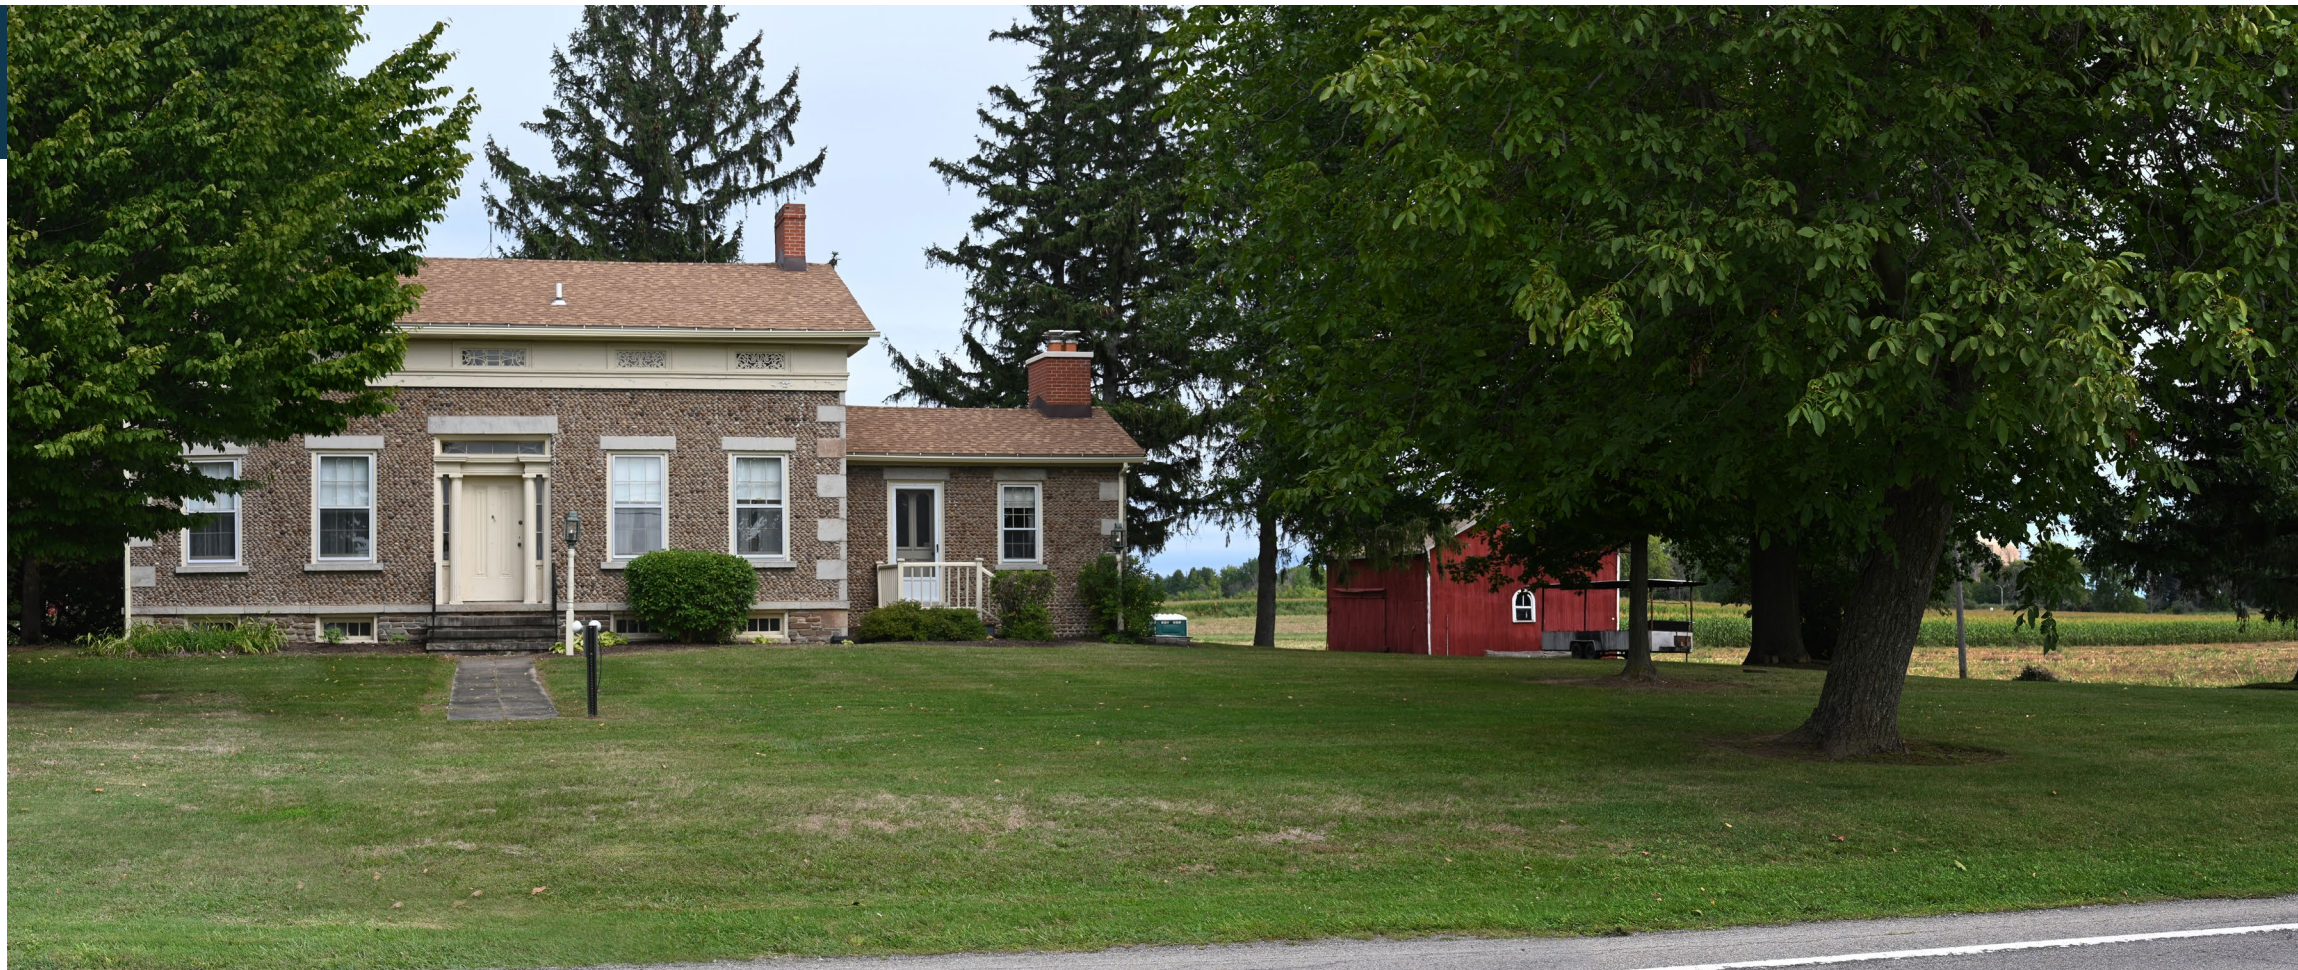
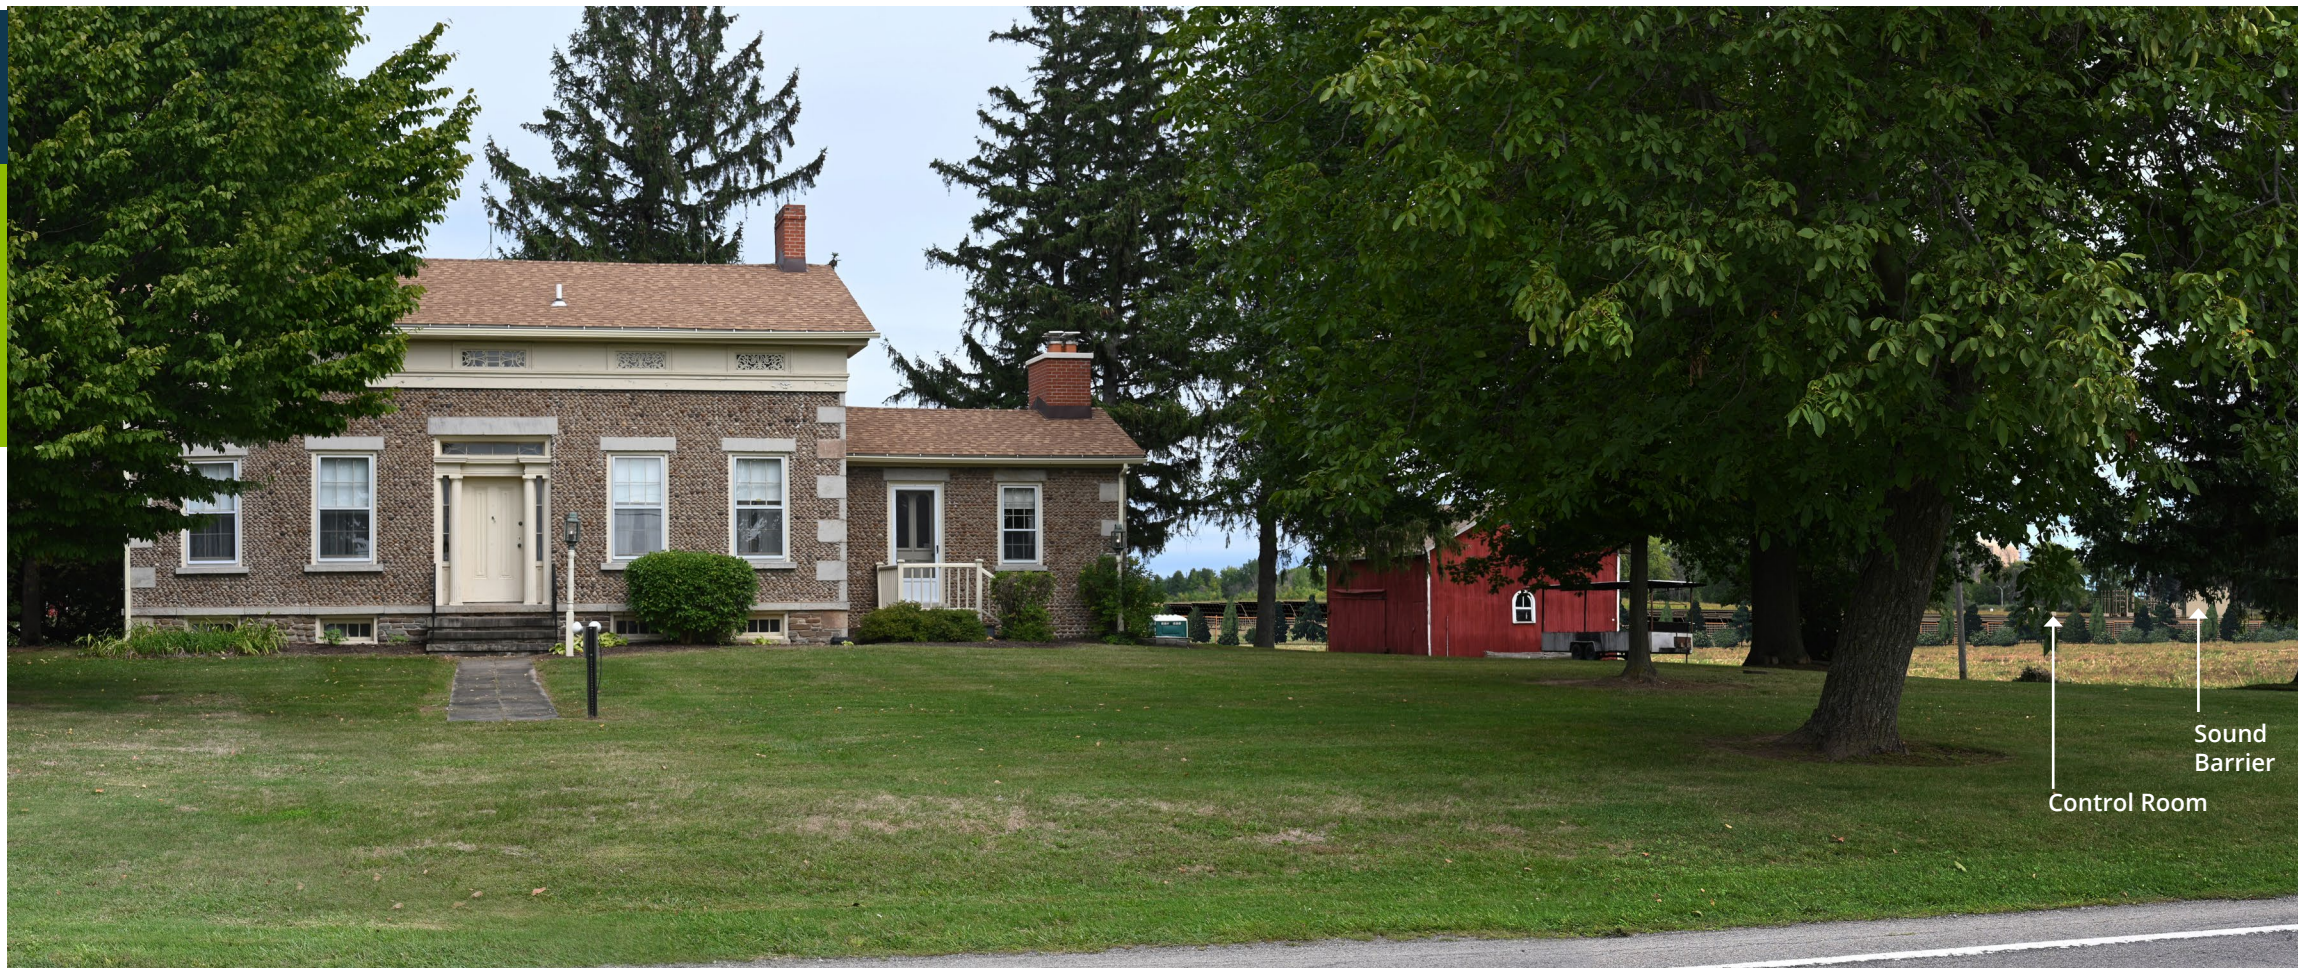
Viewpoint 1B

EXISTING CONDITIONS

SIMULATED CONDITIONS

WITH
PROPOSED
SCREENING
(YEAR 5)

Leaf On

With Proposed Screening
Year 5

Time of photograph: 9:02 a.m.
Date of photograph: 09/16/2022
Weather condition: Sunny
Viewing direction: Northeast
View orientation: Level
Latitude: 43.348945°
Longitude: -78.615007°
Elevation: 302 ft.
Photo Location:
The photo was taken across Lake Road looking toward Babcock House Museum and project area.

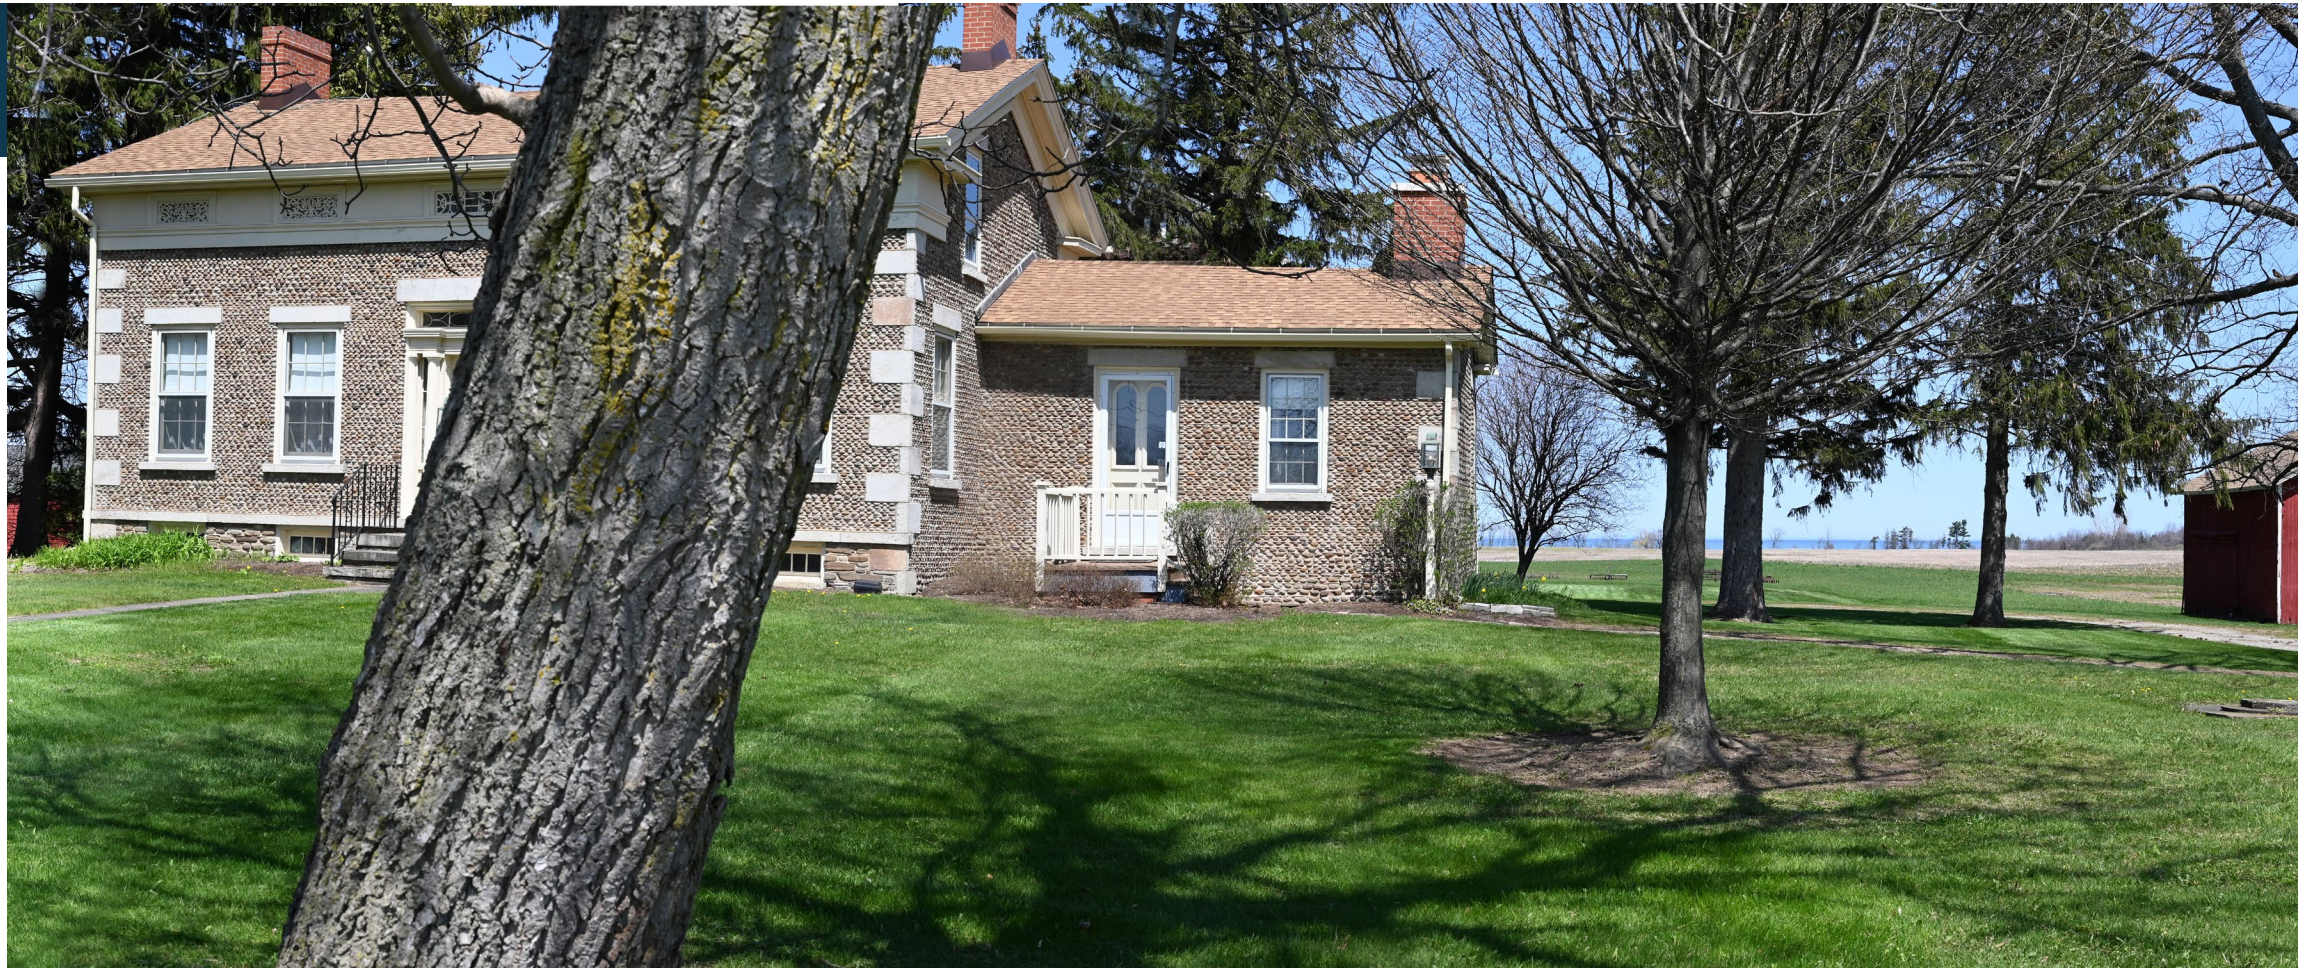
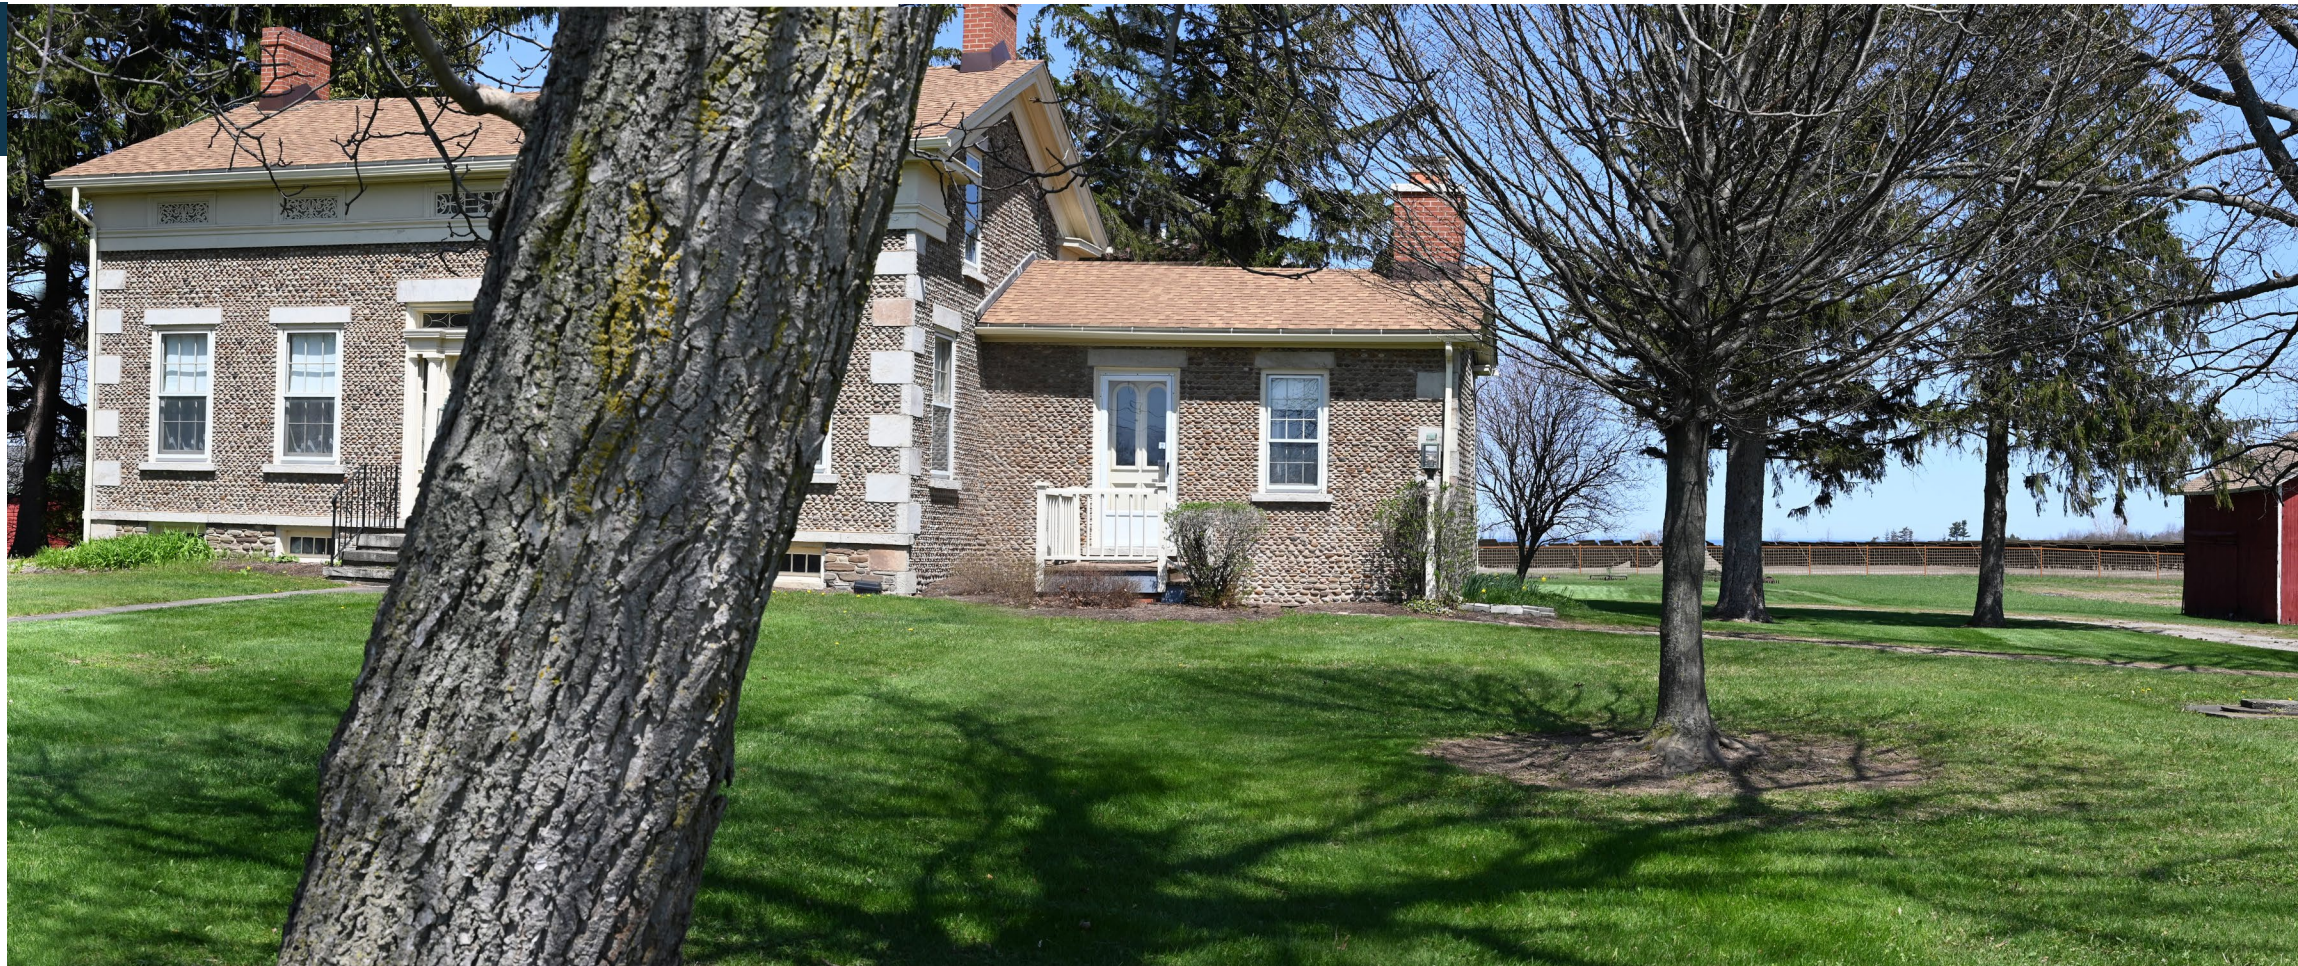
Viewpoint 1B

EXISTING CONDITIONS

SIMULATED CONDITIONS

Leaf Off

No Proposed Screening

Time of photograph: 10:11 a.m.
Date of photograph: 04/29/2022
Weather condition: Sunny
Viewing direction: Northeast
View orientation: Level
Latitude: 43.349136°
Longitude: -78.61498°
Elevation: 302 ft.
Photo Location:
The photo was taken from Lake Road looking toward Babcock House Museum and project area.
