SOMERSET SOLAR FACILITY

VISUAL SIMULATION

AUGUST 2023

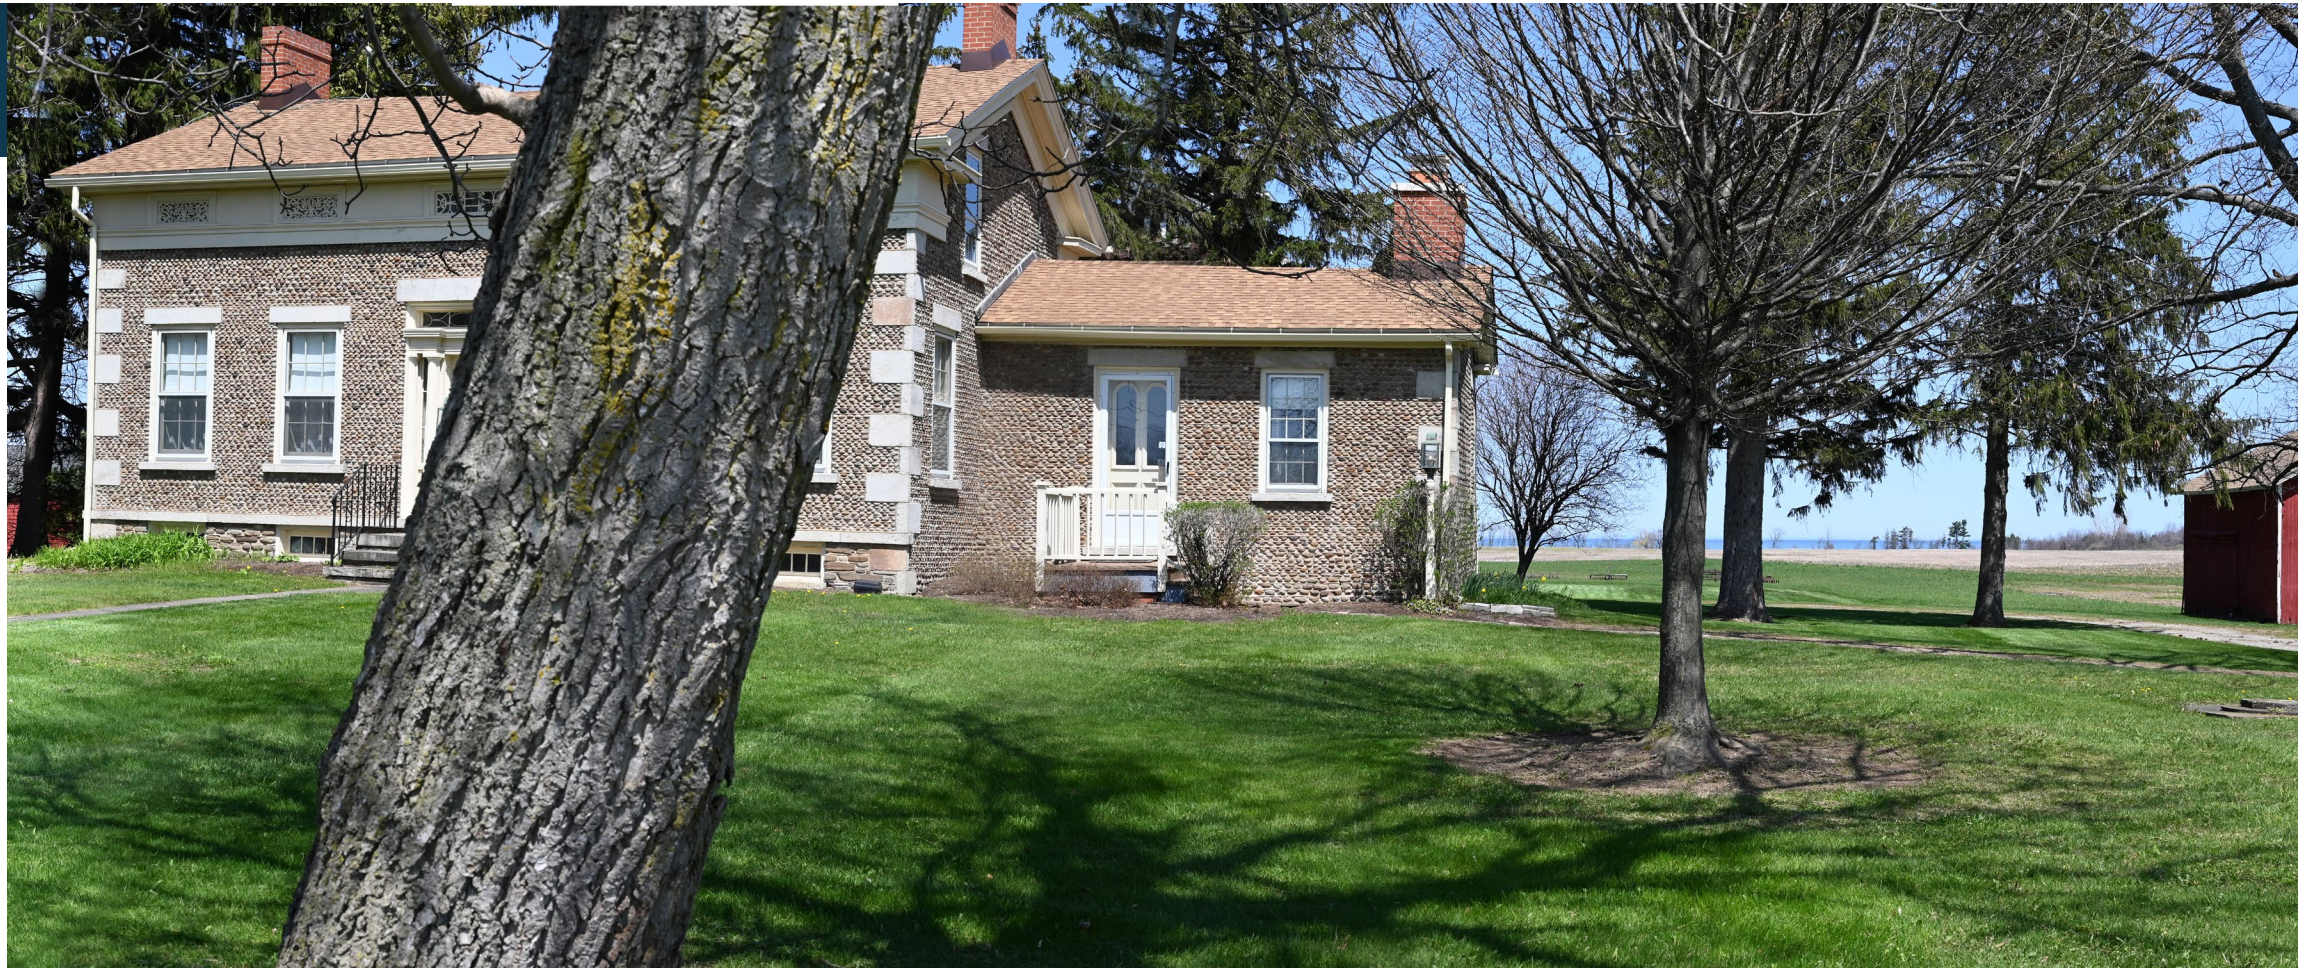
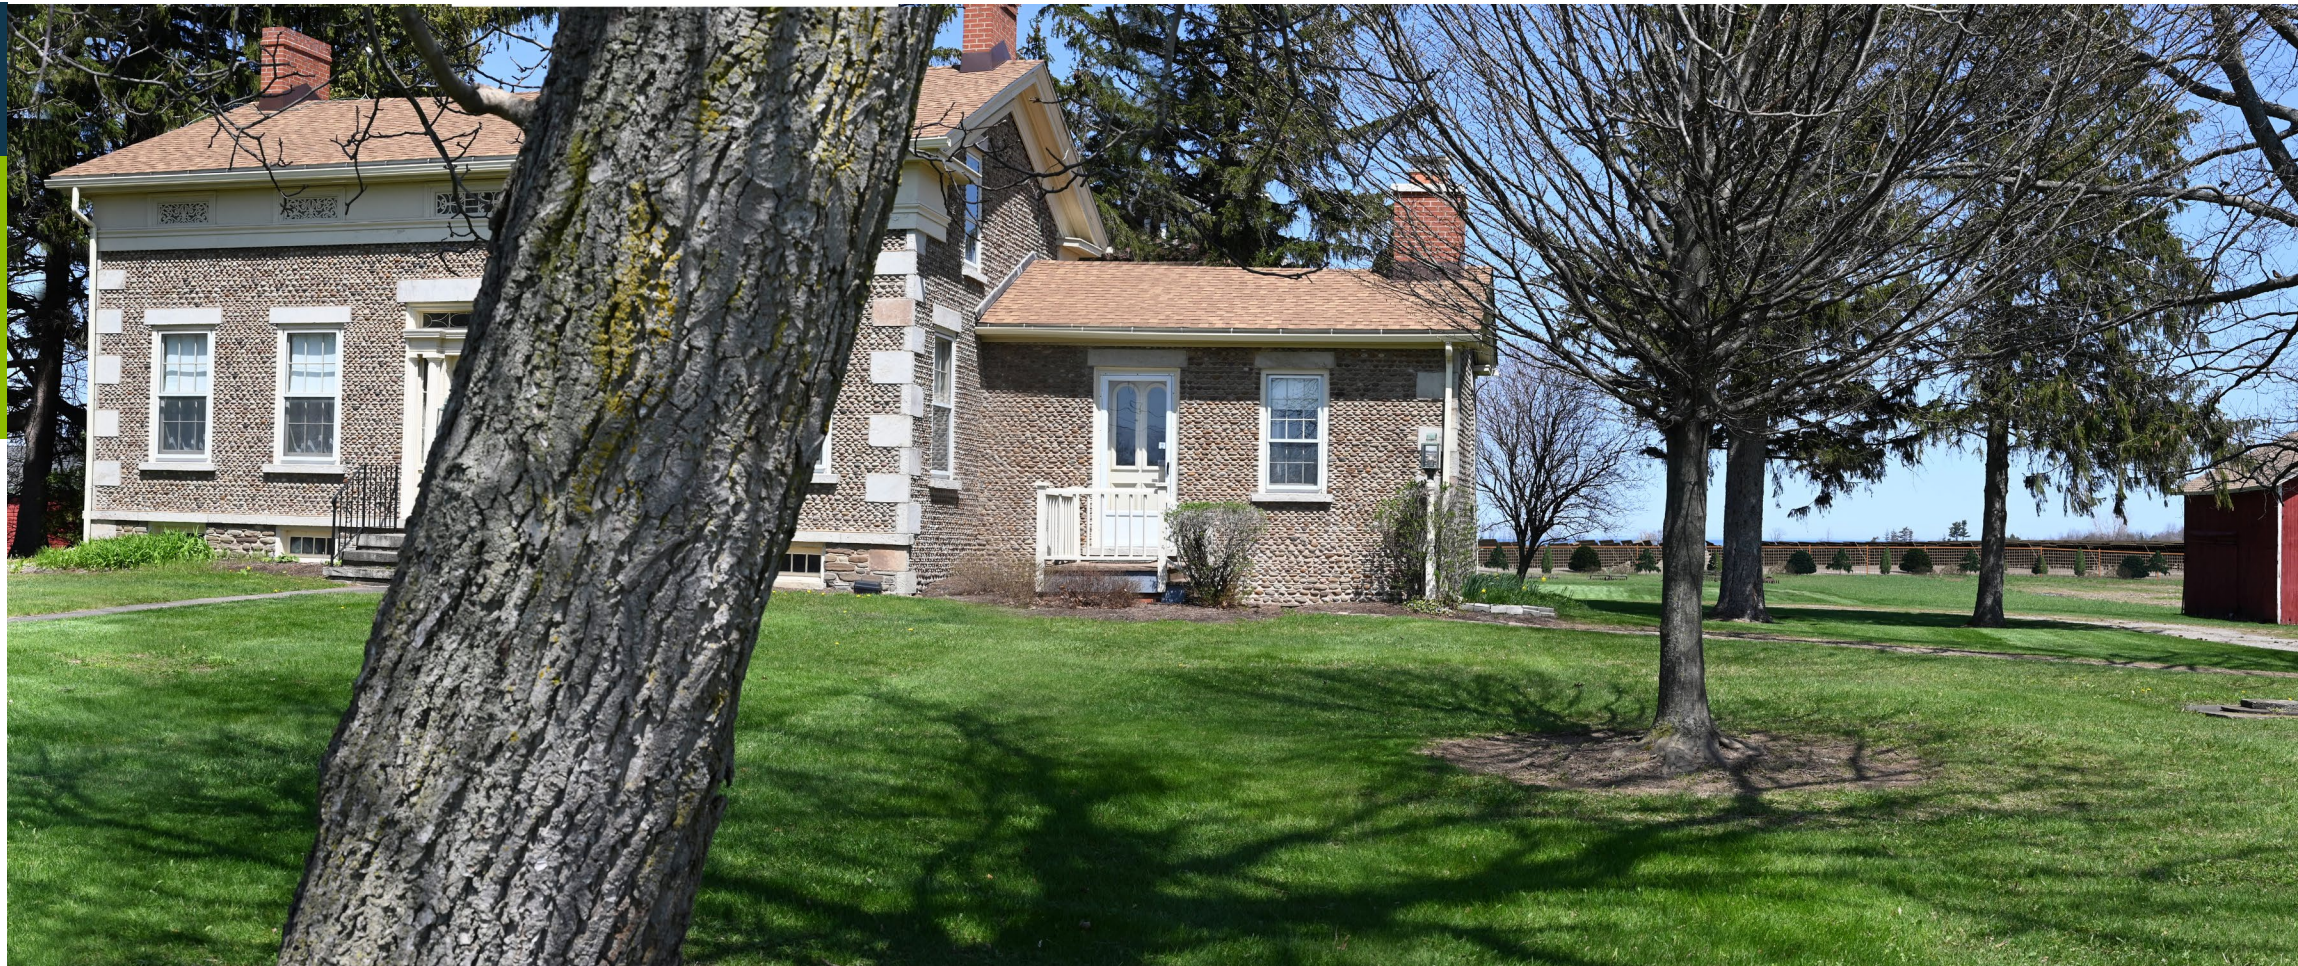
Viewpoint 1B

EXISTING CONDITIONS

SIMULATED CONDITIONS

WITH
PROPOSED
SCREENING
(YEAR 0)

Leaf Off

*With Proposed Screening
Year 0*

Time of photograph: 10:11 a.m.
Date of photograph: 04/29/2022
Weather condition: Sunny
Viewing direction: Northeast
View orientation: Level
Latitude: 43.349136°
Longitude: -78.61498°
Elevation: 302 ft.
Photo Location:
The photo was taken from Lake Road looking toward Babcock House Museum and project area.

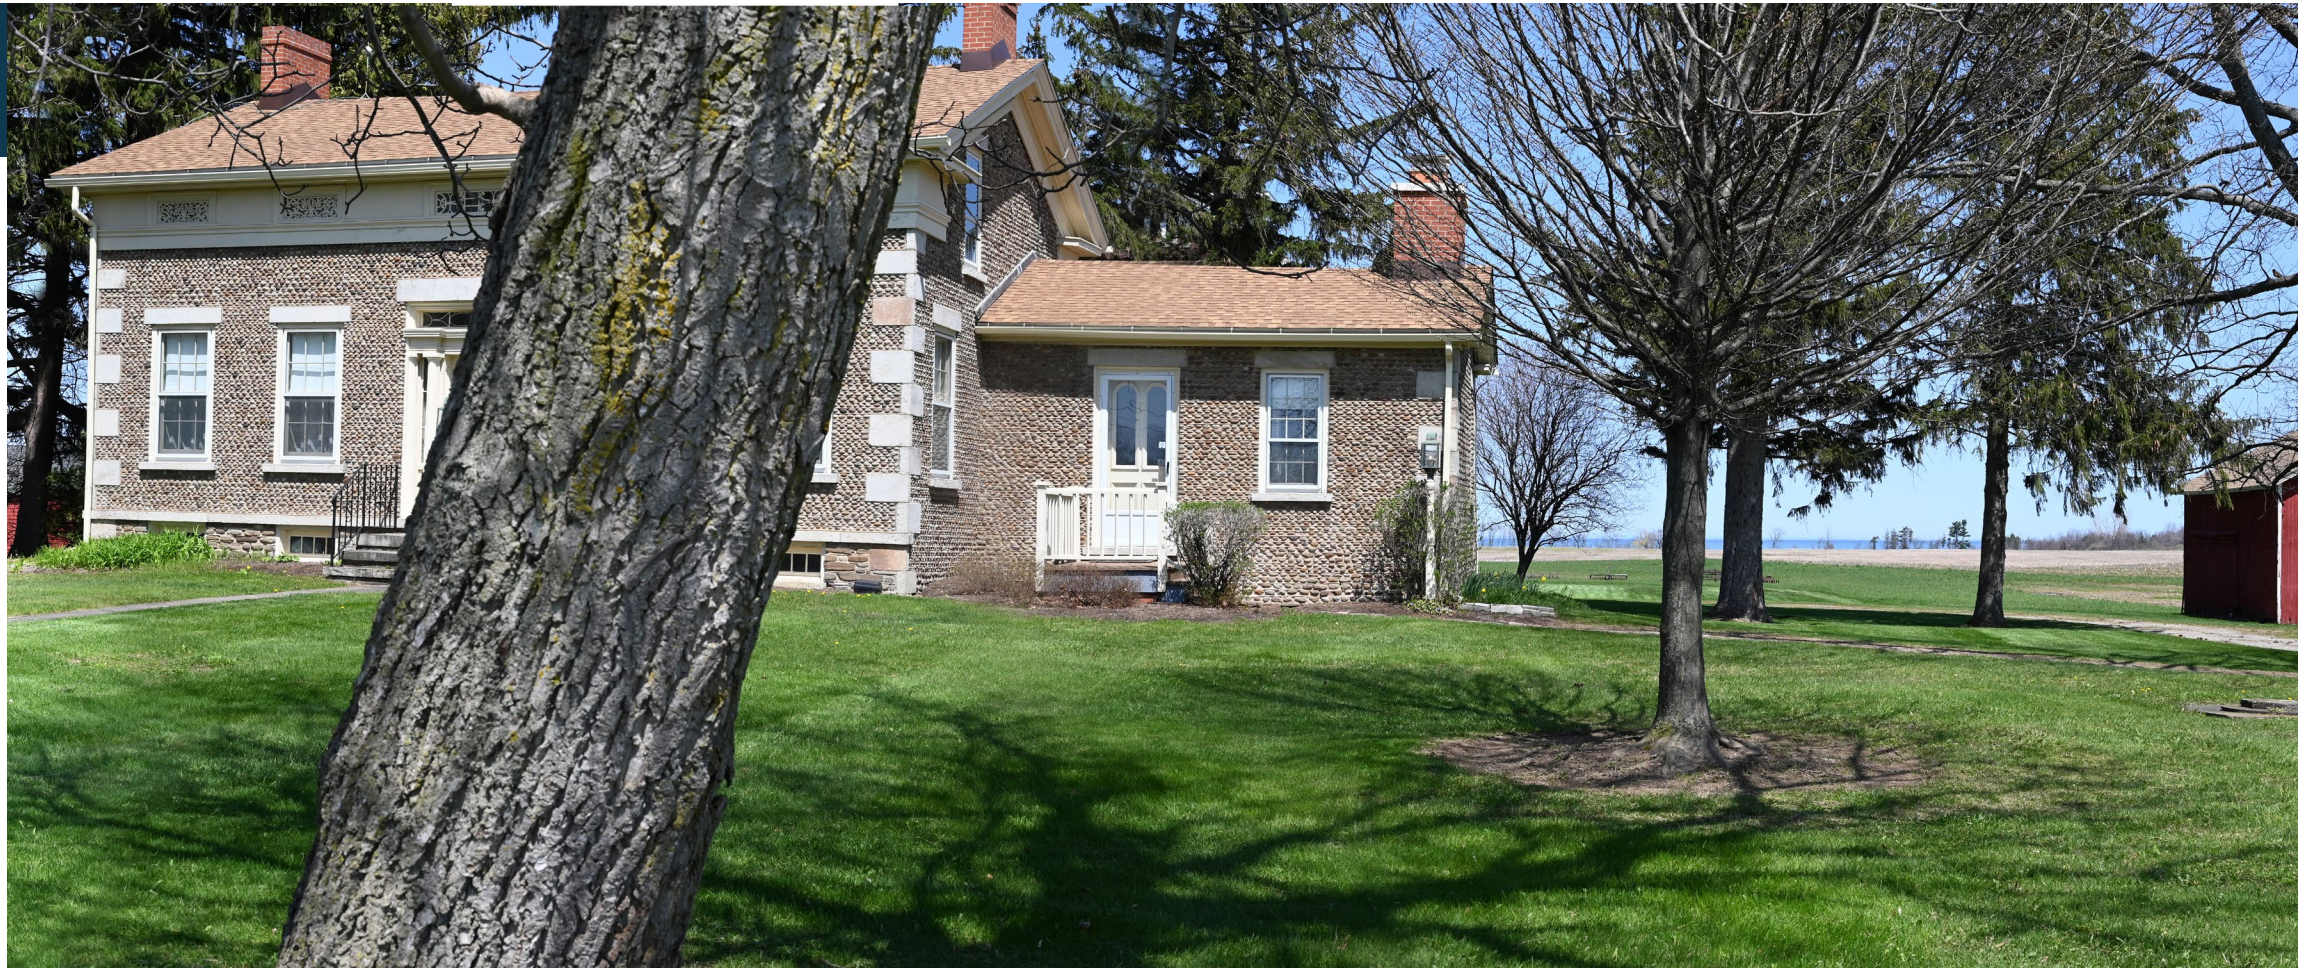
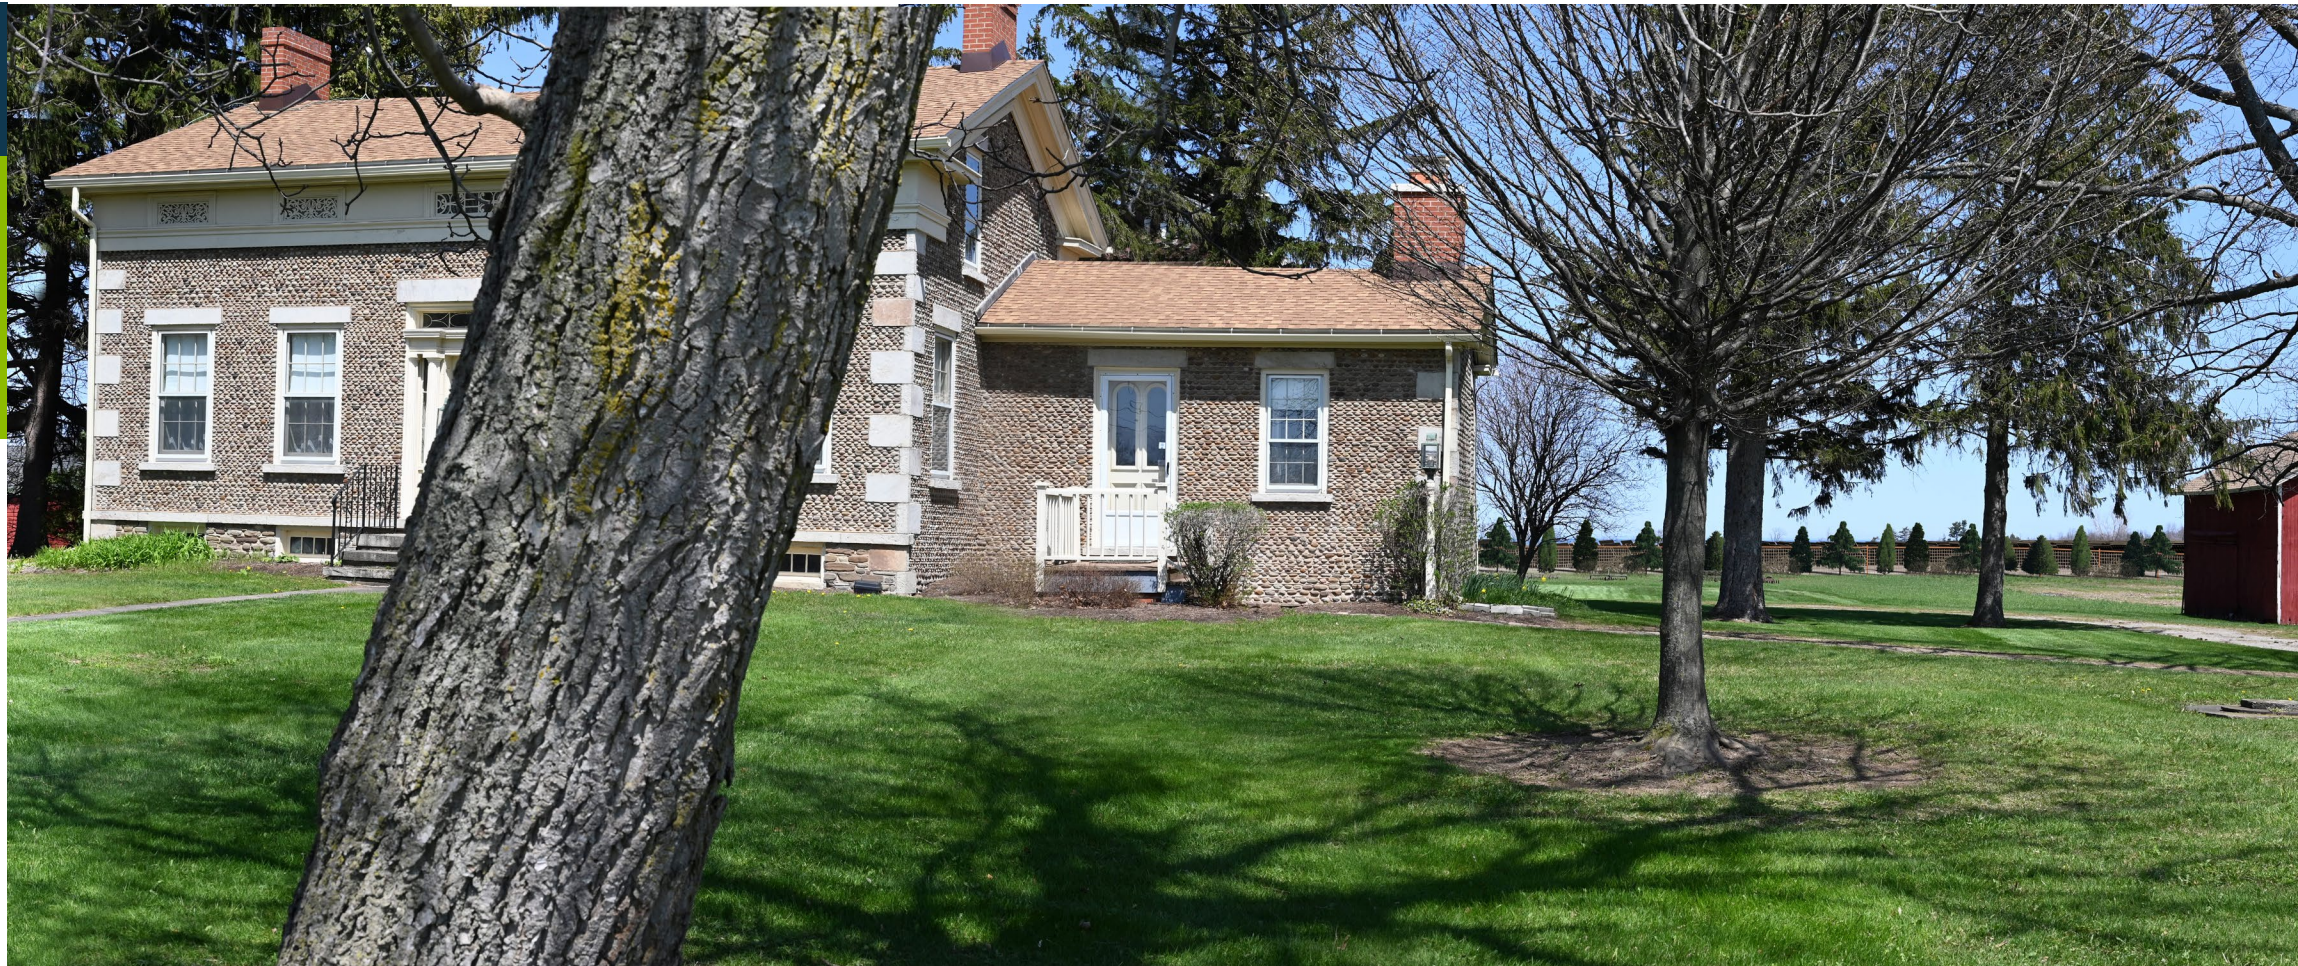
Viewpoint 1B

EXISTING CONDITIONS

Leaf Off

*With Proposed Screening
Year 5*

Time of photograph: 10:11 a.m.
Date of photograph: 04/29/2022
Weather condition: Sunny
Viewing direction: Northeast
View orientation: Level
Latitude: 43.349136°
Longitude: -78.61498°
Elevation: 302 ft.
Photo Location:
The photo was taken from Lake Road looking toward Babcock House Museum and project area.

SIMULATED CONDITIONS

WITH
PROPOSED
SCREENING
(YEAR 5)
