SOMERSET SOLAR  
FACILITY

VISUAL  
SIMULATION

Viewpoint 2A

NY 18/Lake Rd  
Location 1

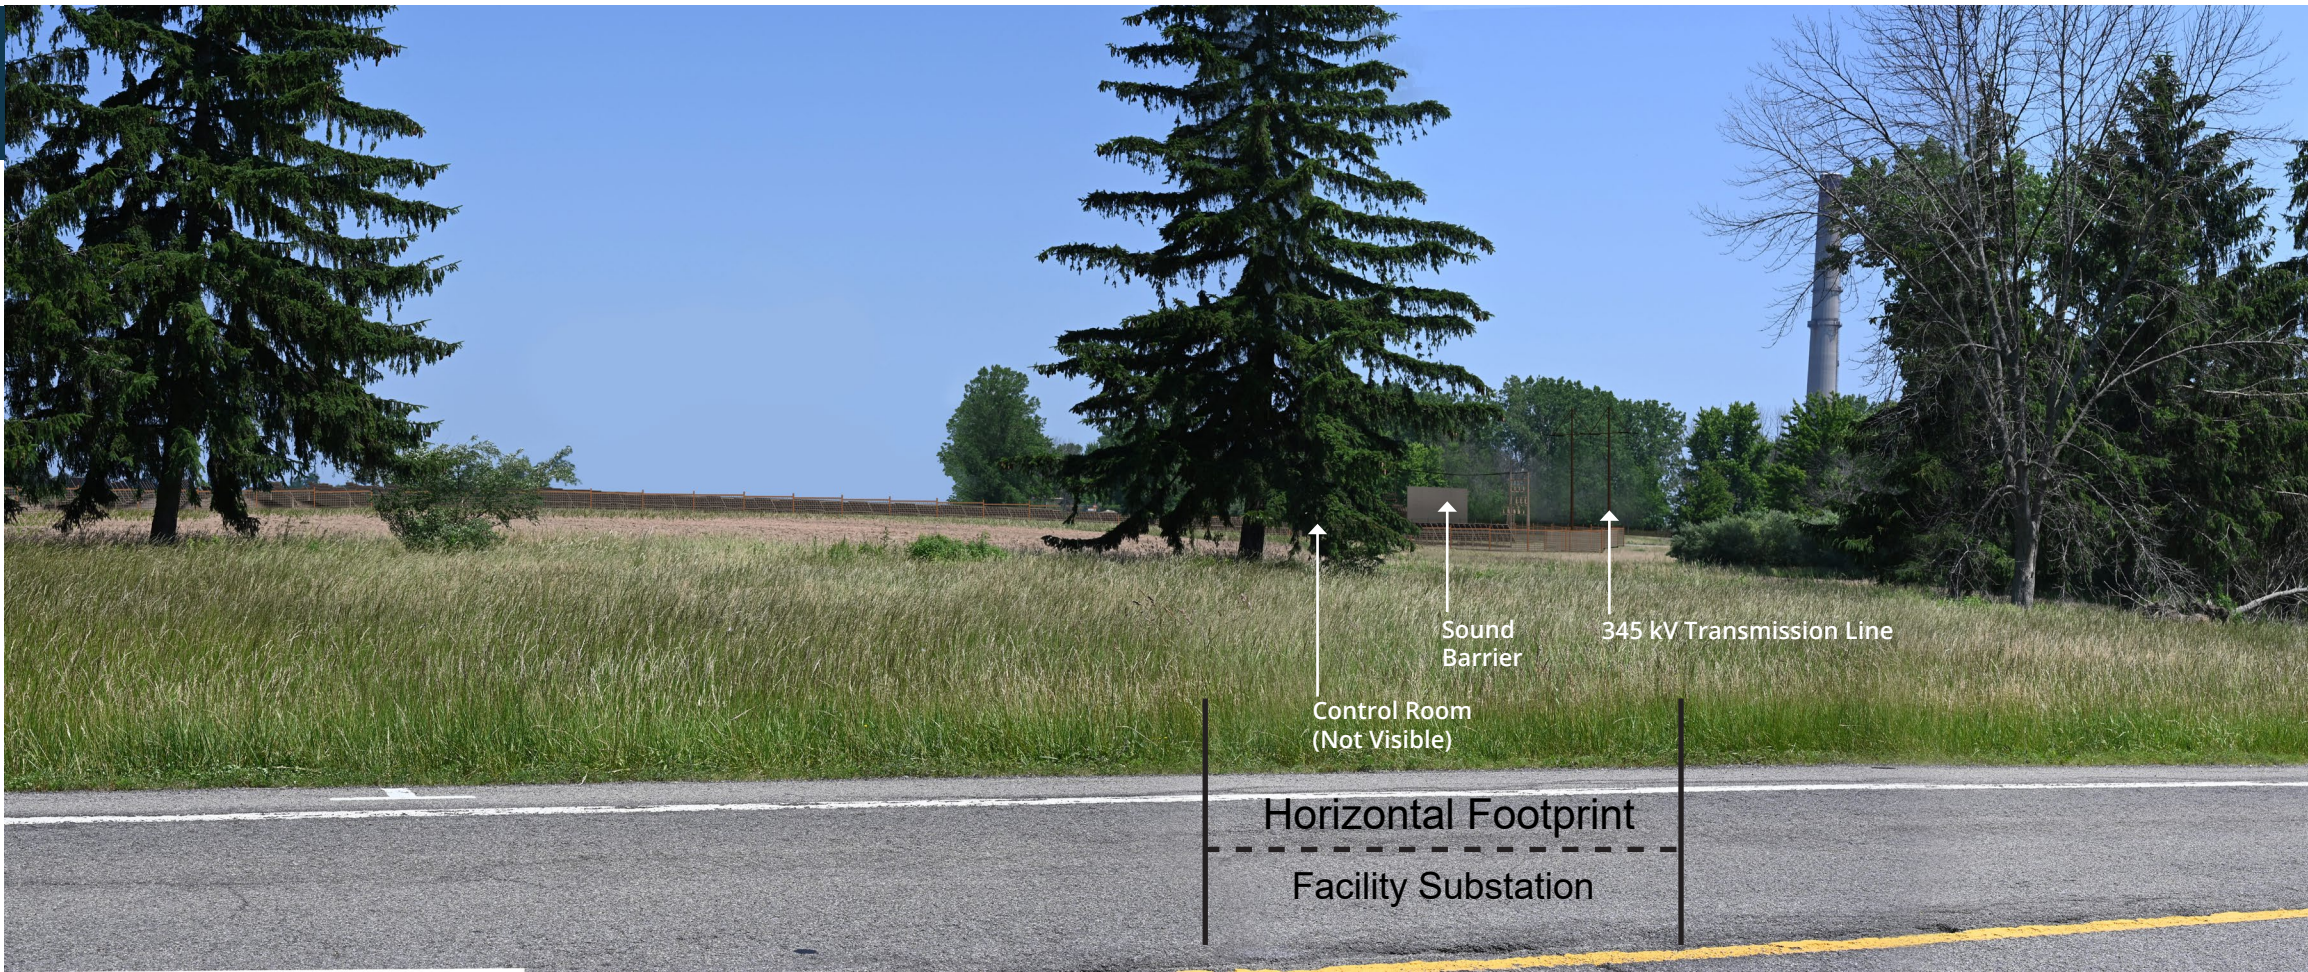
SIMULATED  
CONDITIONS

This simulation depicts the 43 feet in length and 28 feet in height sound wall required within the Facility Substation.

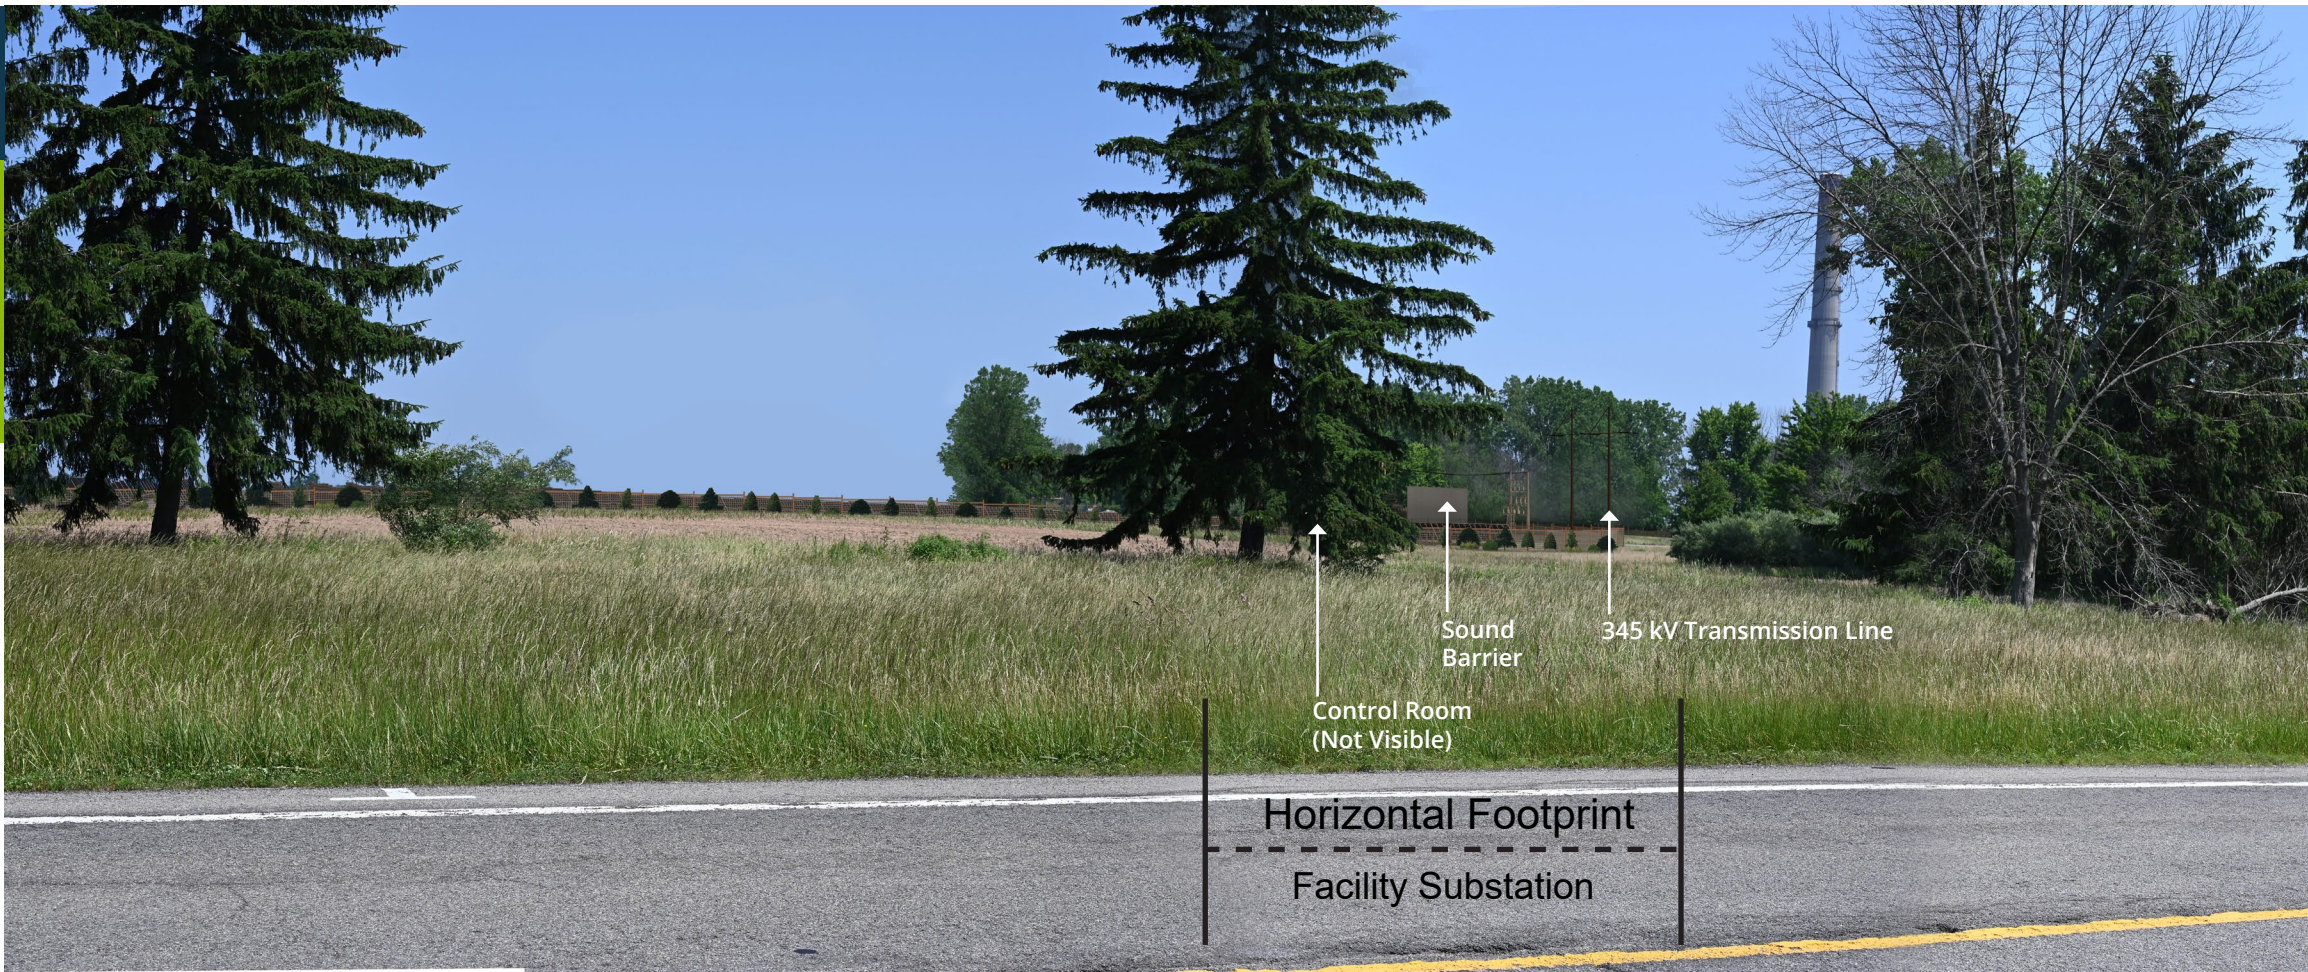
WITH  
PROPOSED  
SCREENING  
(YEAR 0)

This simulation depicts the 43 feet in length and 28 feet in height sound wall required within the Facility Substation.

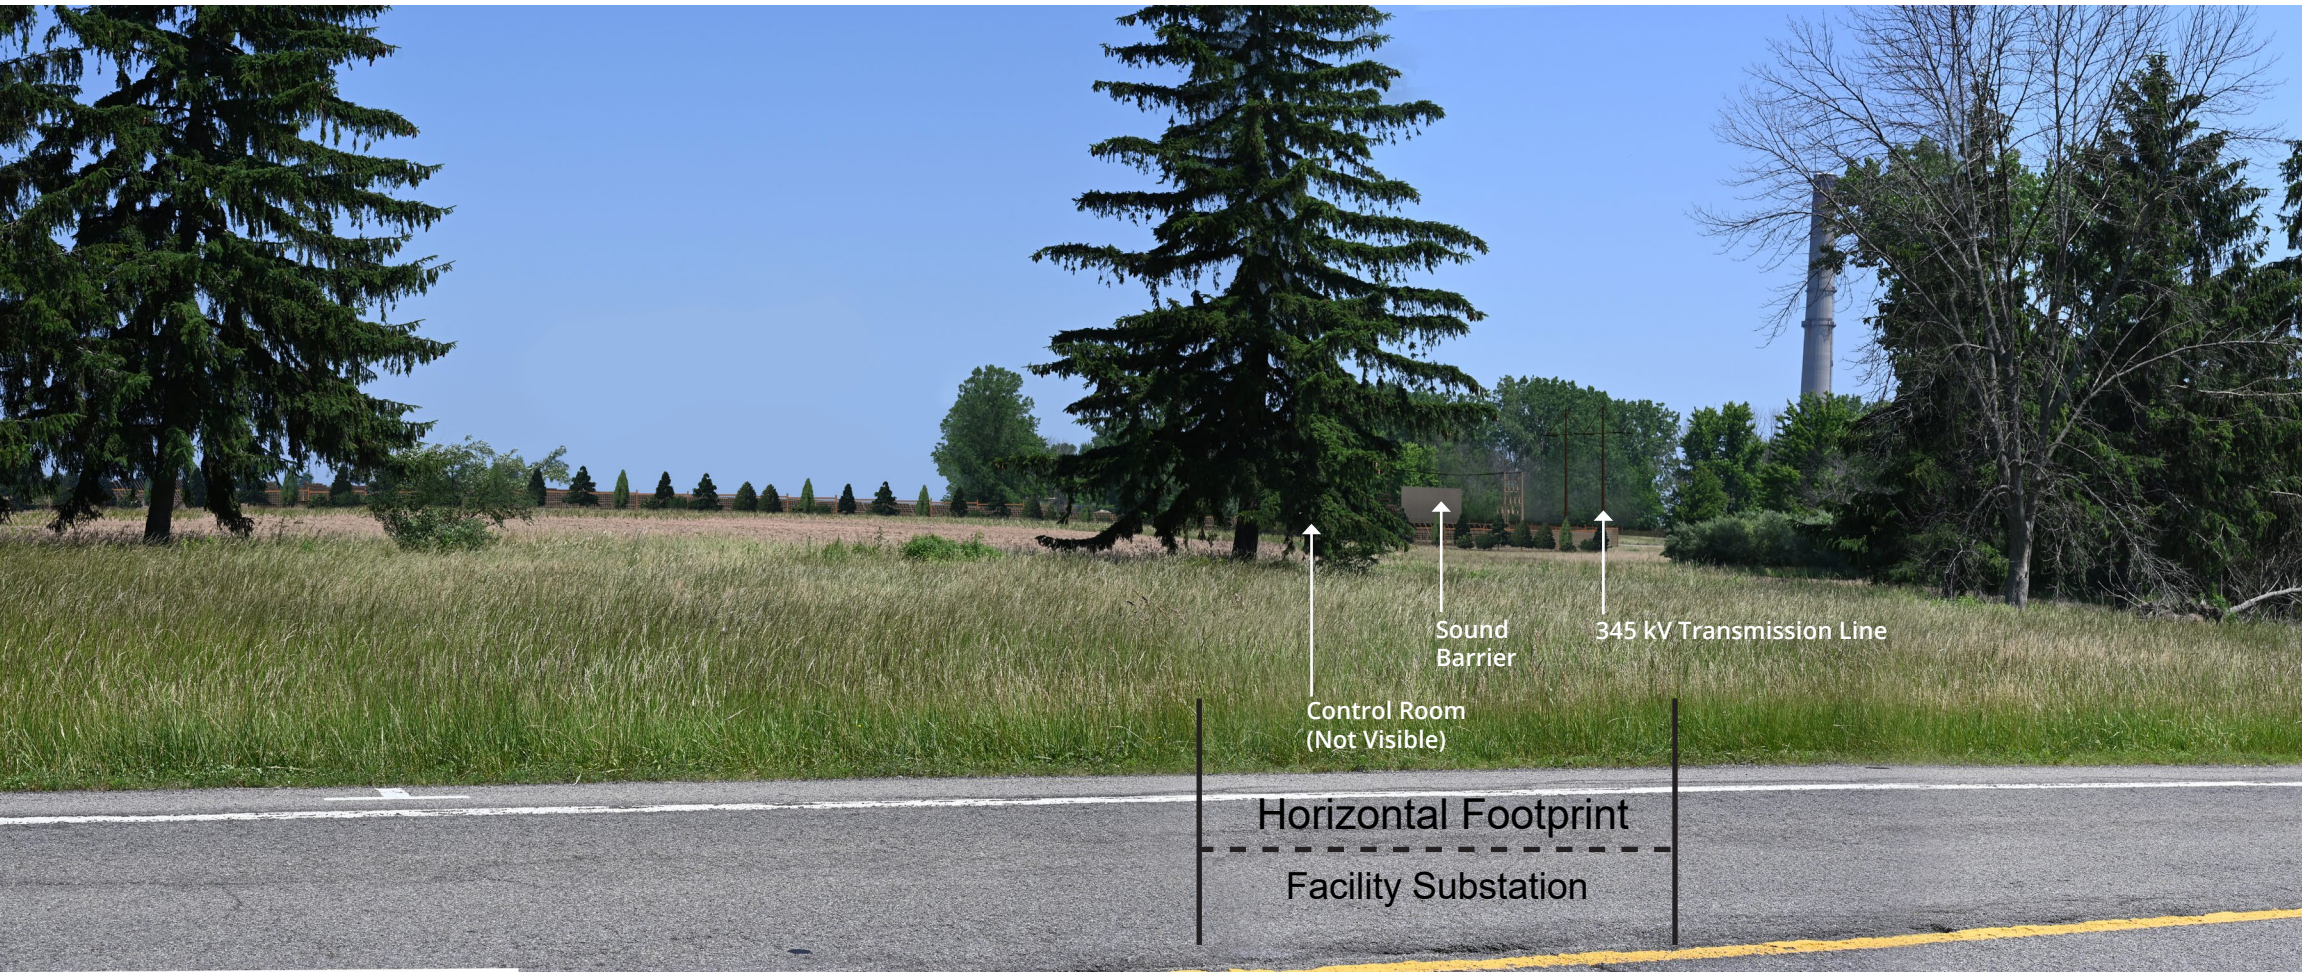
WITH  
PROPOSED  
SCREENING  
(YEAR 5)

This simulation depicts the 43 feet in length and 28 feet in height sound wall required within the Facility Substation.

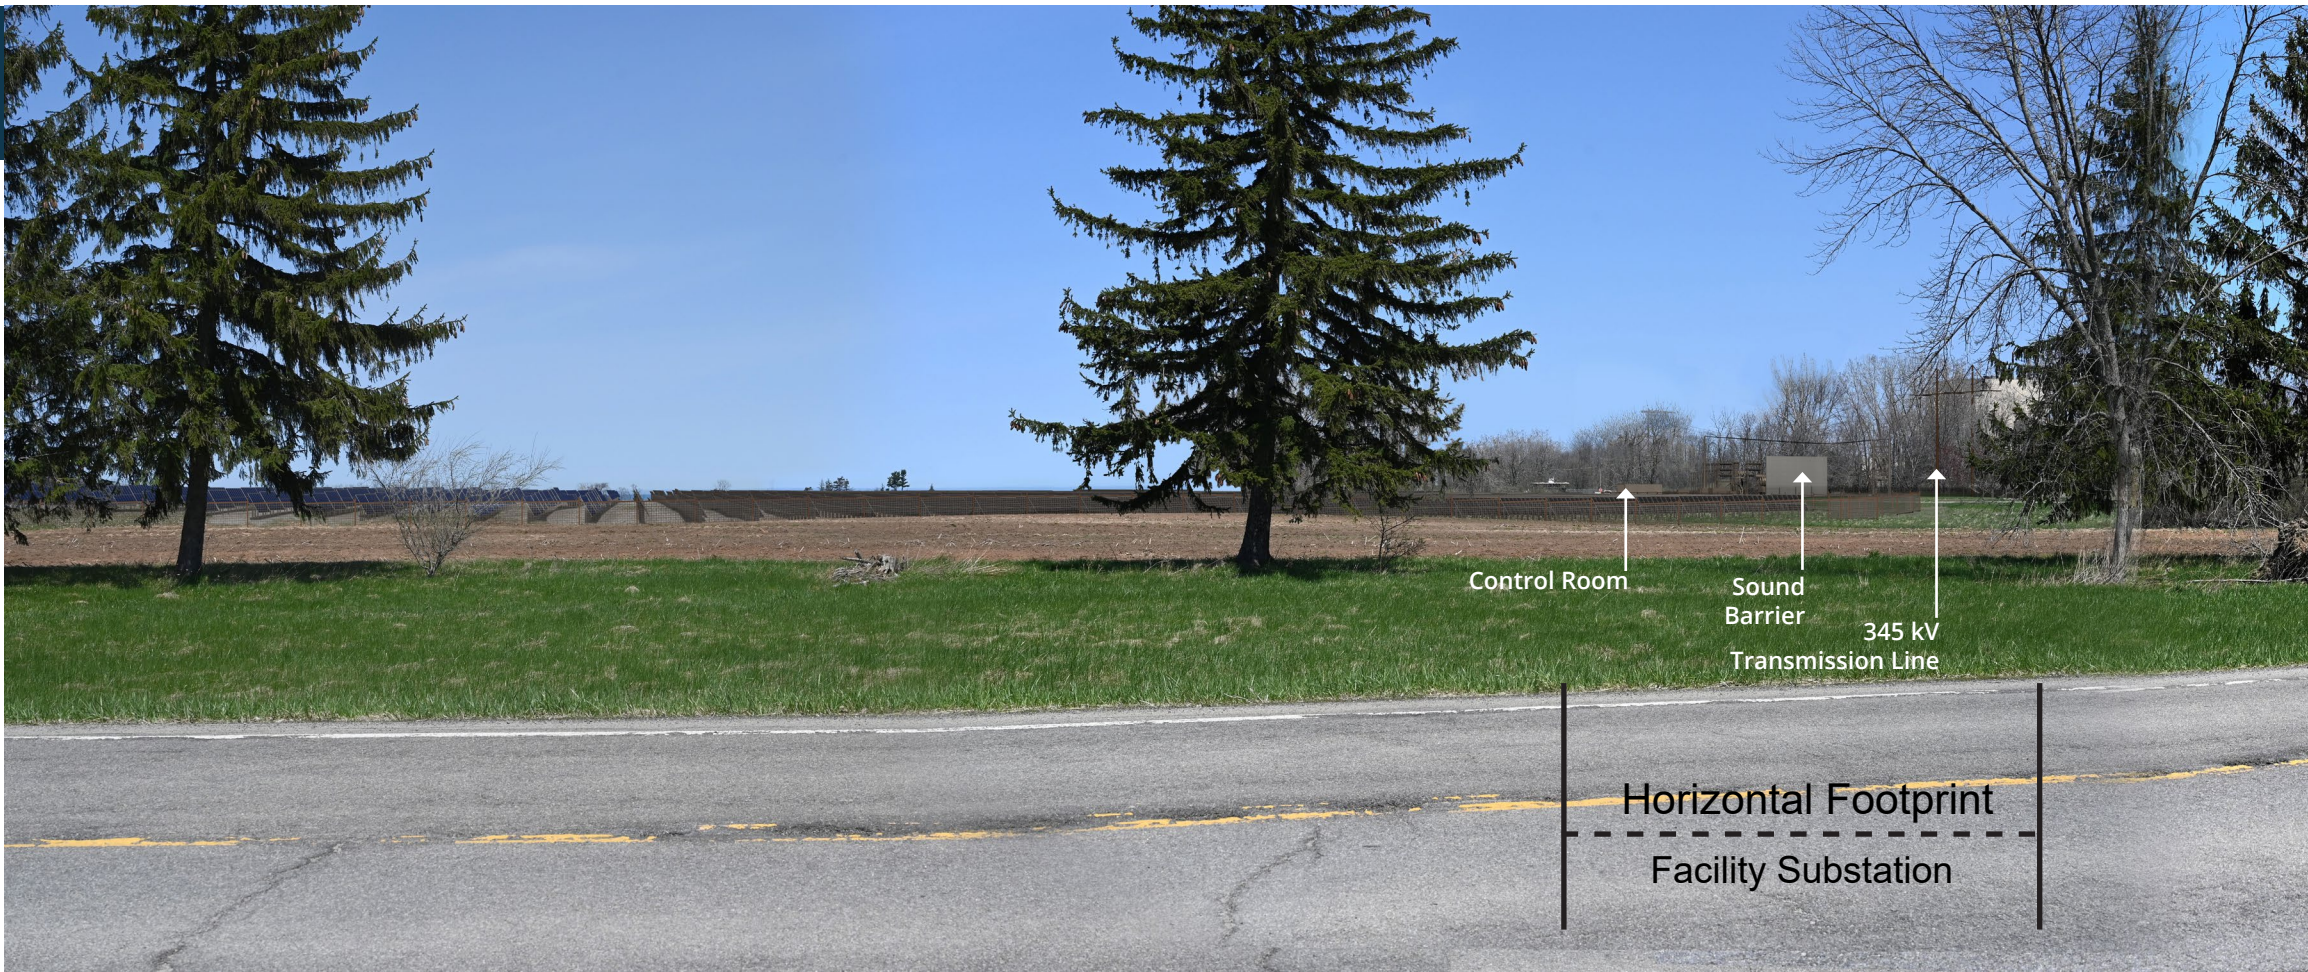
SIMULATED  
CONDITIONS

This simulation depicts the 43 feet in length and 28 feet in height sound wall required within the Facility Substation.

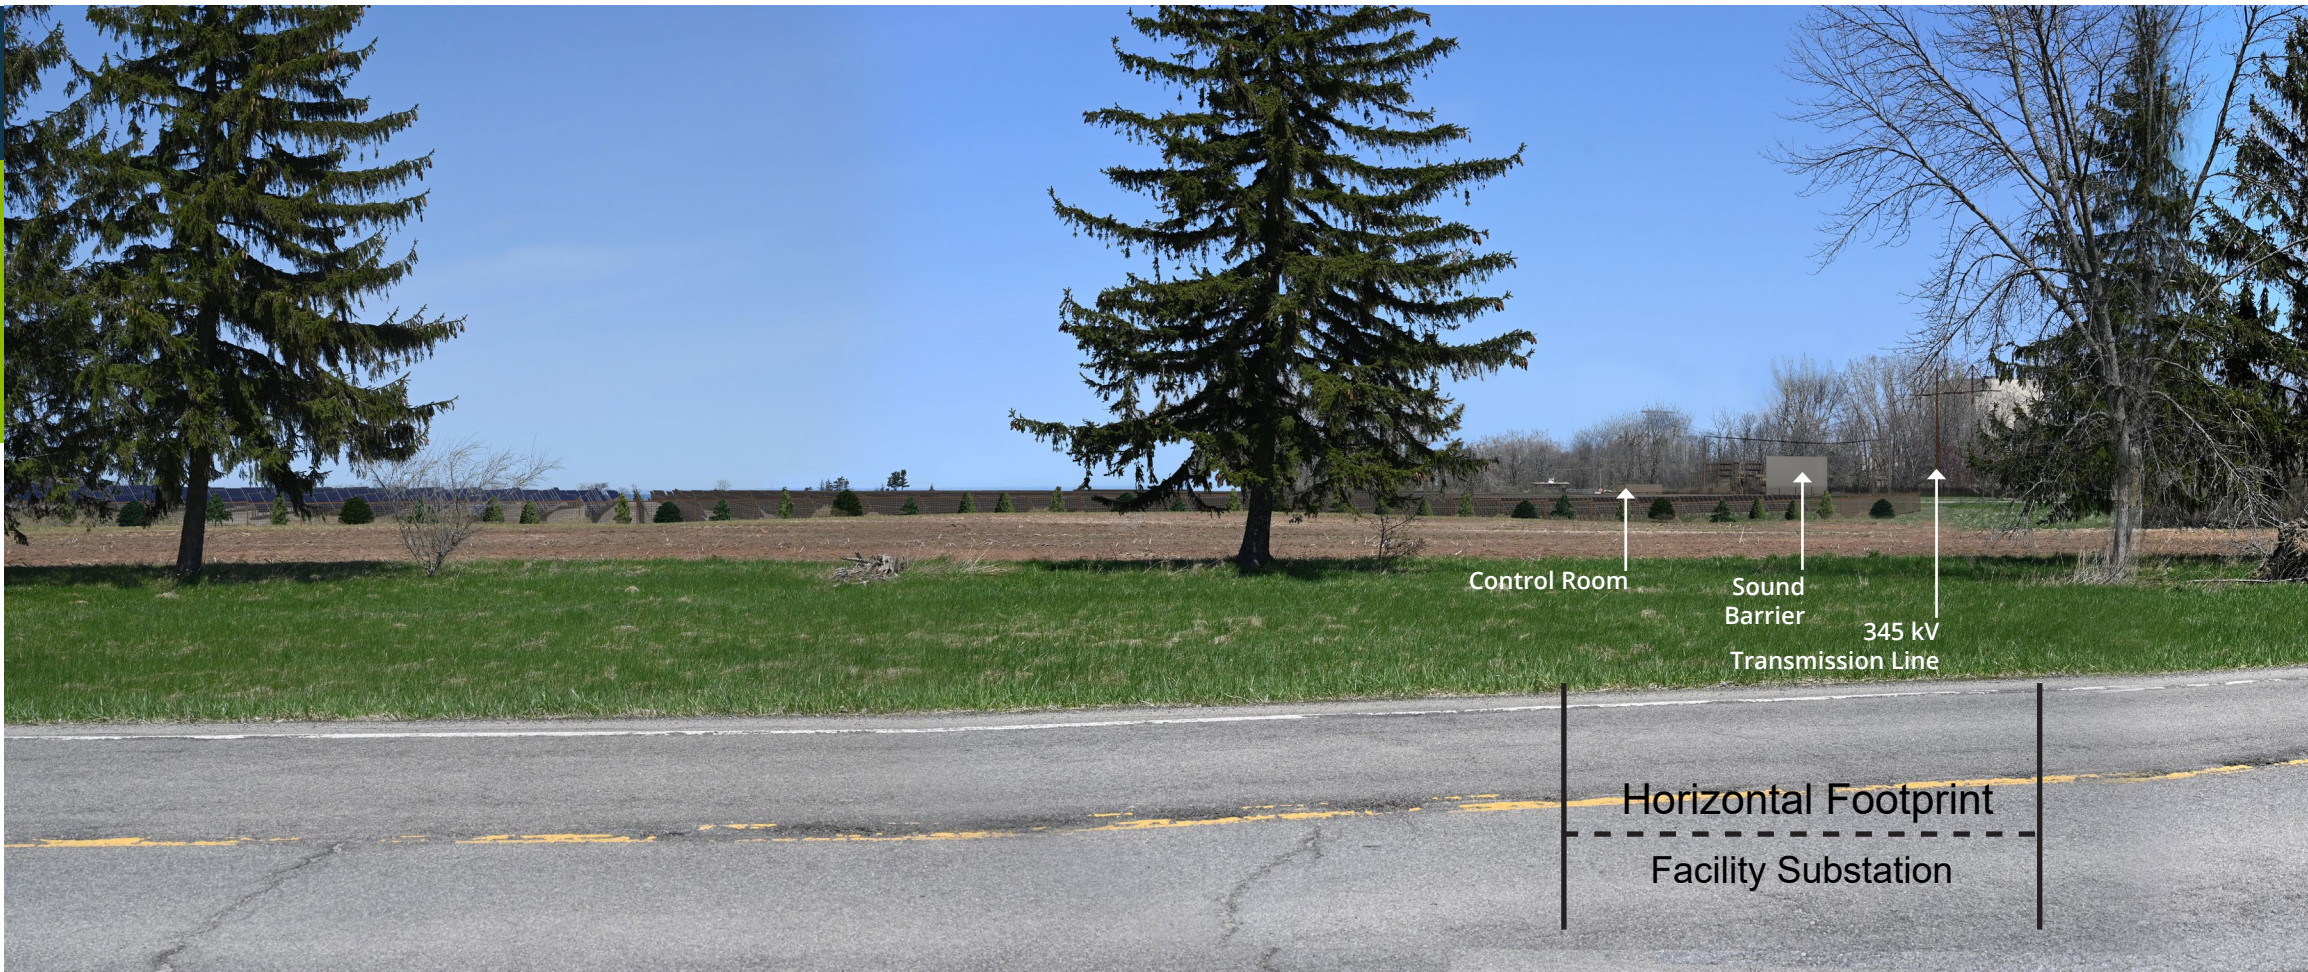
WITH  
PROPOSED  
SCREENING  
(YEAR 0)

This simulation depicts the 43 feet in length and 28 feet in height sound wall required within the Facility Substation.

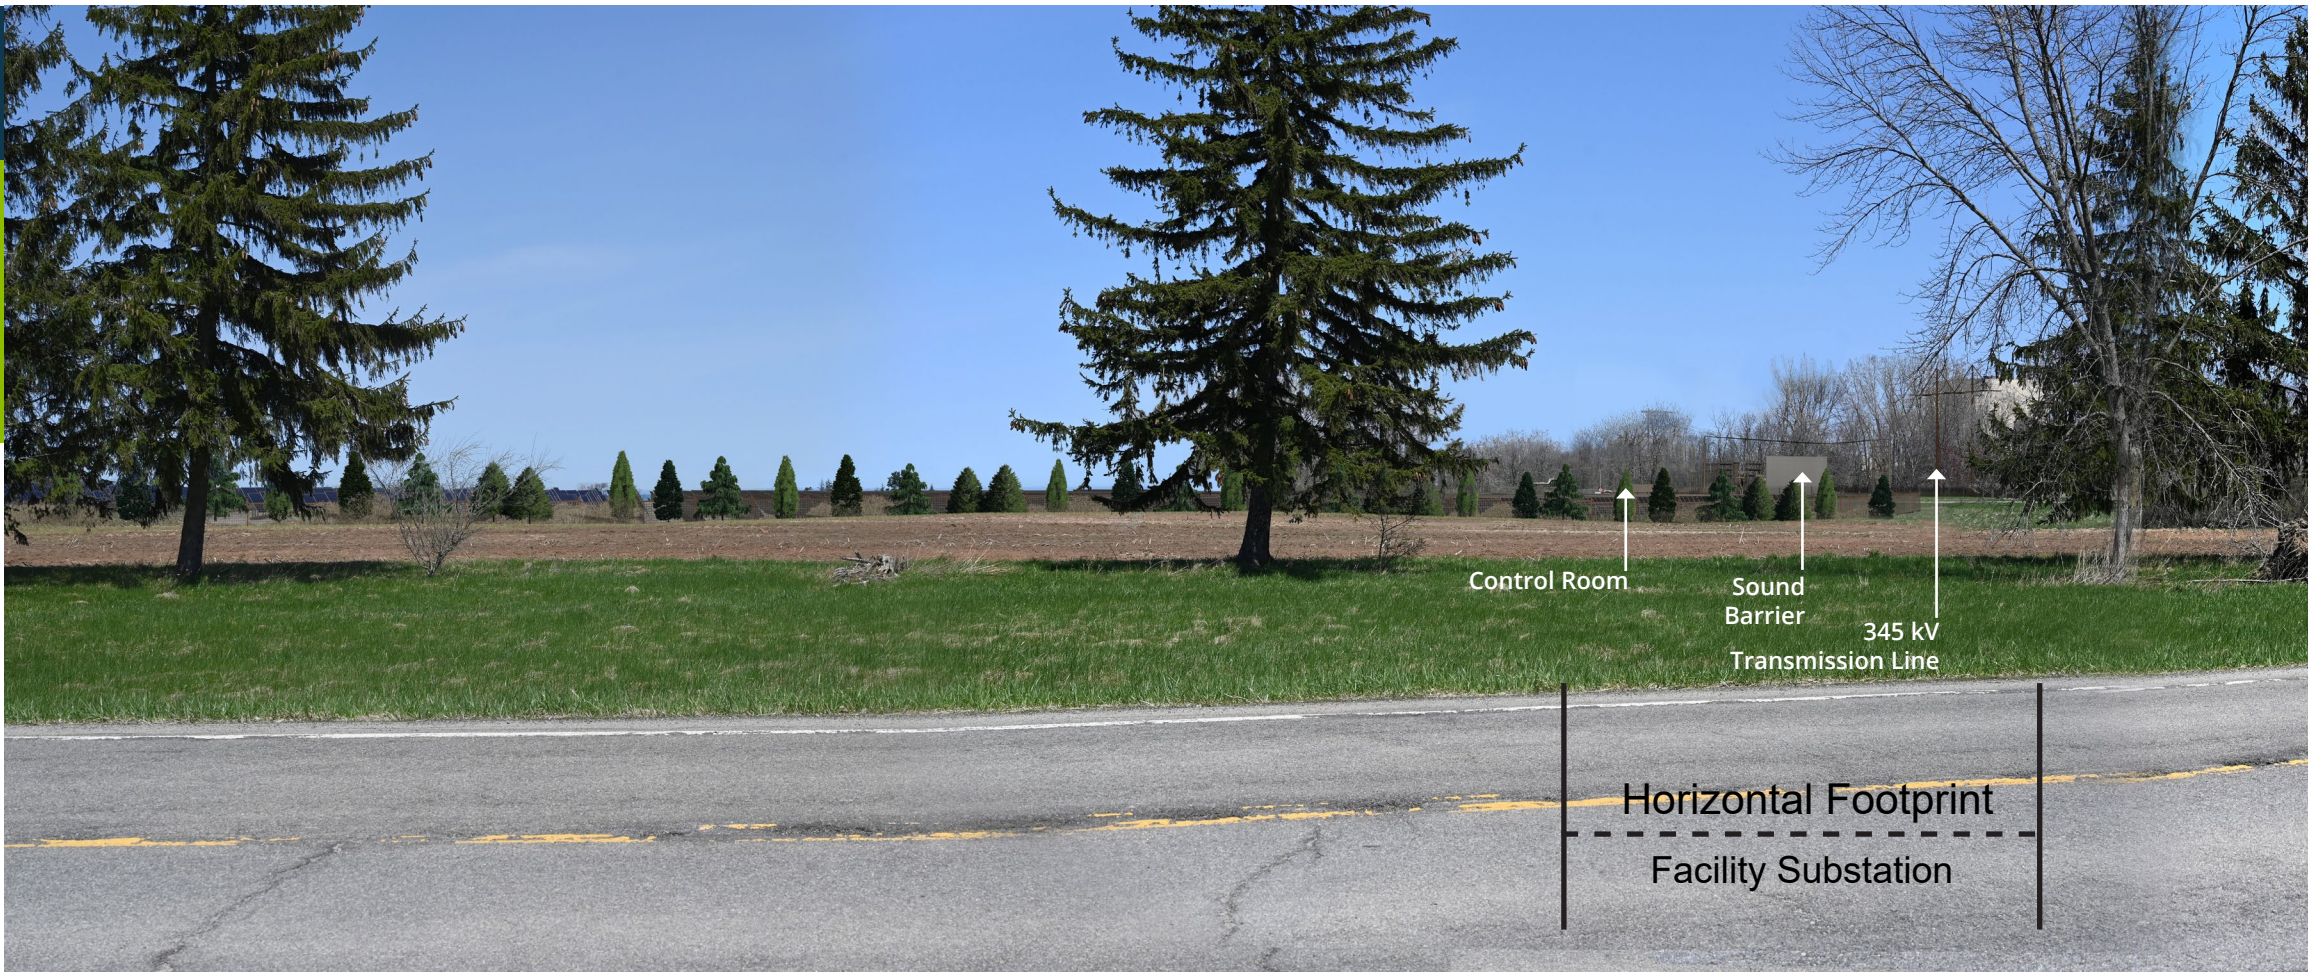
WITH  
PROPOSED  
SCREENING  
(YEAR 5)

This simulation depicts the 43 feet in length and 28 feet in height sound wall required within the Facility Substation.
