**RE: Investigation into the existing Agremax Storage Pile at AES-PR  
Title 40: Protection of the Environment: Part 257 – Criteria  
for Classification of Solid Waste Disposal and Practices**

ON THE GEOTECHNICAL EXPLORATION  
CONDUCTED AT THE SITE OF THE EXISTING  
AGREMAX STORAGE PILE,  
AES FACILITIES  
GUAYAMA, PR

### ON THE EXPLORATION PERFORMED AT THE SITE OF THE AGREMAX STORAGE PILE AT AES FACILITIES, GUAYAMA, PR

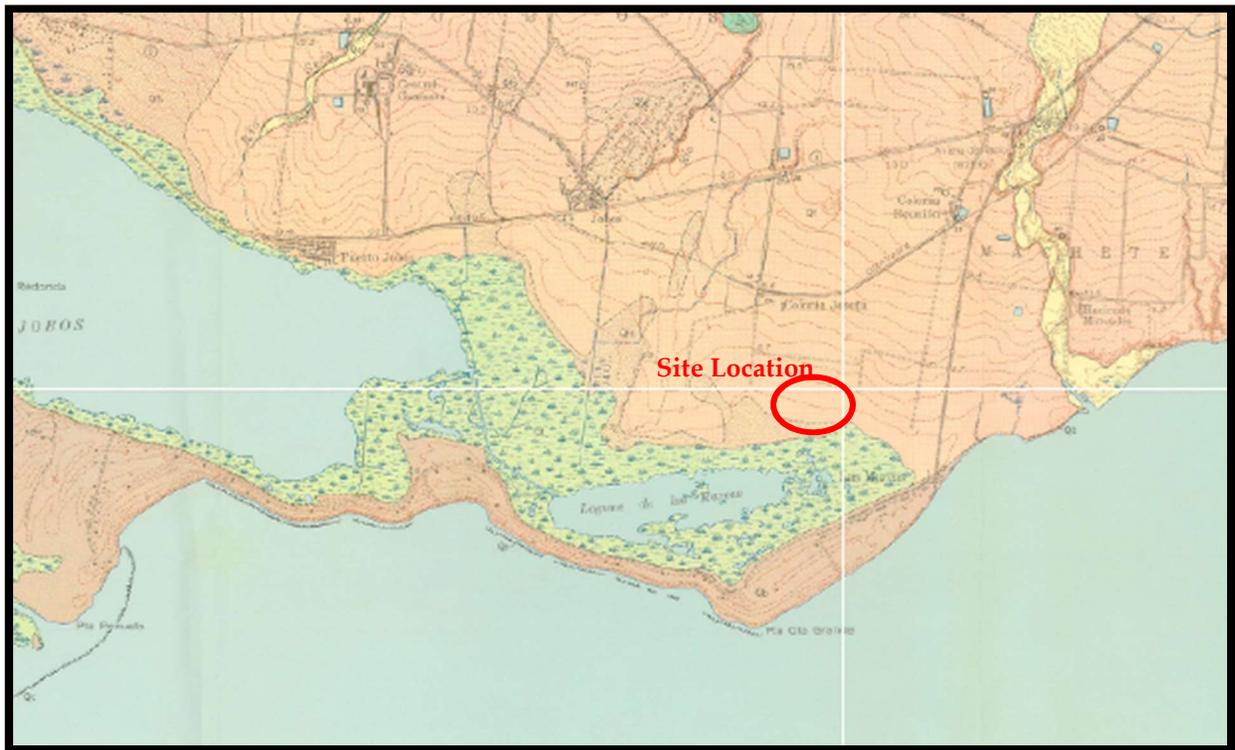
**Figure 1: USGS Geology Map - Central Aguirre Quadrangle**

- **Qf: (Alluvial fans)** – “Unconsolidated stratified clay, silt, sand, gravel, cobbles and boulders; cobbles and boulders mainly in the northern part of alluvial fans; clay, silt, and sand are predominant components of southern half to one-third of fans; areas high in salt, Qfs.”

The site's near surface geology is mainly "Qf" deposit, which corresponds to alluvial fans. This alluvial deposit was encountered at about 14 ft below existing ground surface and continued throughout the final drilled depth of 60 ft. The deposit was mainly described as clayey silt with some sand and varied between soft to stiff consistency. A detailed description of the geological formation on site is included below, along with an illustration of the USGS geological map for the Central Aguirre quadrangle<sup>1</sup>.

This site does not have karst related geology or karst features as defined in the CFR rule. Also there are no existing geologic hazards such as landslide zones prone to mass movements or rock fall. The sites near surface geologic features, as described above, do not represent an unstable condition for the Agremax Storage Pile’s perimeter.

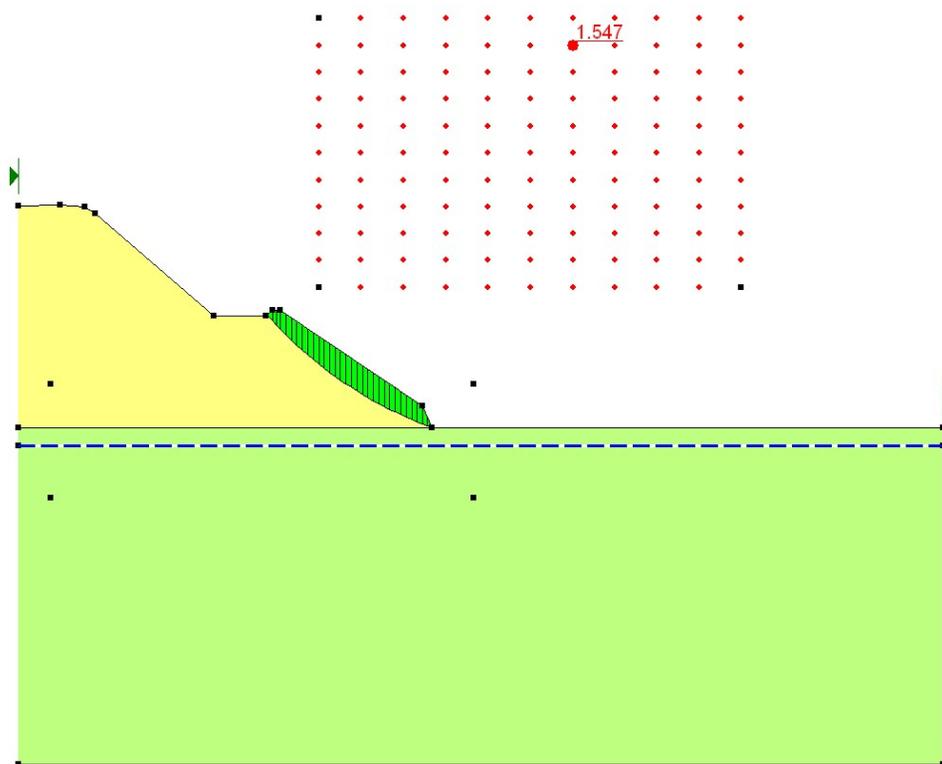
**Figure 2:** Static condition slope stability analysis.

Slope stability was modeled with Slope w software for various critical profiles taken from the existing topography drawings prepared by Agrim. Julio C. Soto CSP, per

drawings dated Sept. 17, 2018, which are enclosed in this report. Data from the field and laboratory tests was incorporated into the model. In consideration of the cohesion that develops from cementing of particles that occurs from the Agremax installation process, the high friction angles and relatively light weight nature of the CCR material (max density ranging from 70 to 80 pcf), the slopes were found to have a Factor of Safety (FS) of over 1.5 for static condition and 1.1 for seismic. These FS values exceed requirements of CFR rule 257.73(e) and standard of practice for geotechnical engineering.

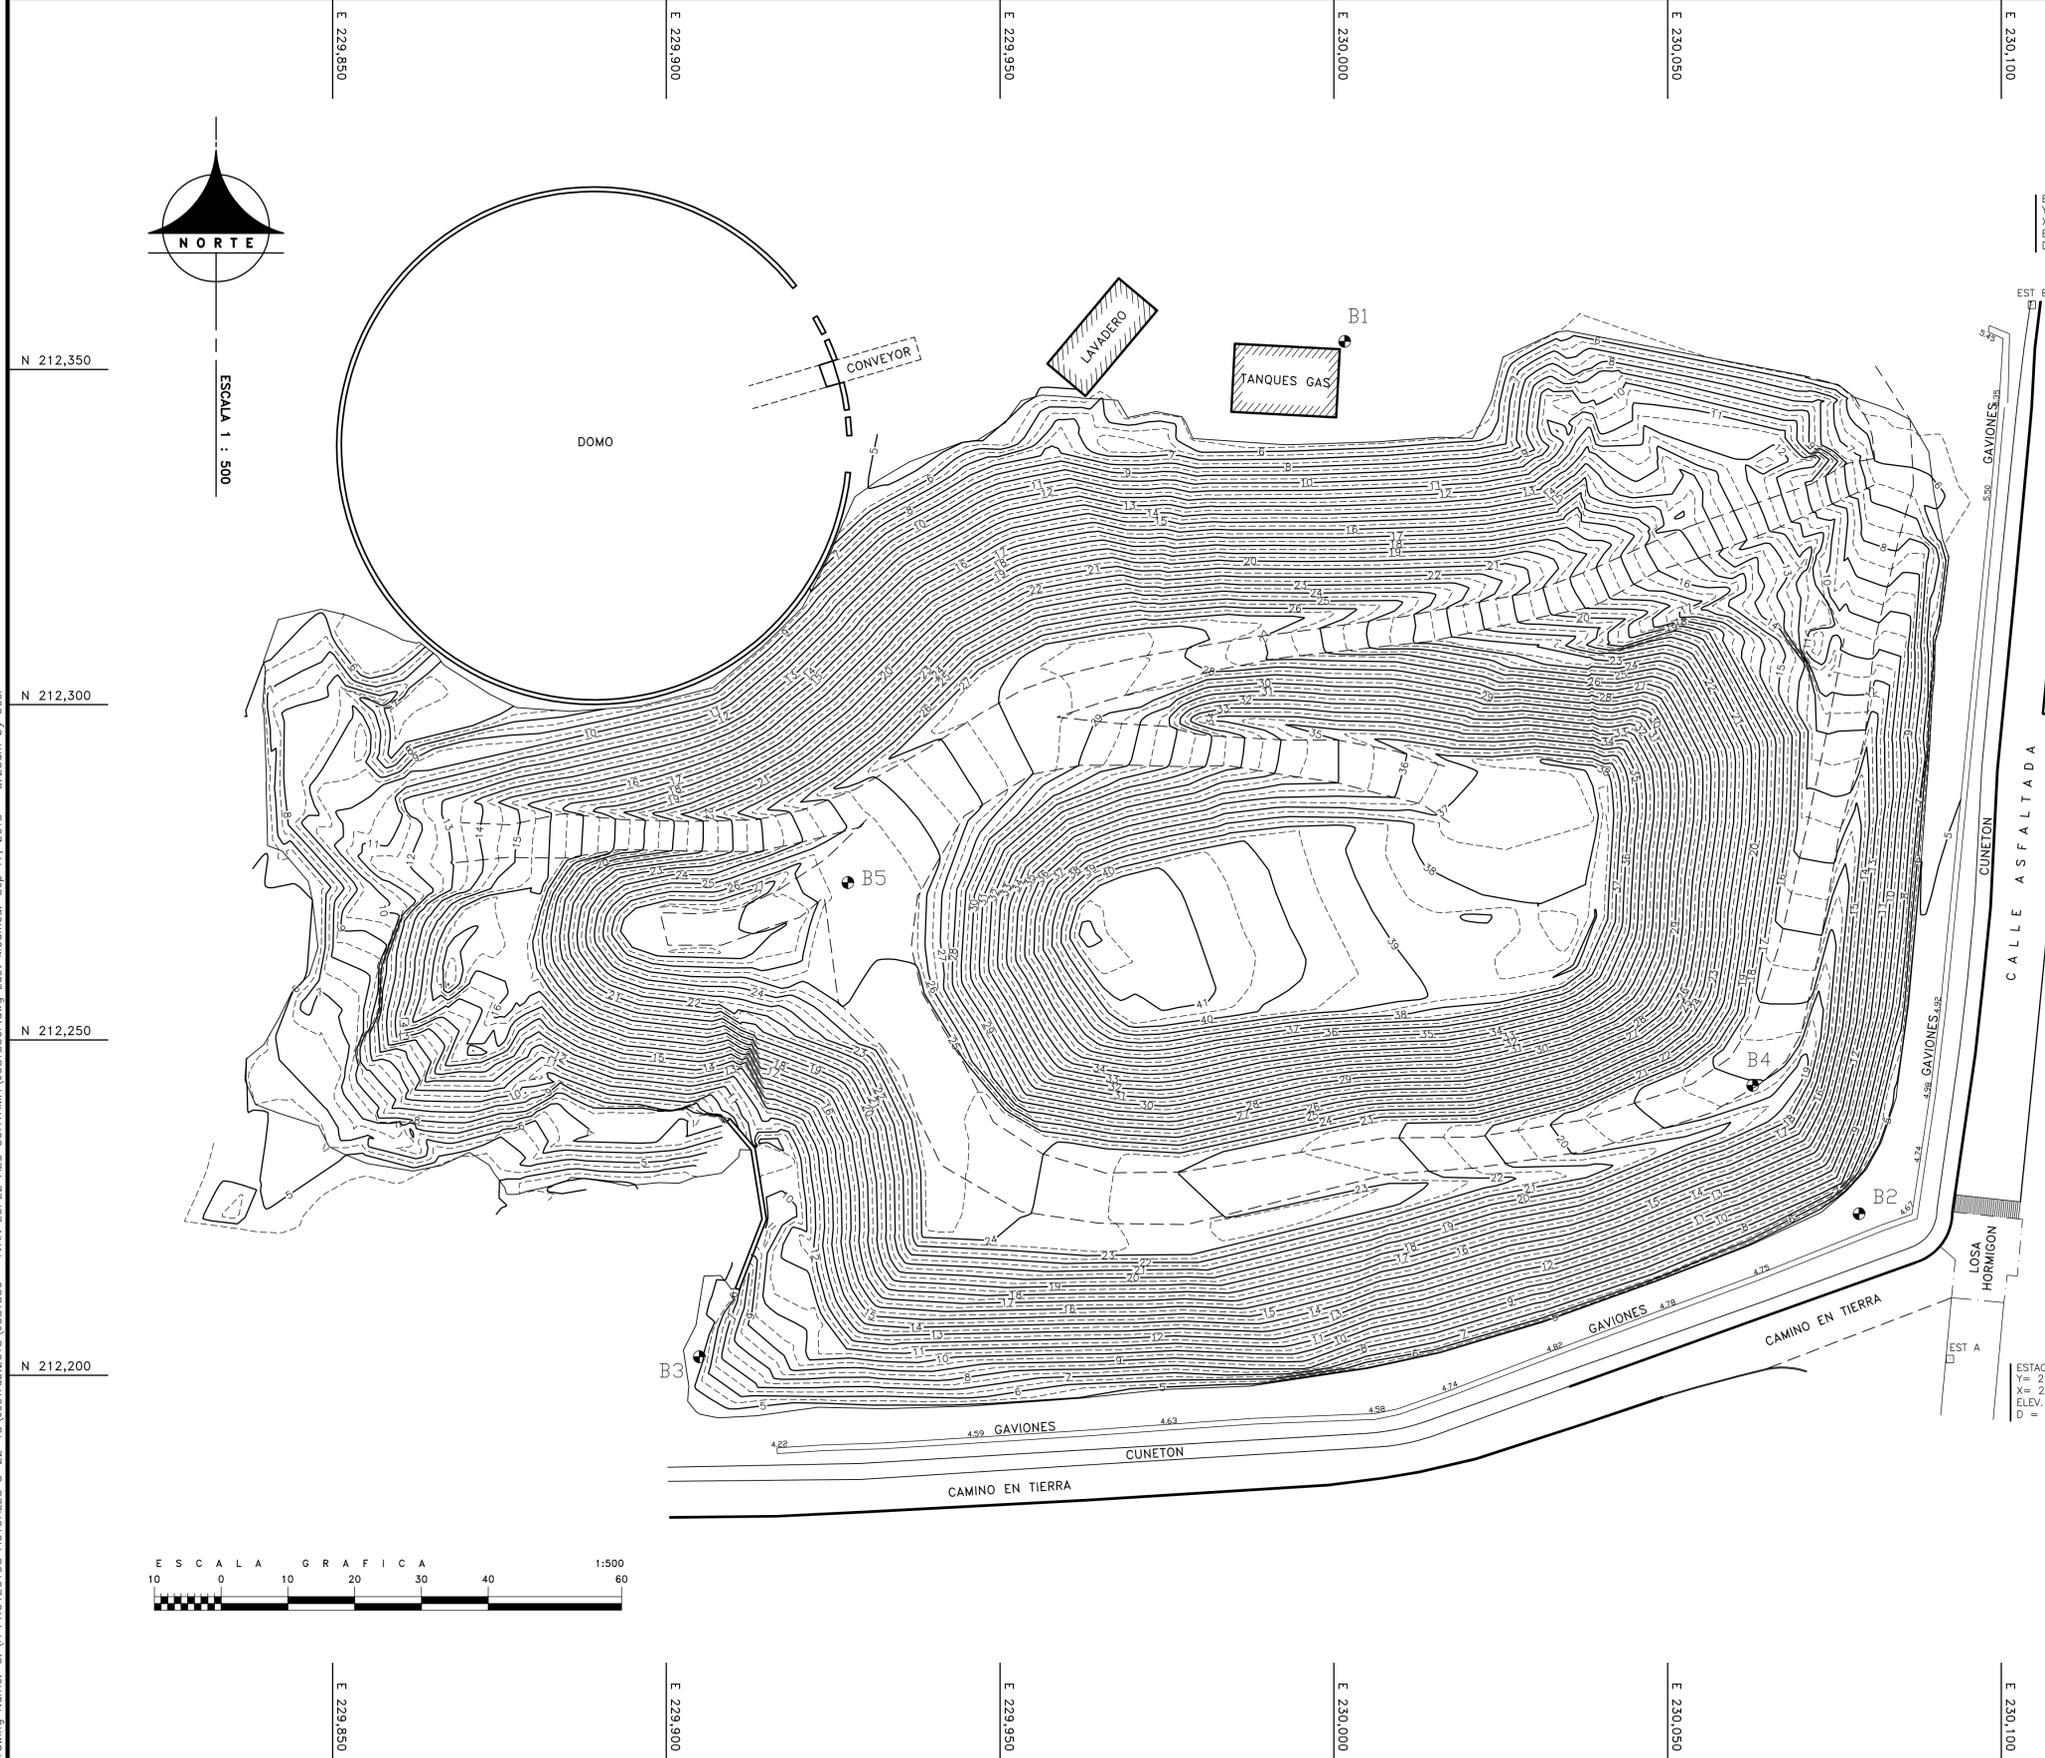
## Boring Locations Plan

**PLANO TOPOGRÁFICO DE DEPOSITO DE MATERIAL**  
EN LAS FACILIDADES DE  
**AES PUERTO RICO, LP**

The field exploration consisted of drilling *five (5)* borings located along the perimeter and within the Agremax storage pile. The borings were drilled to a depth of 25 to 60 ft below existing ground surface (B.E.G.S.). Boring locations are shown on Appendix A and Boring logs on Appendix B of this report.

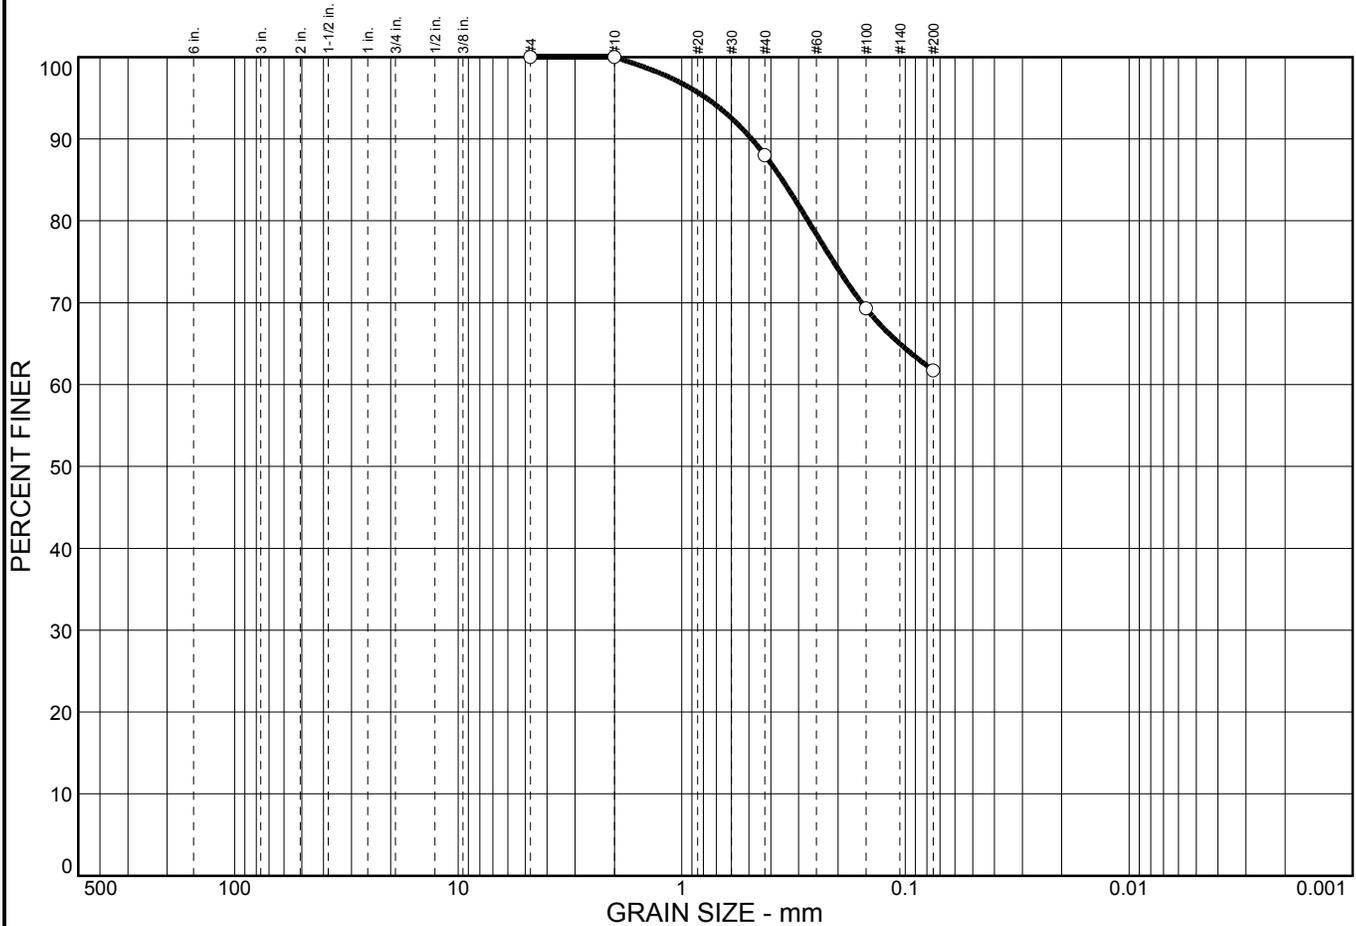
# Particle Size Distribution Report

% COBBLES	% GRAVEL	% SAND	% SILT	% CLAY
0.0	0.0	38.3	61.7

SIEVE SIZE	PERCENT FINER	SPEC.* PERCENT	PASS? (X=NO)
#4	100.0		
#10	100.0		
#40	88.0		
#100	69.3		
#200	61.7

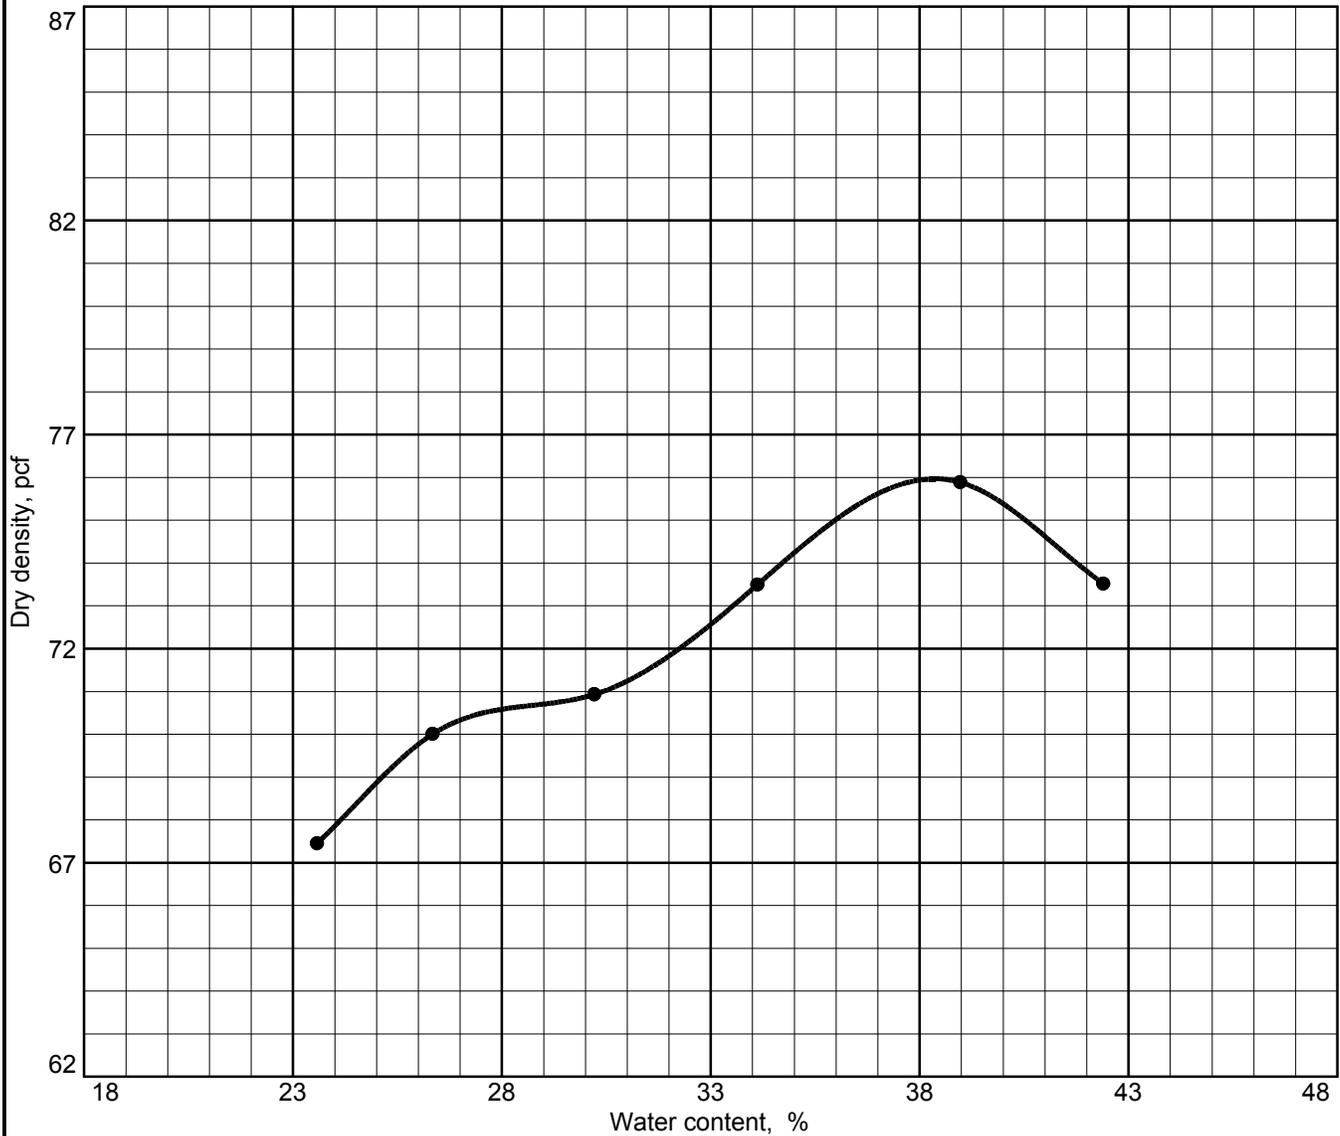
# COMPACTION TEST REPORT

Test specification: ASTM D 1557-00 Method C Modified

Elev/ Depth	Classification		Nat. Moist.	Sp.G.	LL	PI	% > 3/4 in.	% < No.200
	USCS	AASHTO						
	ML	A-4(0)			NP	NP	0.0	61.7

TEST RESULTS	MATERIAL DESCRIPTION
Maximum dry density = 76.0 pcf Optimum moisture = 38.4 %	Sandy silt. Aggremax Grab
<b>Project No.</b> 7899 <b>Client:</b> Carrasquillo Engineering Services <b>Project:</b> CDR Landfill at AES, Guayama, PR <span style="float: right;"><b>Date:</b> 9/7/18</span> <b>Location:</b> Guayama, PR      Source Sample: Project Site	<b>Remarks:</b> Tested by: F. Santos Checked by: Rommel Cintron Aponte, MSCE, PE Job No.: 7899
<b>JACA &amp; SIERRA TESTING LABORATORIES</b> <b>San Juan, Puerto Rico</b>

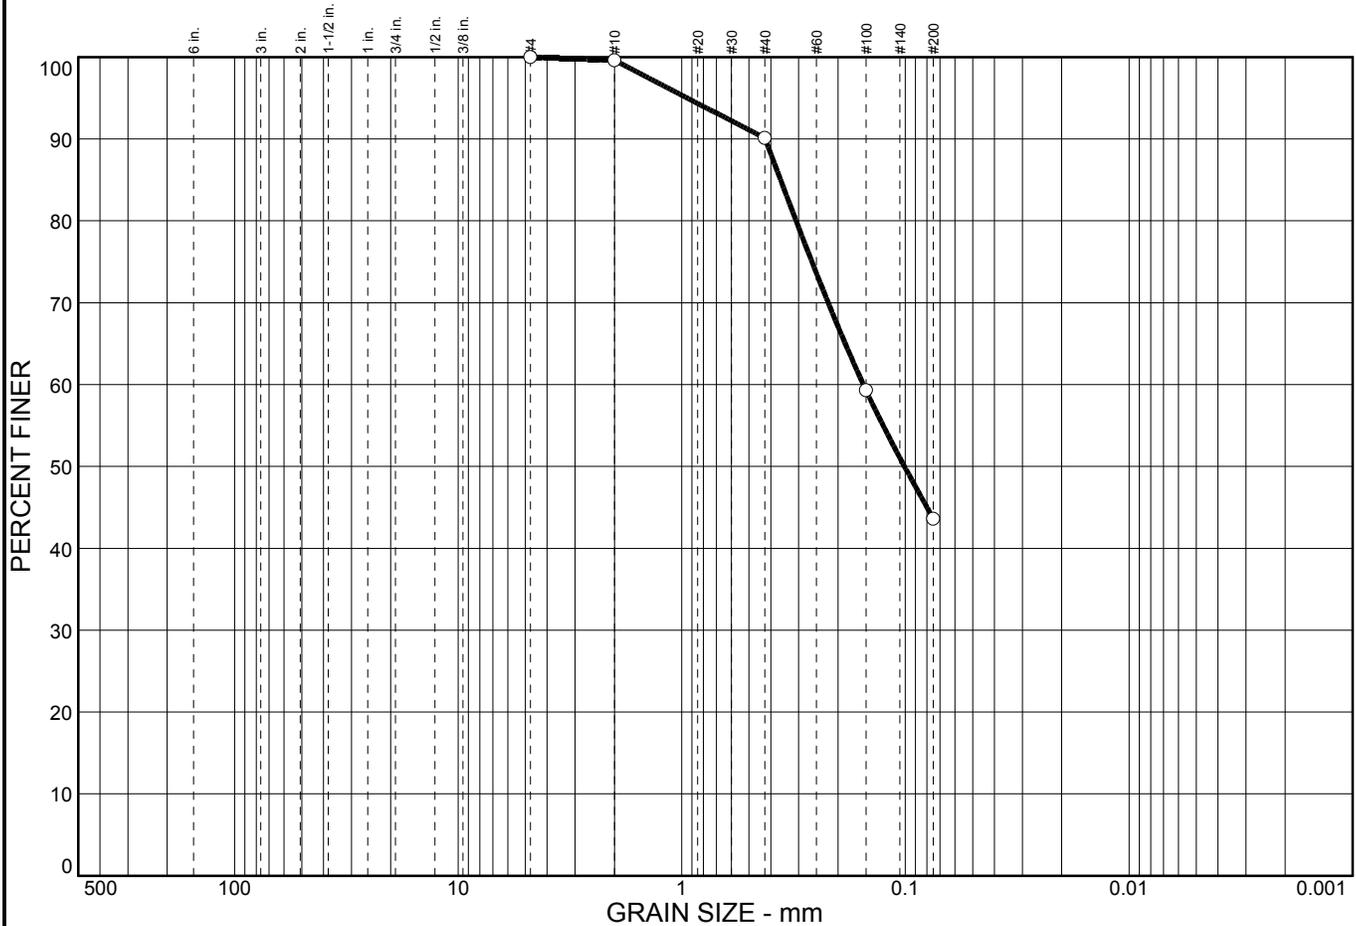
# Particle Size Distribution Report

% COBBLES	% GRAVEL	% SAND	% SILT	% CLAY
0.0	0.0	56.4	43.6

SIEVE SIZE	PERCENT FINER	SPEC.* PERCENT	PASS? (X=NO)
#4	100.0		
#10	99.6		
#40	90.1		
#100	59.3		
#200	43.6

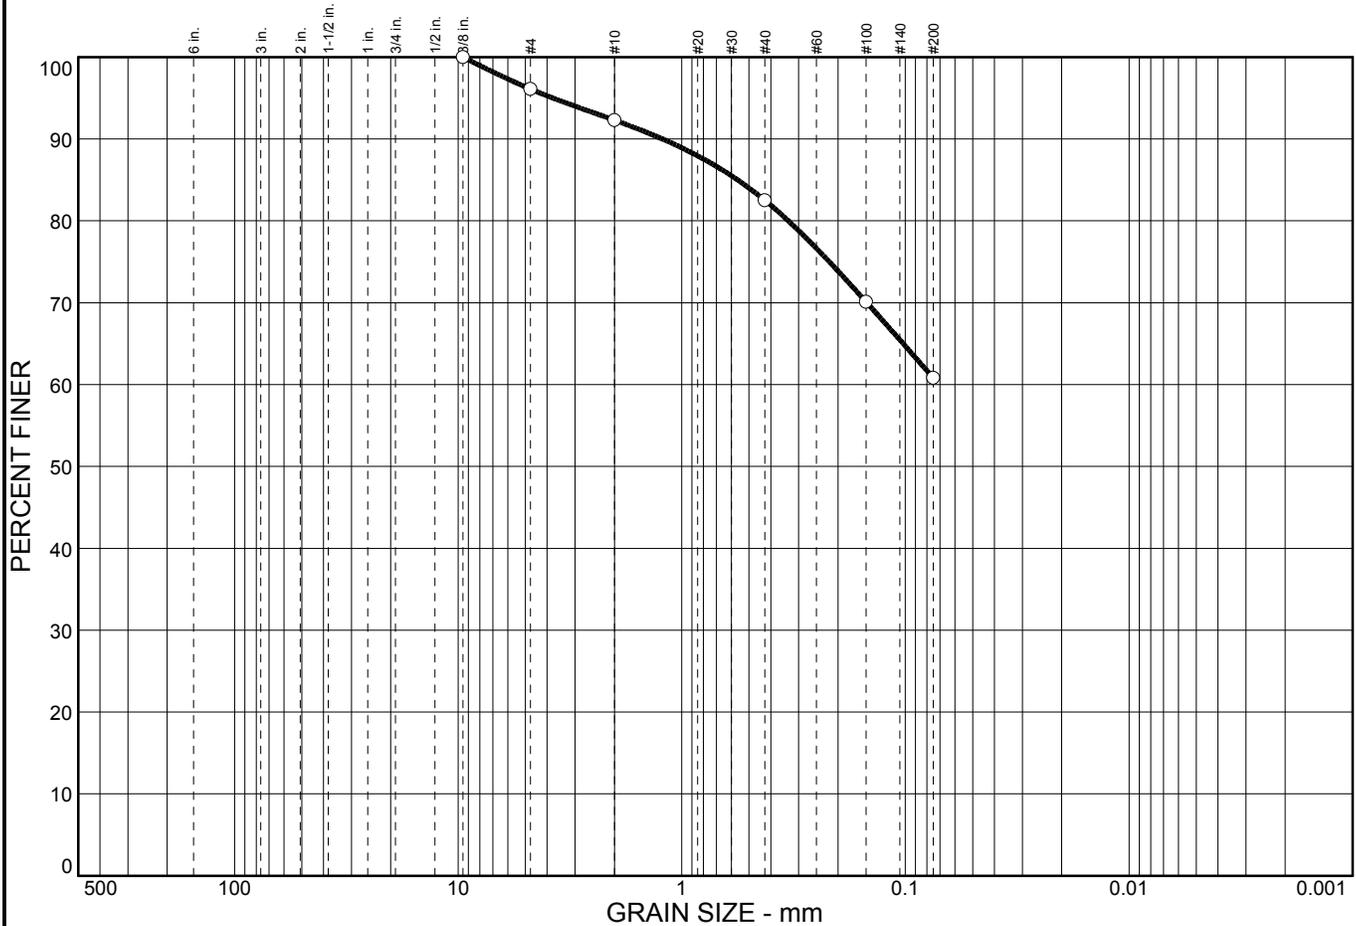
# Particle Size Distribution Report

% COBBLES	% GRAVEL	% SAND	% SILT	% CLAY
0.0	3.9	35.3	60.8

SIEVE SIZE	PERCENT FINER	SPEC.* PERCENT	PASS? (X=NO)
.375 in.	100.0		
#4	96.1		
#10	92.3		
#40	82.5		
#100	70.1		
#200	60.8

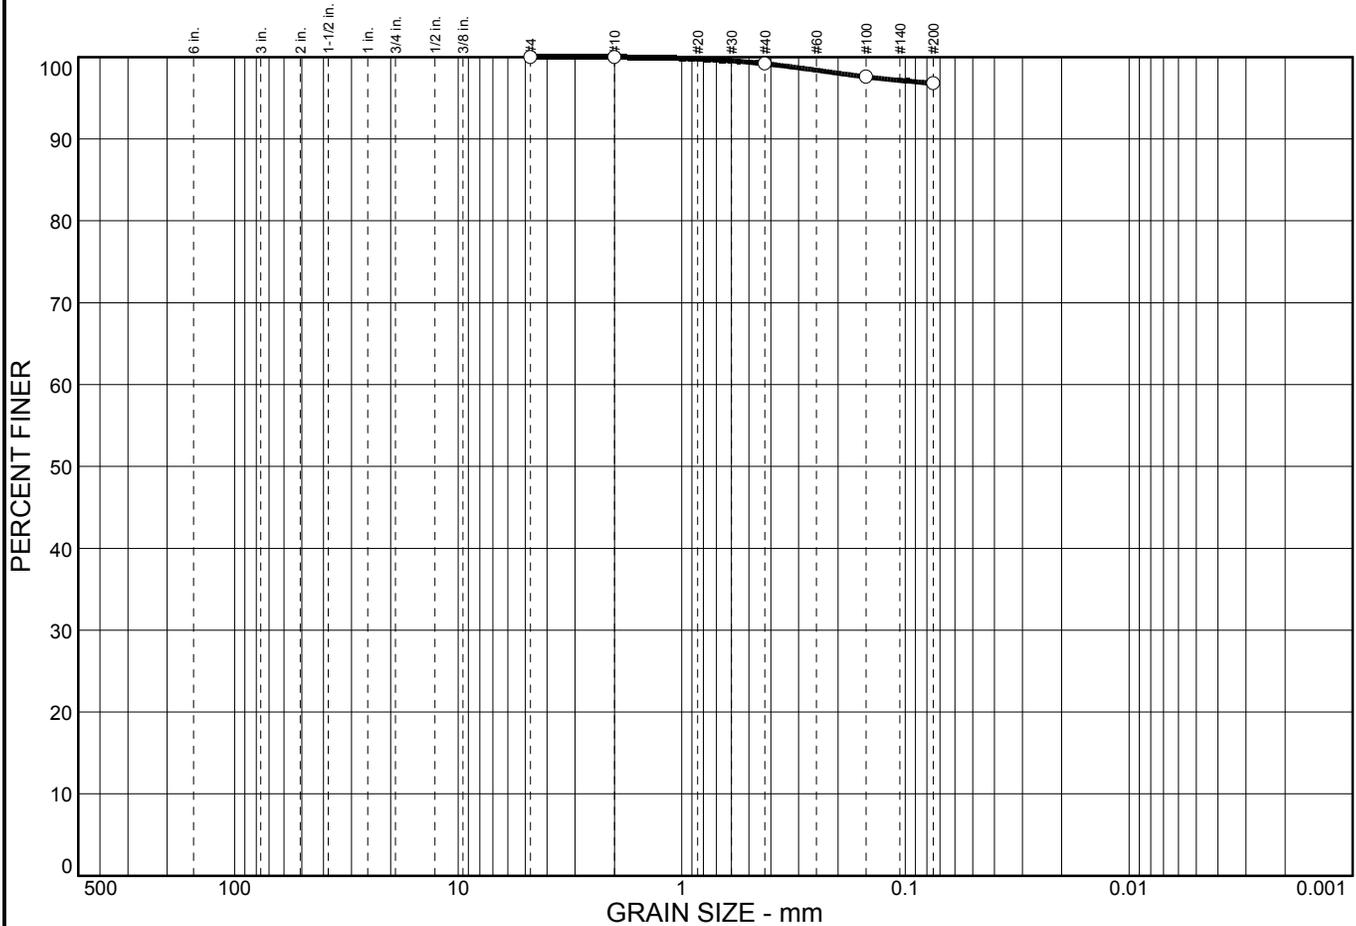
# Particle Size Distribution Report

% COBBLES	% GRAVEL	% SAND	% SILT	% CLAY
0.0	0.0	3.2	96.8

SIEVE SIZE	PERCENT FINER	SPEC.* PERCENT	PASS? (X=NO)
#4	100.0		
#10	100.0		
#40	99.2		
#100	97.6		
#200	96.8

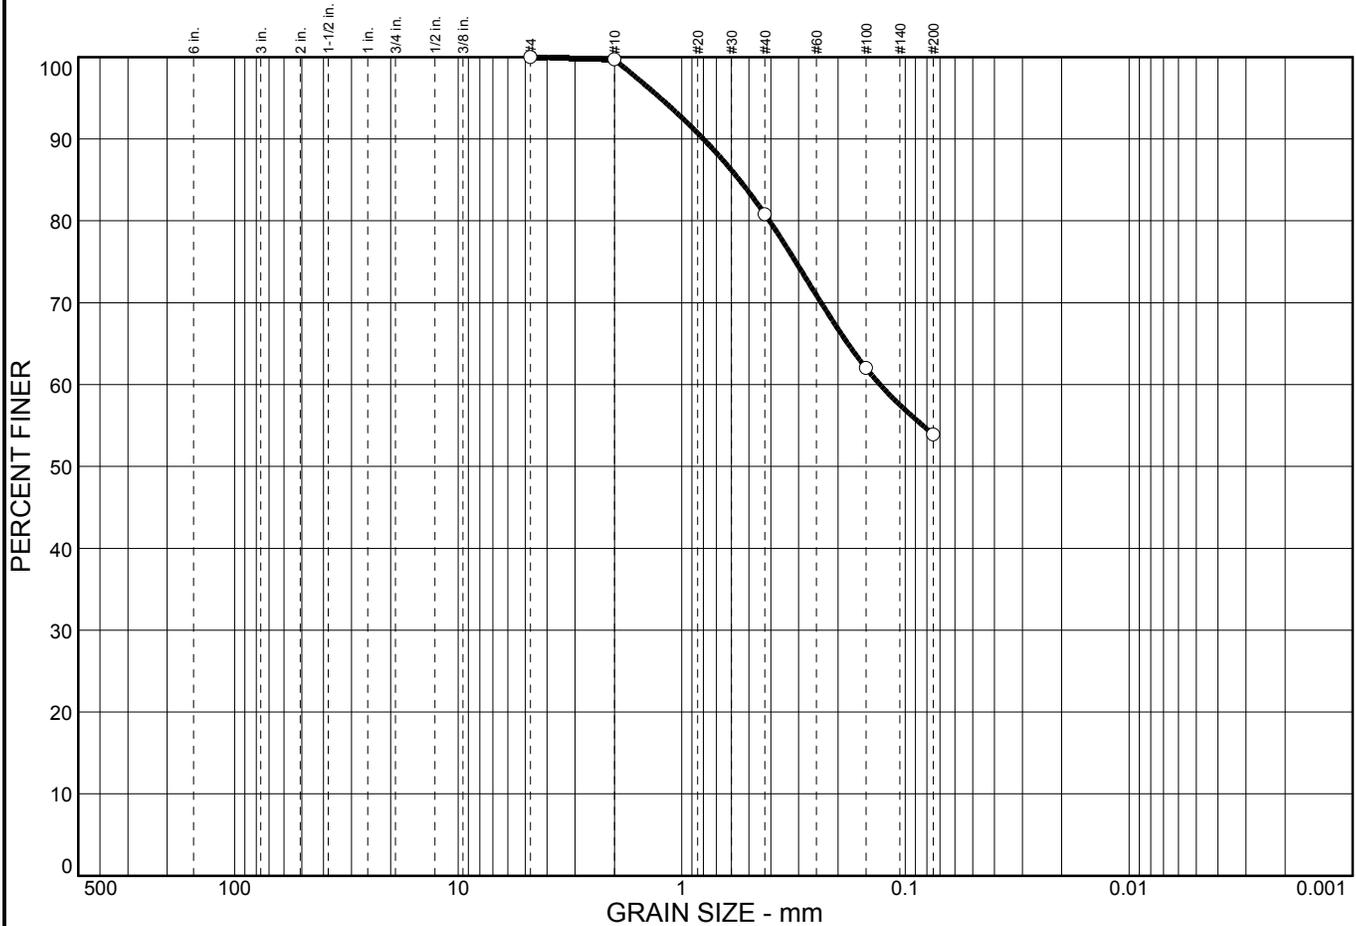
# Particle Size Distribution Report

% COBBLES	% GRAVEL	% SAND	% SILT	% CLAY
0.0	0.0	46.1	53.9

SIEVE SIZE	PERCENT FINER	SPEC.* PERCENT	PASS? (X=NO)
#4	100.0		
#10	99.7		
#40	80.8		
#100	62.0		
#200	53.9

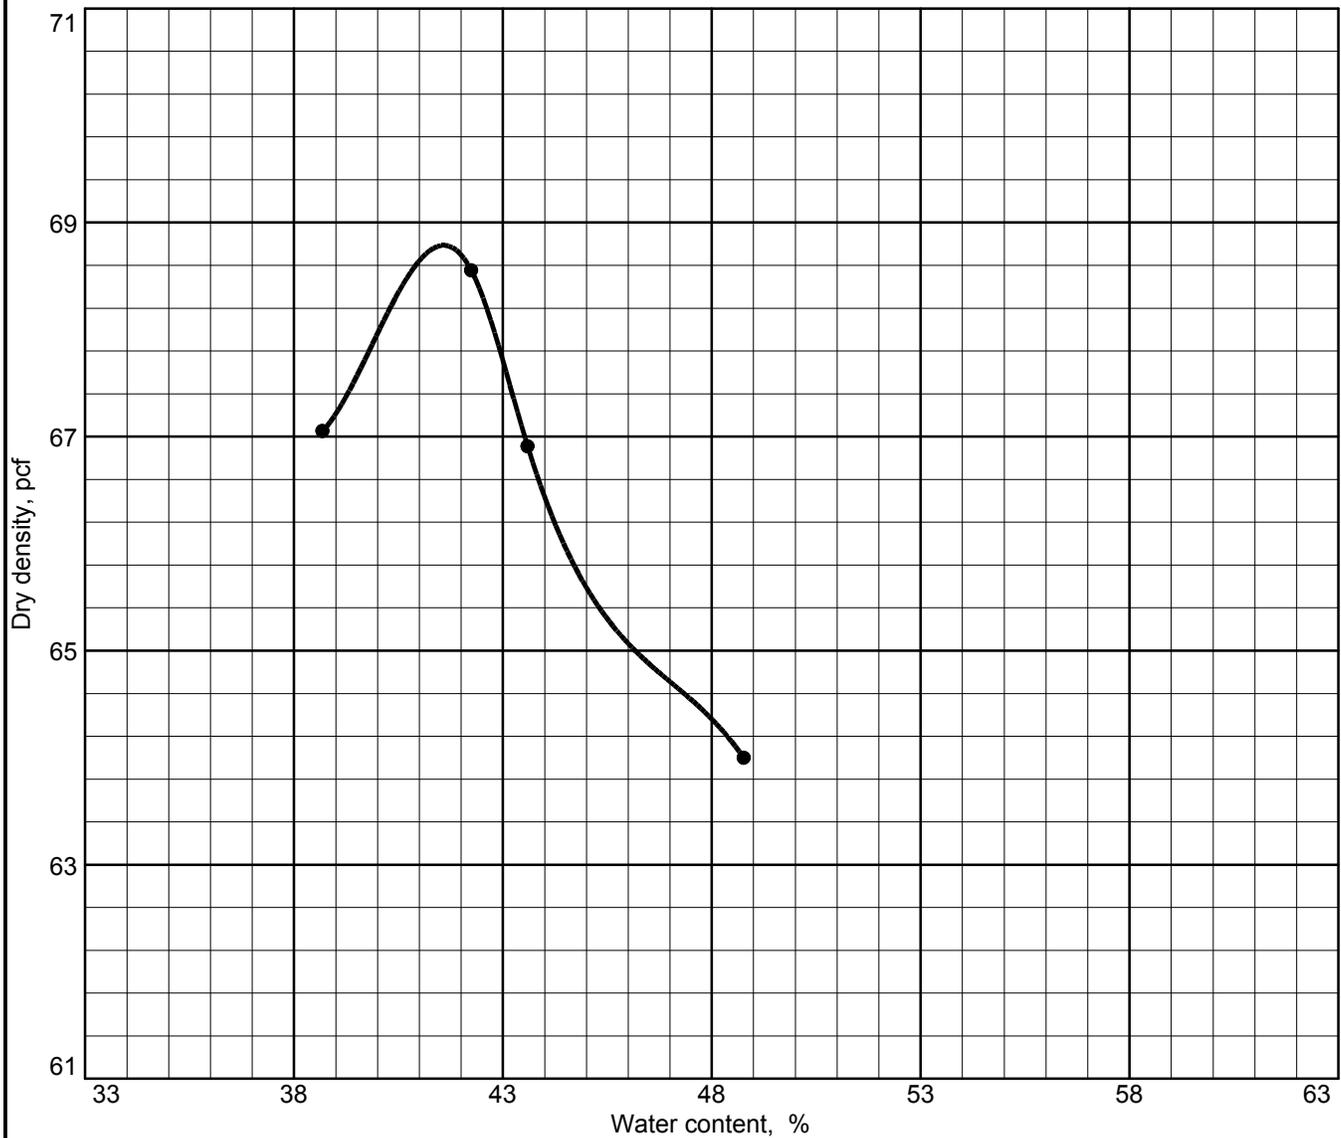
# COMPACTION TEST REPORT

Test specification: ASTM D 1557-00 Method C Modified

Elev/ Depth	Classification		Nat. Moist.	Sp.G.	LL	PI	% > 3/4 in.	% < No.200
	USCS	AASHTO						
	ML	A-4(0)			NP	NP	0.0	53.9

TEST RESULTS	MATERIAL DESCRIPTION
Maximum dry density = 68.8 pcf Optimum moisture = 41.6 %	Sandy silt. Aggremax Grab
<b>Project No.</b> 7899 <b>Client:</b> Carrasquillo Engineering Services <b>Project:</b> CDR Landfill at AES, Guayama, PR <span style="float: right;"><b>Date:</b> 9/7/18</span> <b>Location:</b> Guayama, PR      Source Sample: Project Site	<b>Remarks:</b> Tested by: J. Ortiz/J. Cordova Checked by: Rommel Cintron Aponte, MSCE, PE Job No.: 7899
<b>JACA &amp; SIERRA TESTING LABORATORIES</b> <b>San Juan, Puerto Rico</b>

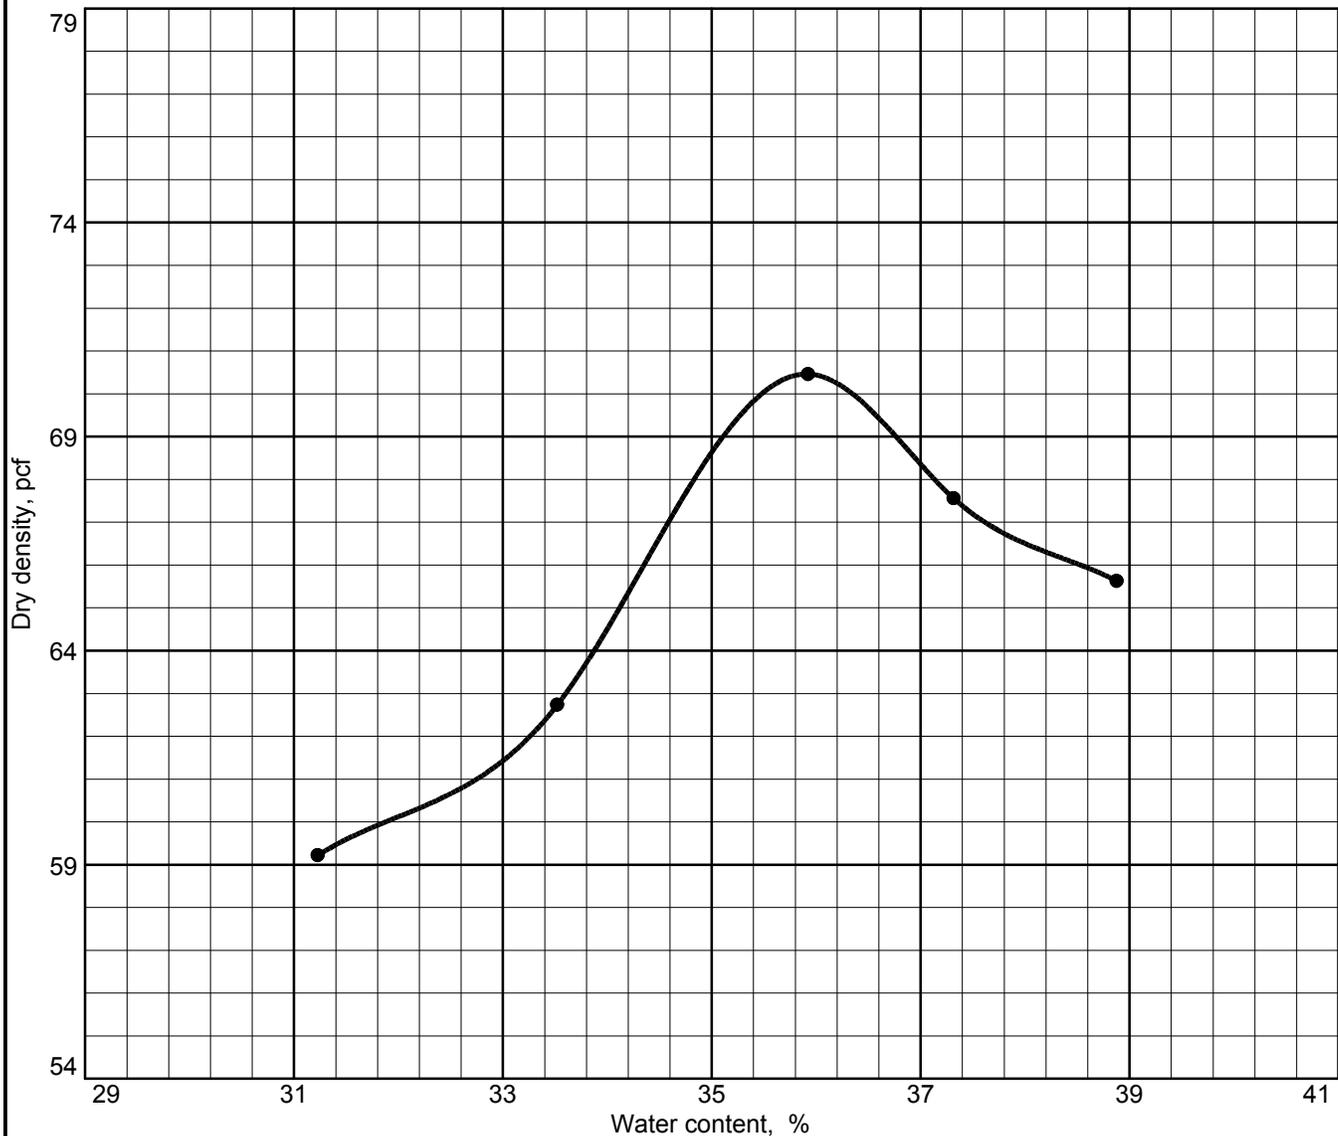
# COMPACTION TEST REPORT

Test specification: ASTM D 1557-00 Method C Modified

Elev/ Depth	Classification		Nat. Moist.	Sp.G.	LL	PI	% > 3/4 in.	% < No.200
	USCS	AASHTO						
	SM	A-4(0)			NP	NP	0.0	39.5

TEST RESULTS	MATERIAL DESCRIPTION
Maximum dry density = 70.5 pcf Optimum moisture = 35.9 %	Silty sand. Aggremax Grab
<b>Project No.</b> 7899 <b>Client:</b> Carrasquillo Engineering Services <b>Project:</b> CDR Landfill at AES, Guayama, PR <span style="float: right;"><b>Date:</b> 9/7/18</span> <b>• Location:</b> Guayama, PR      Source Sample: Project Site	<b>Remarks:</b> Tested by: J. Ortiz/J. Cordova Checked by: Rommel Cintron Aponte, MSCE, PE Job. No. 7899
<b>JACA &amp; SIERRA TESTING LABORATORIES</b> <b>San Juan, Puerto Rico</b>

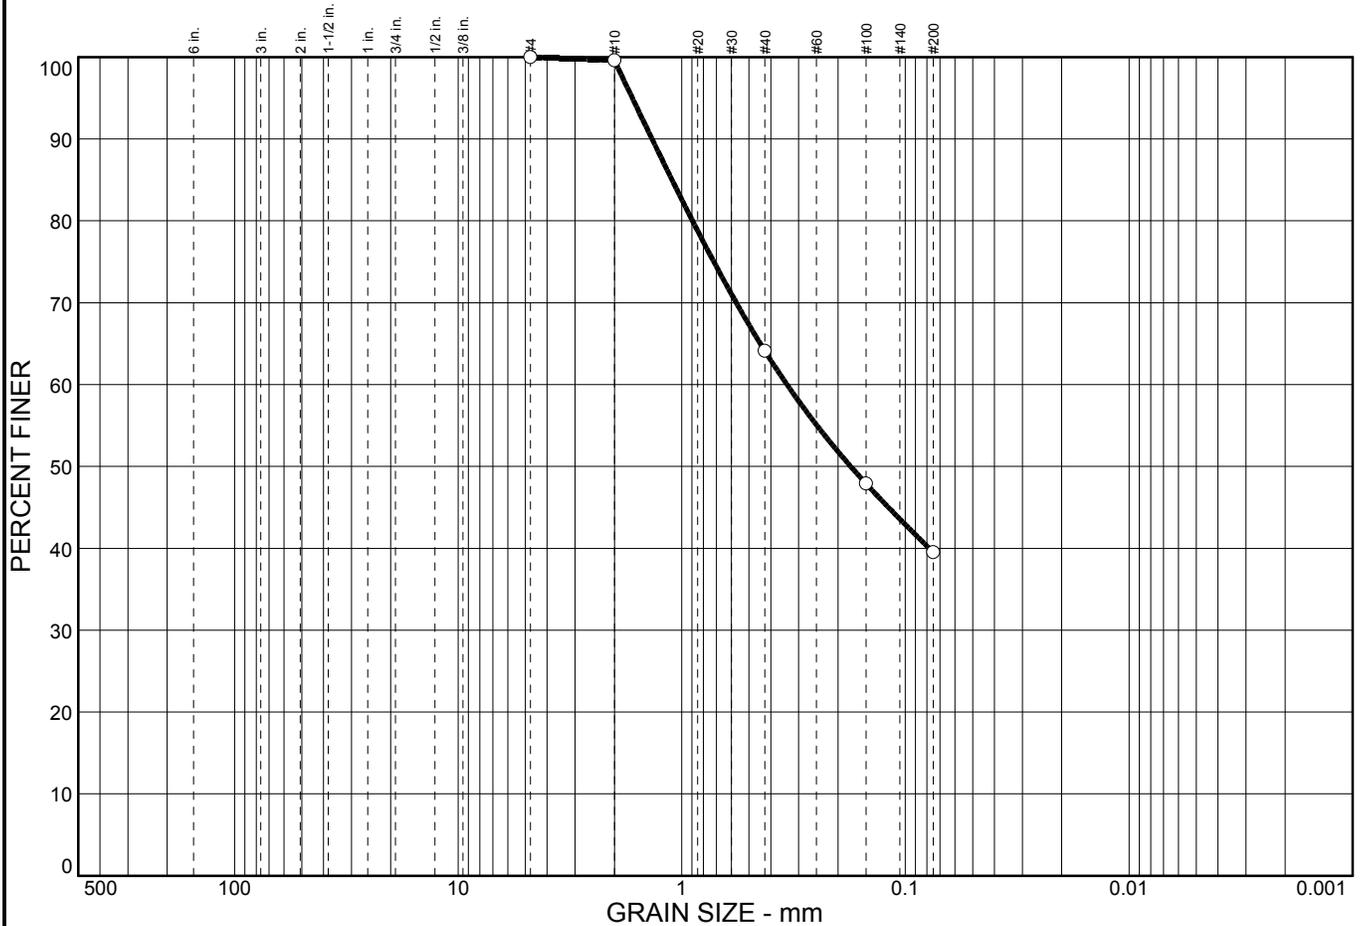
# Particle Size Distribution Report

% COBBLES	% GRAVEL	% SAND	% SILT	% CLAY
0.0	0.0	60.5	39.5

SIEVE SIZE	PERCENT FINER	SPEC.* PERCENT	PASS? (X=NO)
#4	100.0		
#10	99.6		
#40	64.1		
#100	47.9		
#200	39.5
