Preliminary Karst Field Reconnaissance

AES – Riverside Solar Project

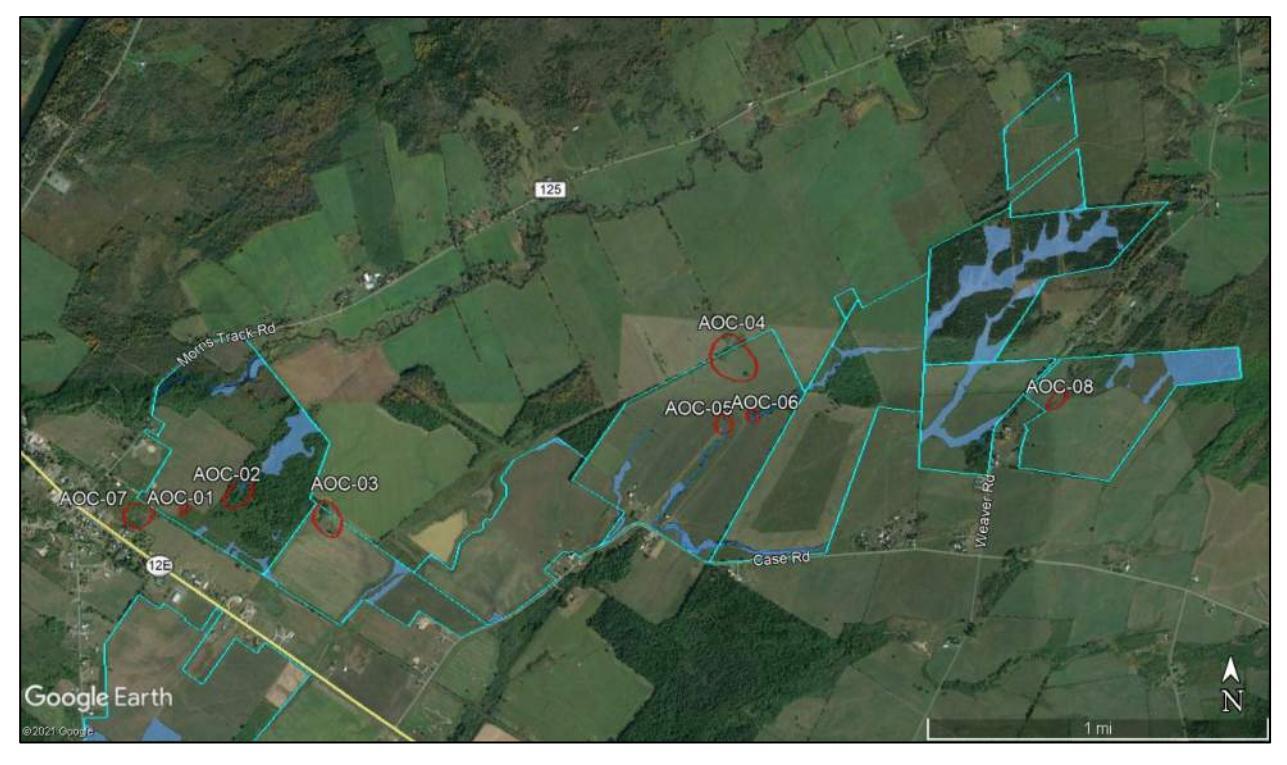
Figure 1 – Site Map

Prior to the start of work, ANS Geo was provided a figure identifying the location of four areas of consideration ("AOC"). Each of these areas have been labeled as AOC-01 through AOC-04, from west to east. Additionally, while on site and after reviewing publicly available digital elevation models, our geotechnical representative added four more areas to be evaluated, labeled AOC-05 through AOC-08. A map is provided below with the areas labeled.
